a. Micerinus Pyramid Temple, seen from the Second Pyramid, looking down to south. Previous to excavation. December 1, 1906.

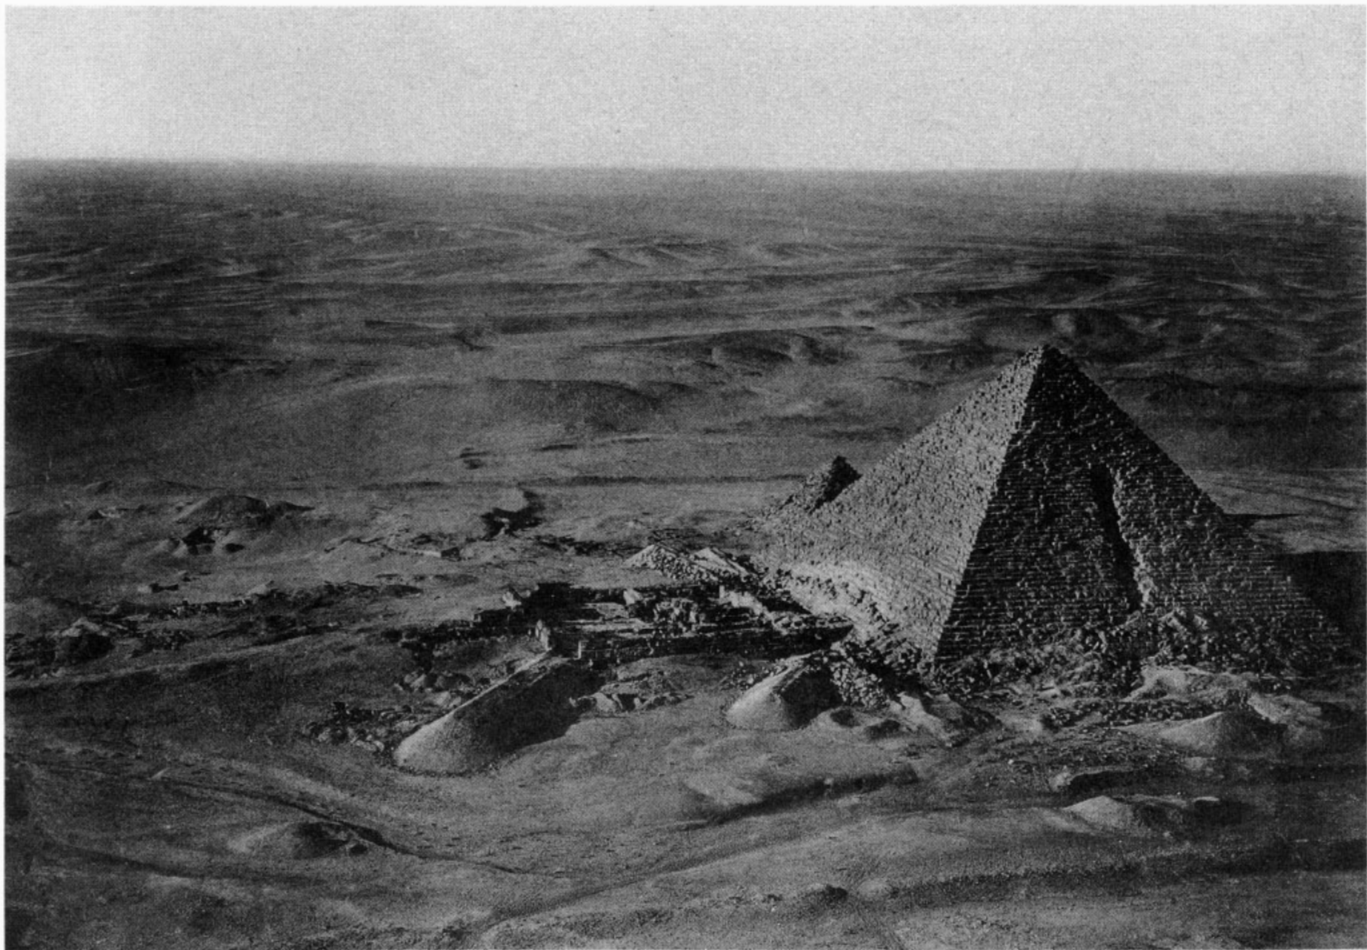
b. Micerinus Pyramid Temple, seen from the Second Pyramid, looking down to south. After excavation. April 16, 1907.

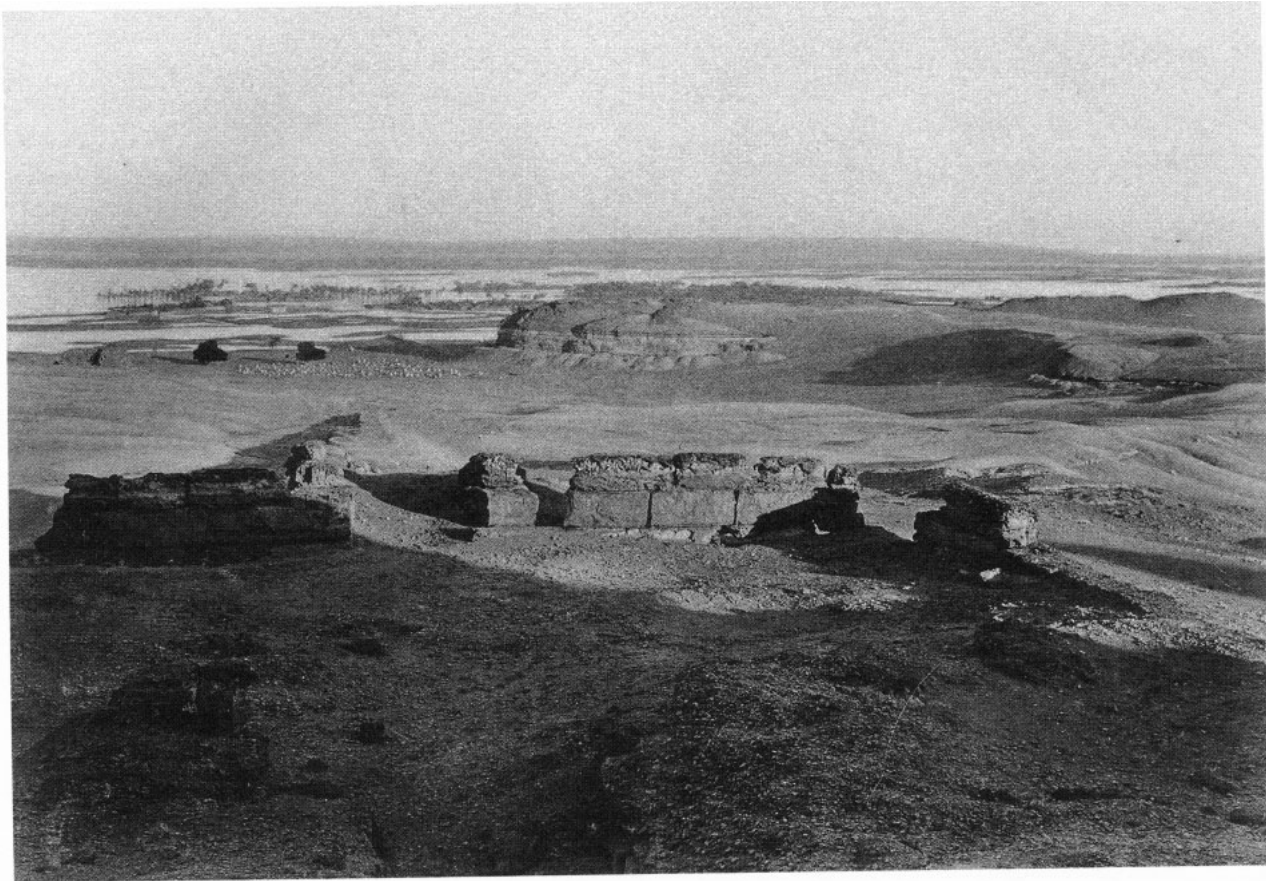
a. Mycerinus Pyramid Temple, outer temple, seen from the Third Pyramid, looking down to east. Previous to excavation, December 1, 1906.

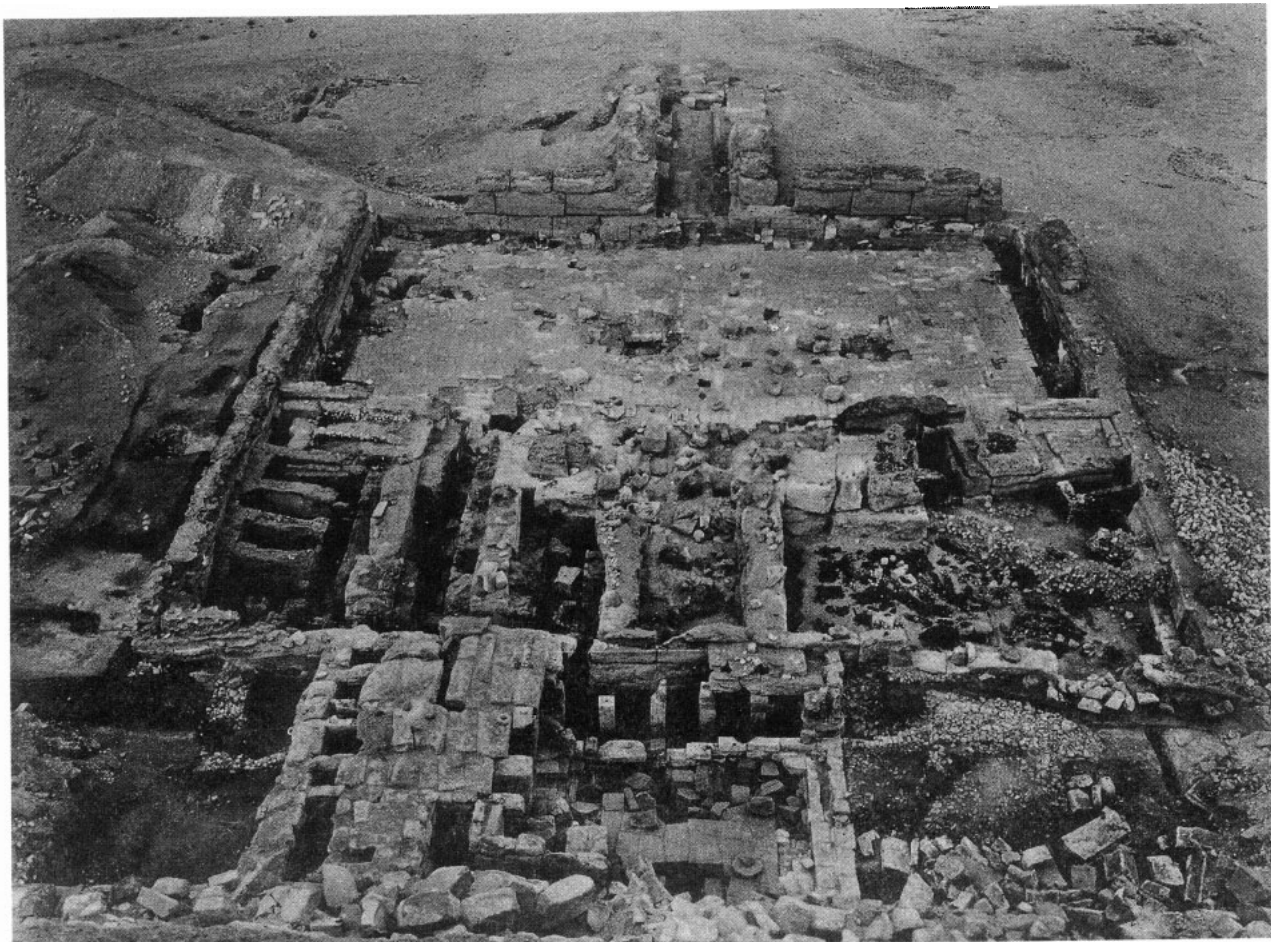
b. Mycerinus Pyramid Temple, seen from the Third Pyramid, looking down to east. After excavation, May 18, 1907.

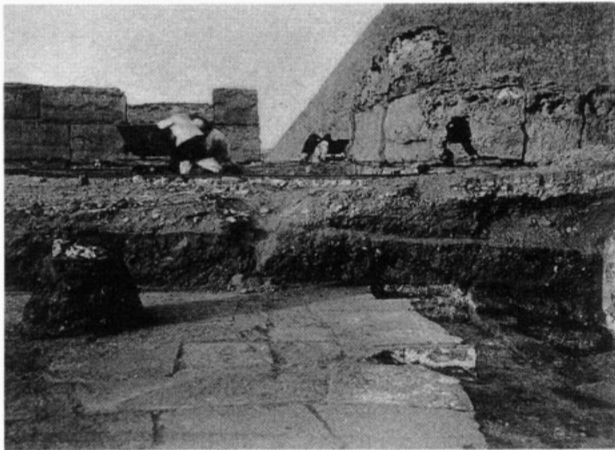
a. M. P. T., court (5), with layers of debris, looking north, January 9, 1907.

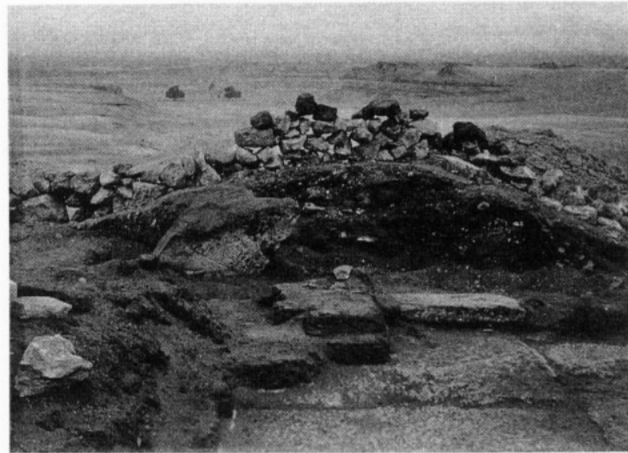
b. M. P. T., entrance doorway (2), looking east, stela 07-1-21 as found, January 6, 1907.

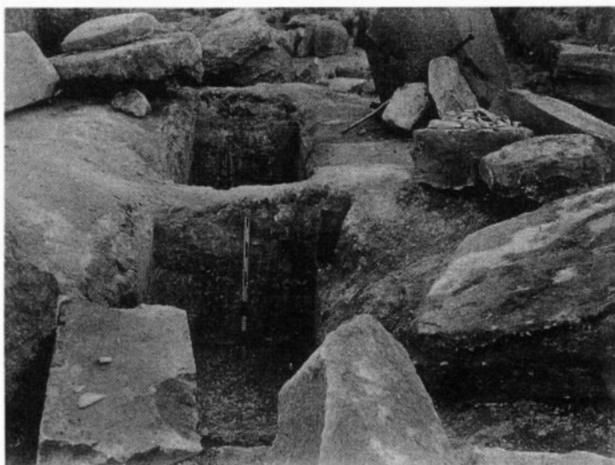
c. M. P. T., portico (7), pillar-sockets south of temple axis, looking west, May 10, 1907.

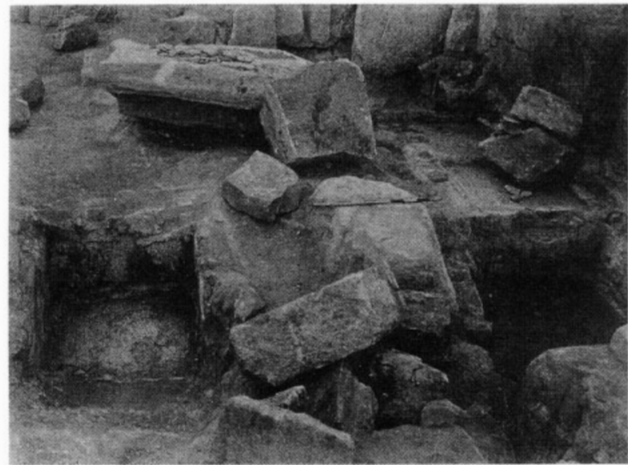
d. M. P. T., portico (7), pillar-sockets of western row, north side, looking west, May 10, 1907.

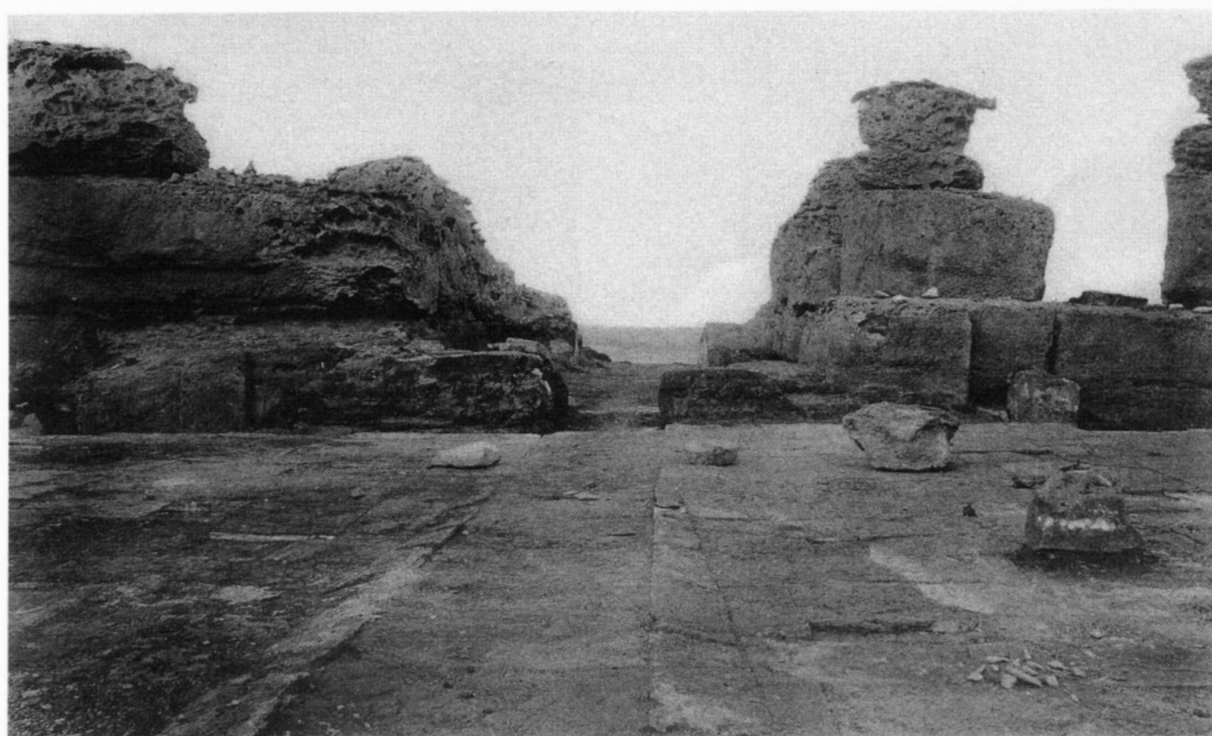
e. M. P. T., footway across court (5) and entrance corridor (3), looking east from center of court, June, 1907.

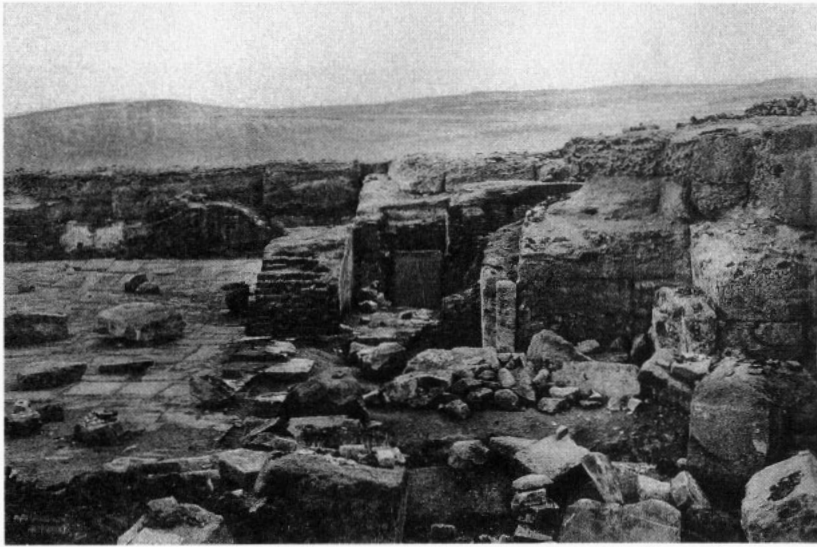
a. M. P. T., portico (7) and screen-wall, looking south, February 7, 1907.

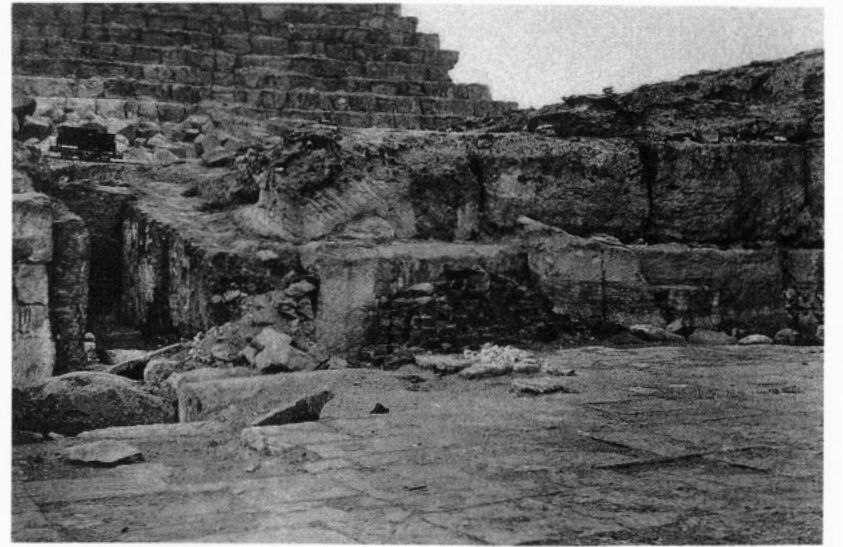
b. M. P. T., court (5), N. W. quarter with doorway (12), looking northwest, February 7, 1907.

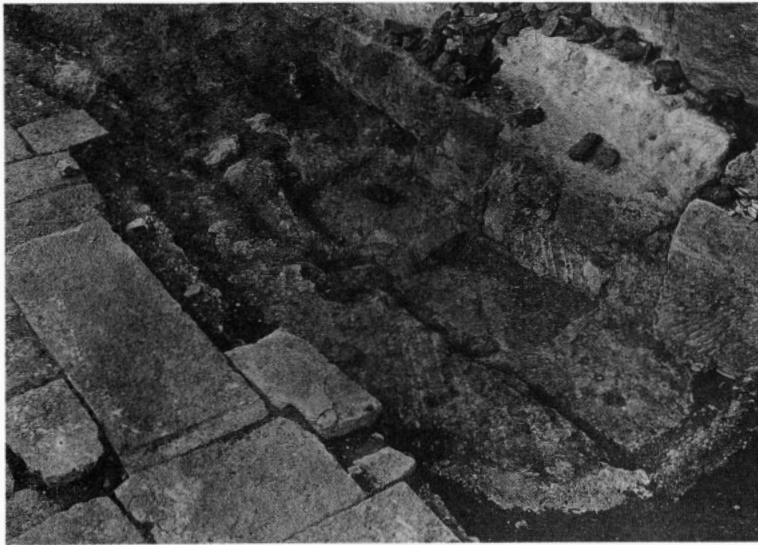
c. M. P. T., court (5), east wall, south part, emplacements for granite casing, looking down to N. E., June, 1907.

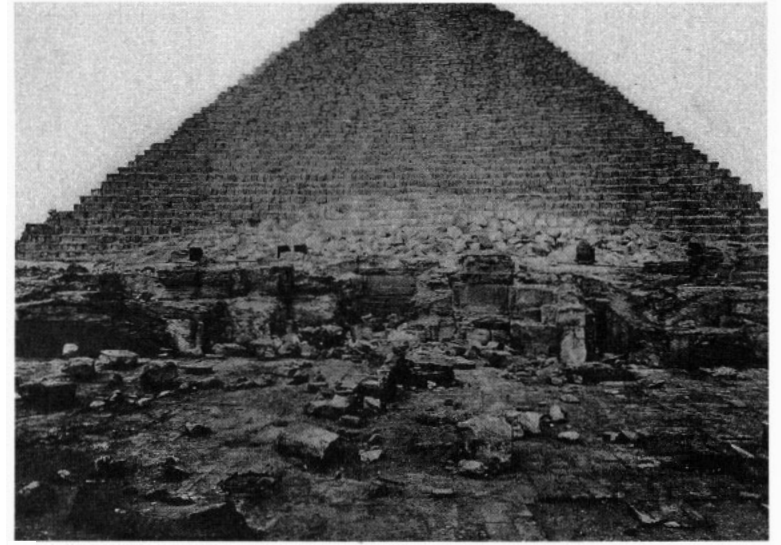
d. M. P. T., court (5), portico (7) and offering room (8), from eastern side of court, looking west, June, 1907.

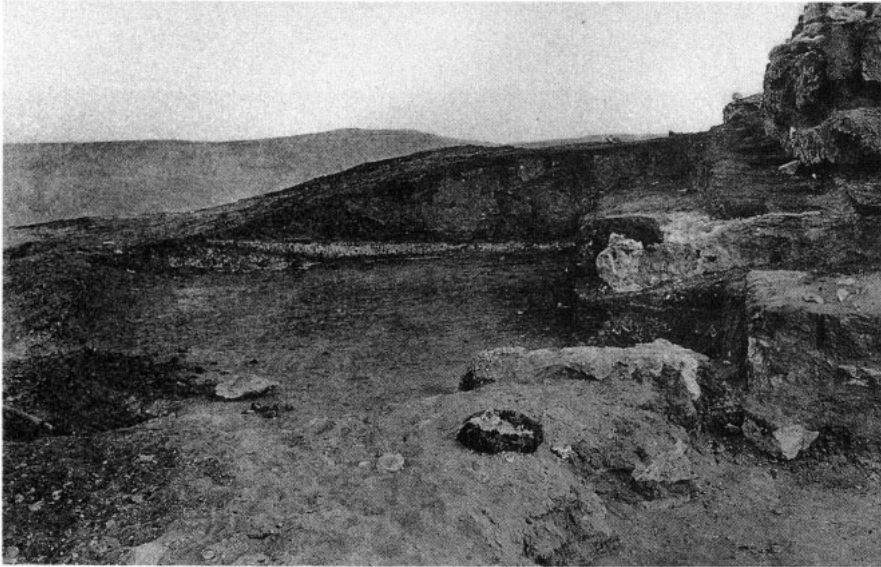
a. M. P. T., causeway corridor, western end, looking south, June, 1907.

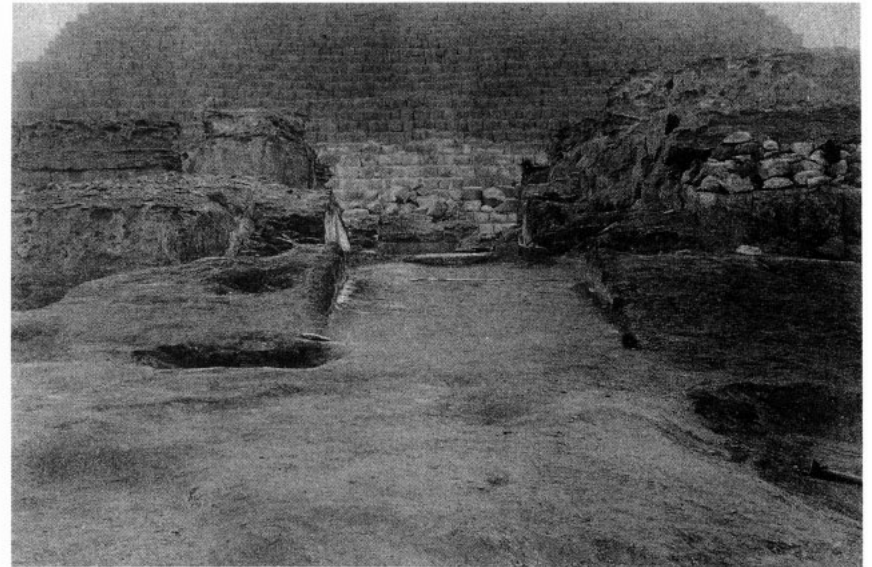
b. M. P. T., causeway corridor, western end, looking west into temple, June, 1907.

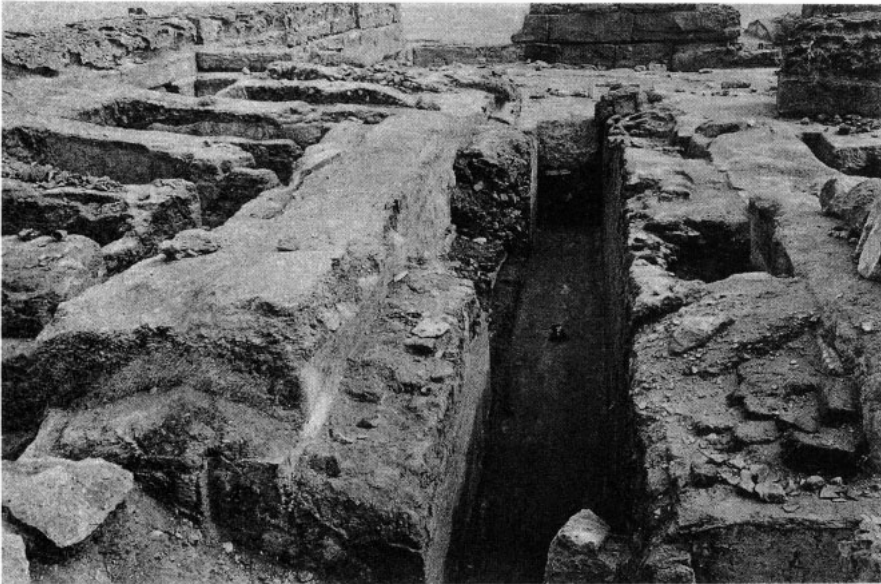
c. M. P. T., northern corridor, (13), looking east, February 10, 1907.

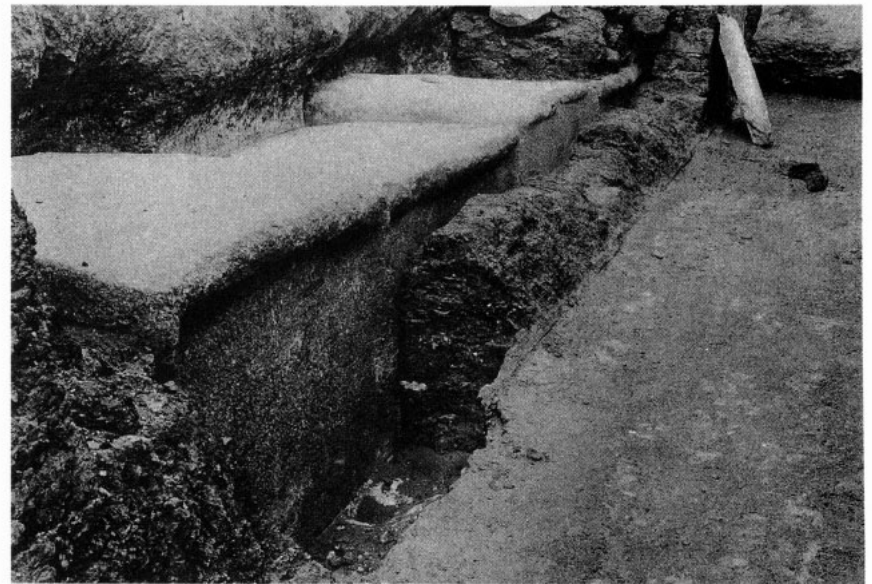
d. M. P. T., northern corridor (13), north wall, black granite casing, looking N. E., May 27, 1907.

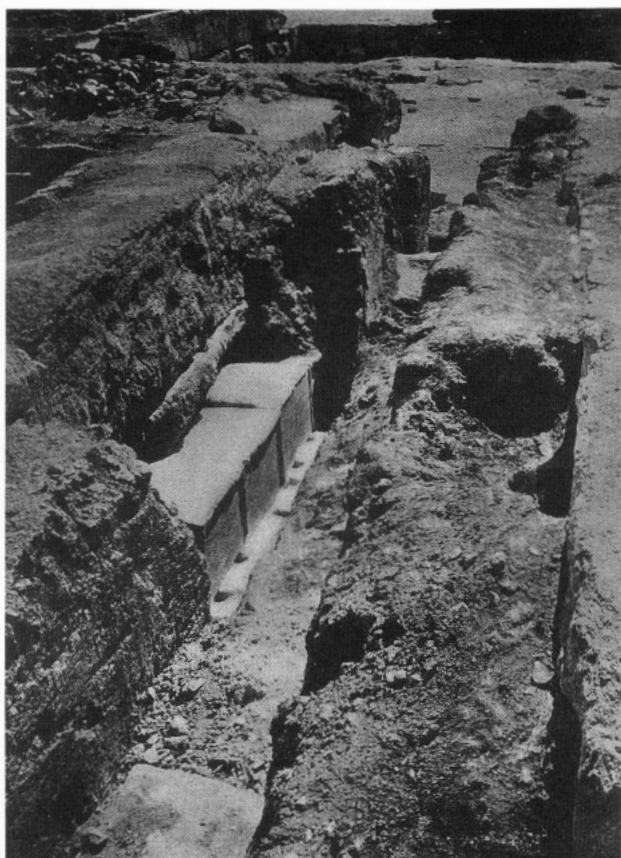
a. M. P. T., northern corridor (13), north wall, granite casing, looking down to E. N. E., October, 1923.

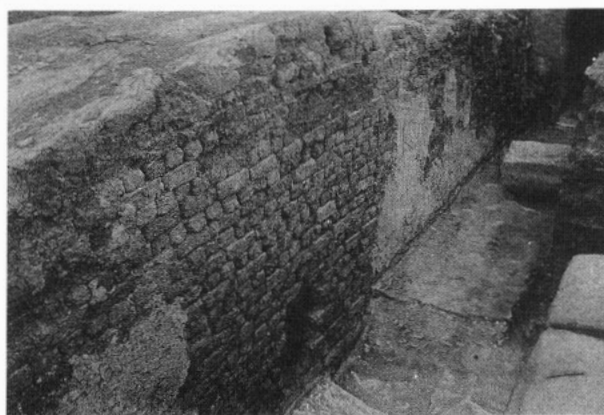
b. M. P. T., northern corridor (13), south wall, crude-brick casing partly stripped of plaster, looking down to W. S. W., October, 1923.

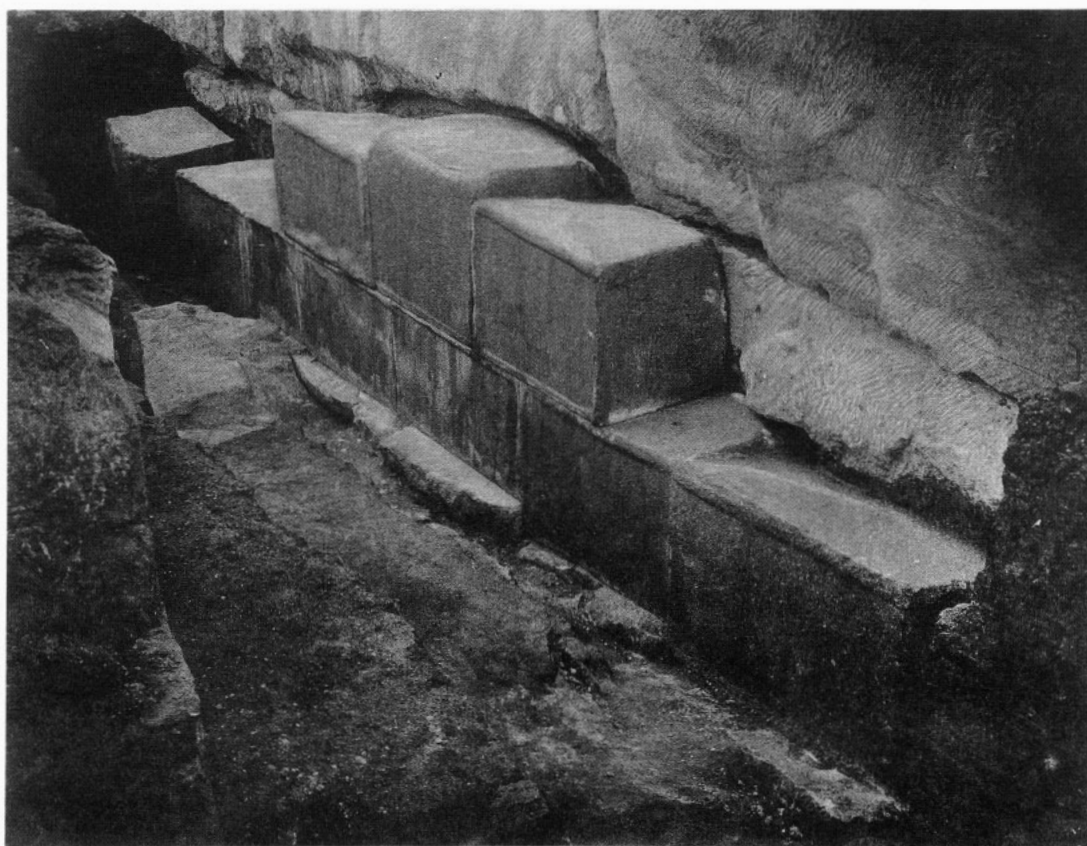
c. M. P. T., northern corridor (13), south wall, black granite casing, looking southeast, October, 1923.

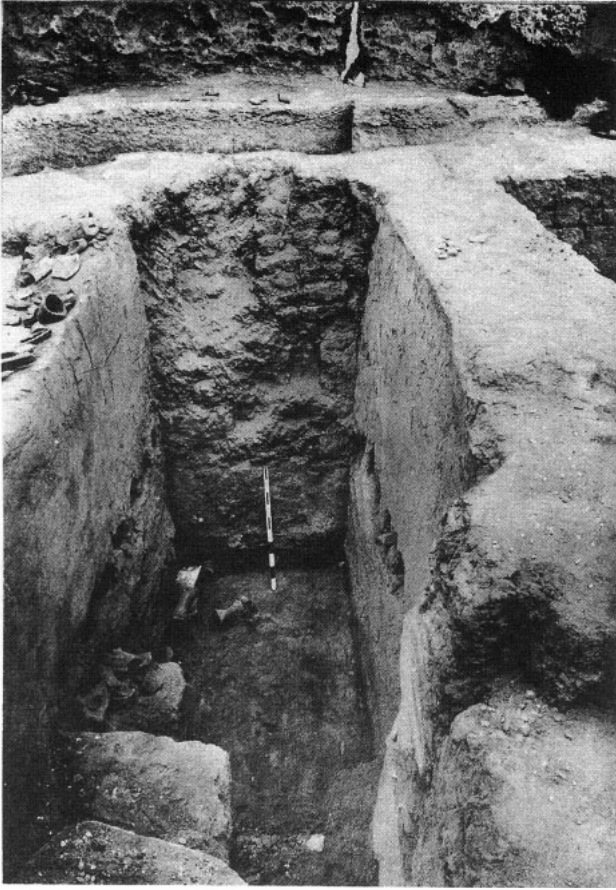
a. M. P. T., magazine (17), looking down north, January 22, 1907.

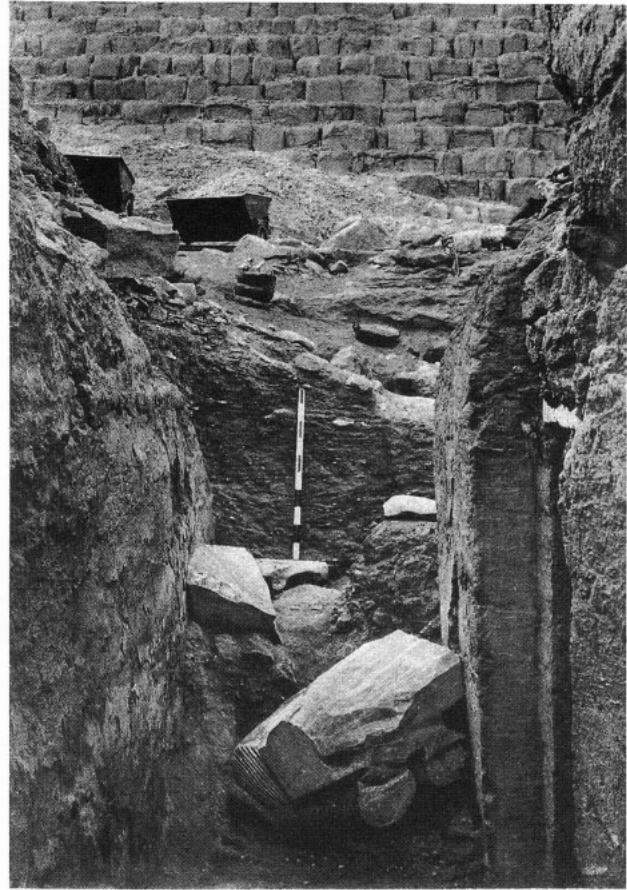
b. M. P. T., corridor (15), looking west, fragments of statues as found, January 23, 1907.

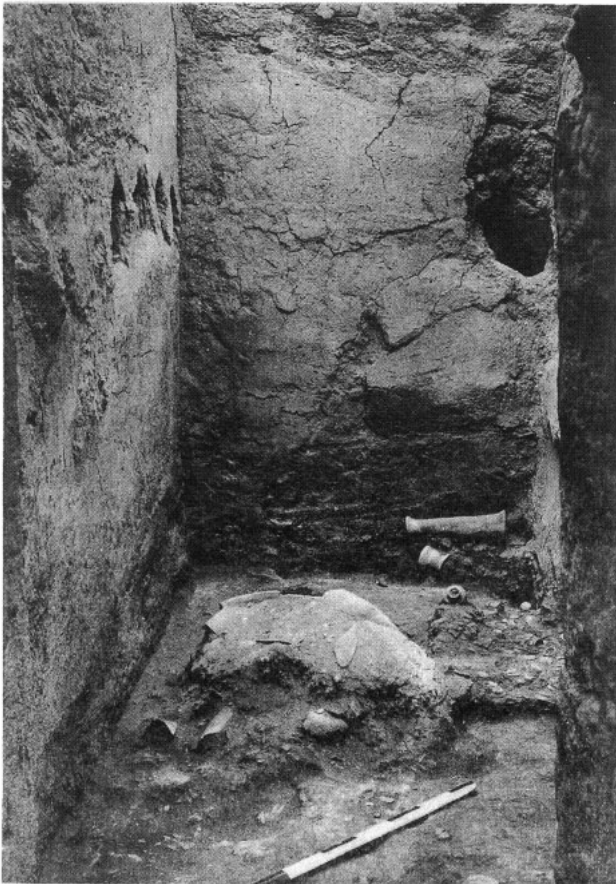
c. M. P. T., magazine (18), looking north, January 22, 1907.

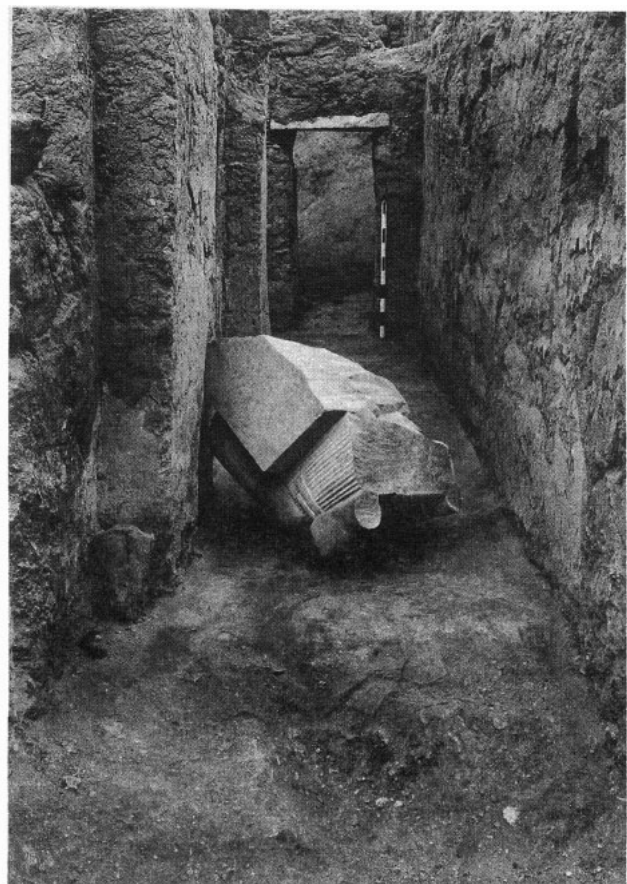
d. M. P. T., corridor (15), looking east, knees of statue No. 1, as found, January 23, 1907.

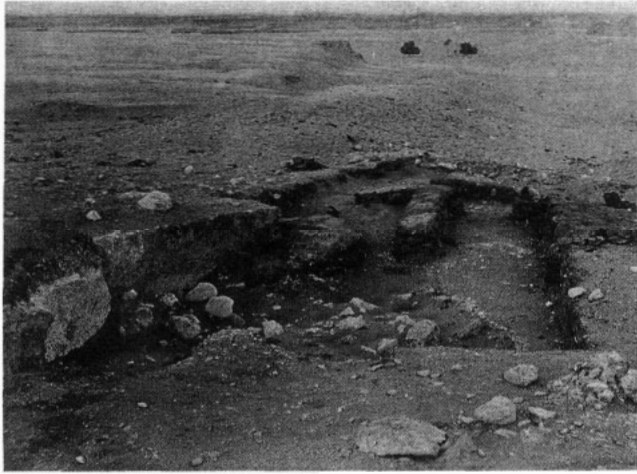
a. M. P. T., crude-brick walls, south of western end of causeway, looking east, June, 1907.

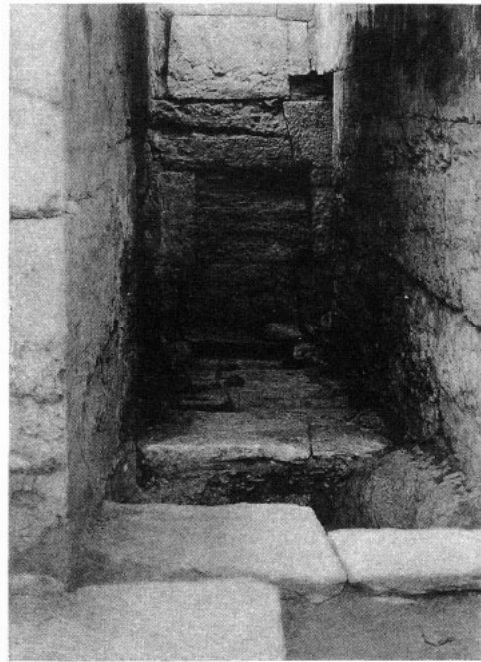
d. M. P. T., corridor (28), sloping floor, looking north, April 5, 1907.

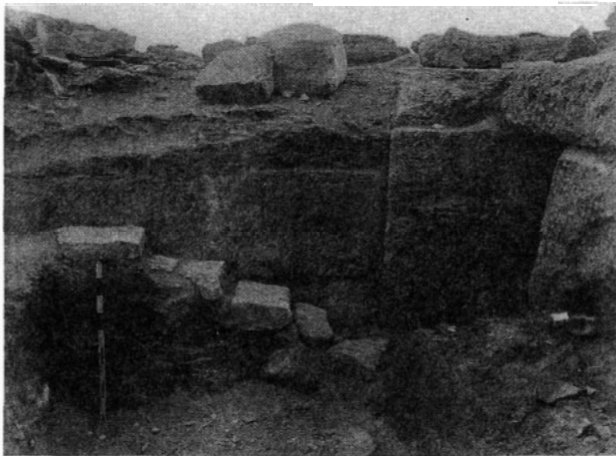
e. M. P. T., room (36), Roman stair on sand, looking east, April 4, 1907.

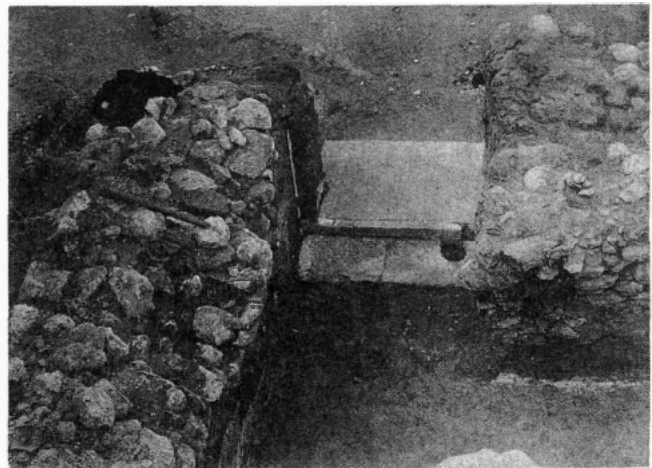
f. M. P. T., room (36), doorway, looking down north, April 12, 1907.

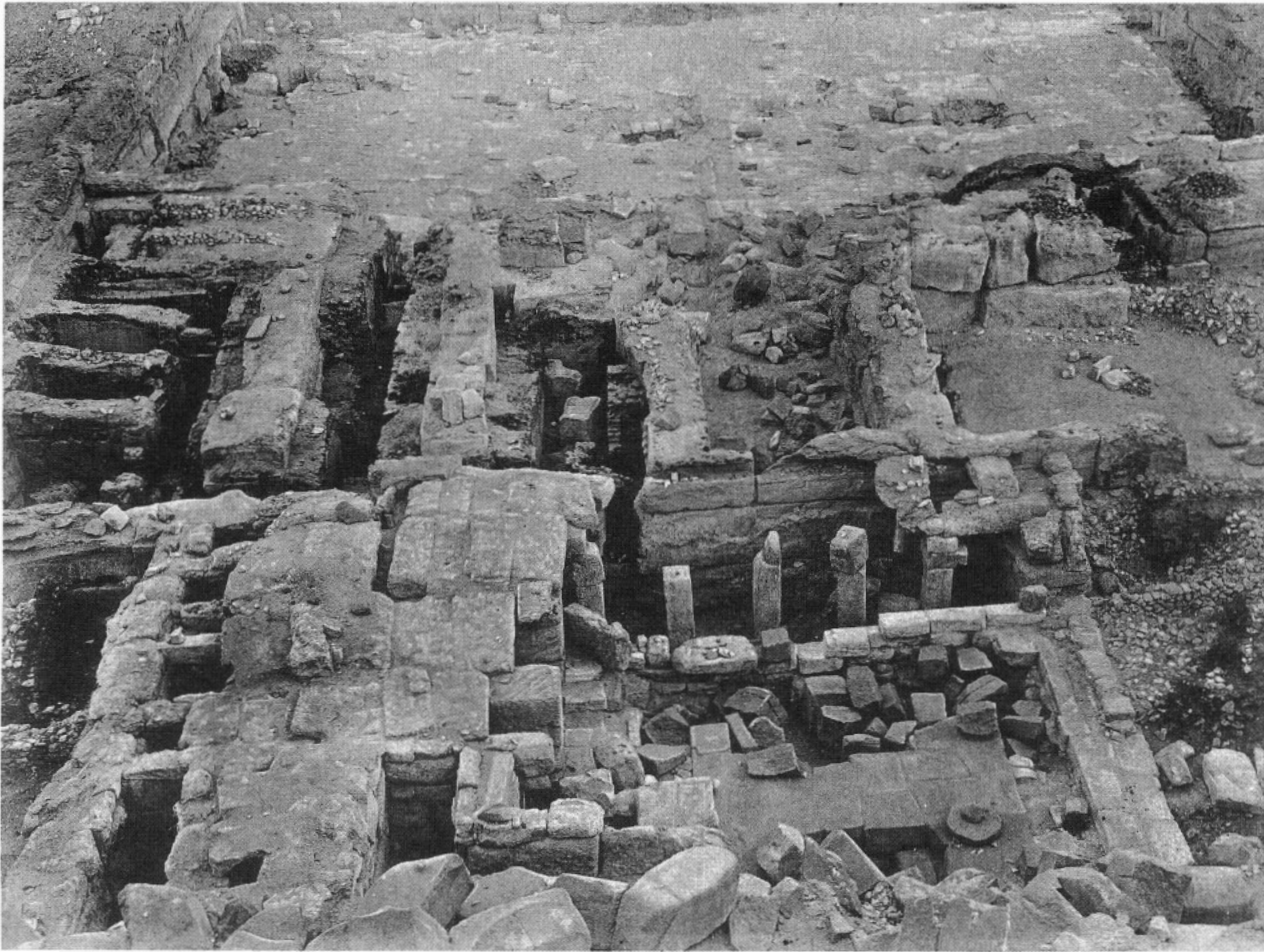
a. M. P. T., inner temple and magazines of outer temple, looking down to east from the pyramid, June, 1907.

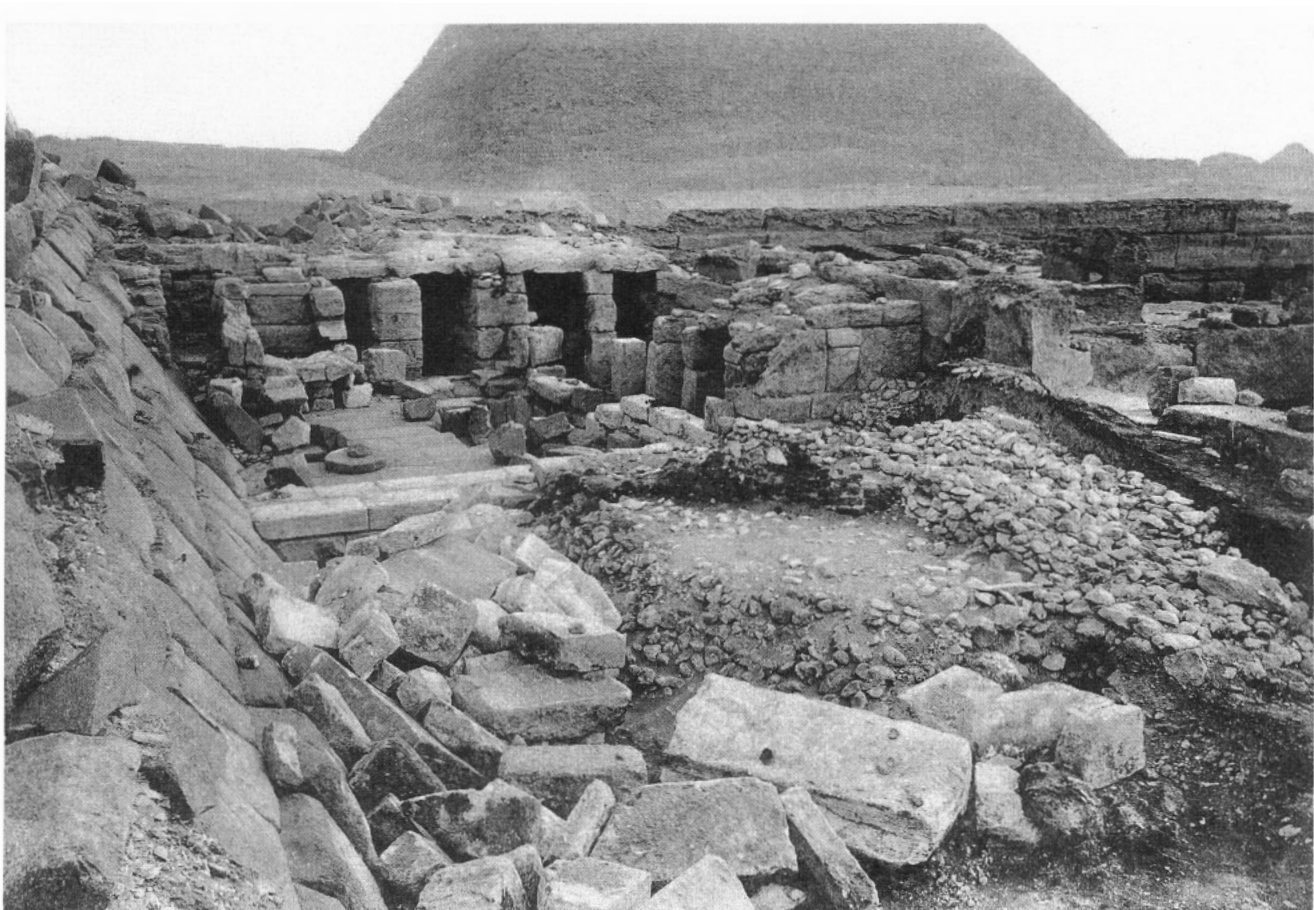
b. M. P. T., inner temple and construction plane, looking north, June, 1907.
