THE WORLD OF ANCIENT EGYPT
ESSAYS IN HONOR OF
AHMED ABD EL-QADER EL-SAWI

ENGINEERING STABILITY AND CONSERVATION OF THE SPHINX: DIAGNOSIS AND TREATMENT

Hany HELAL

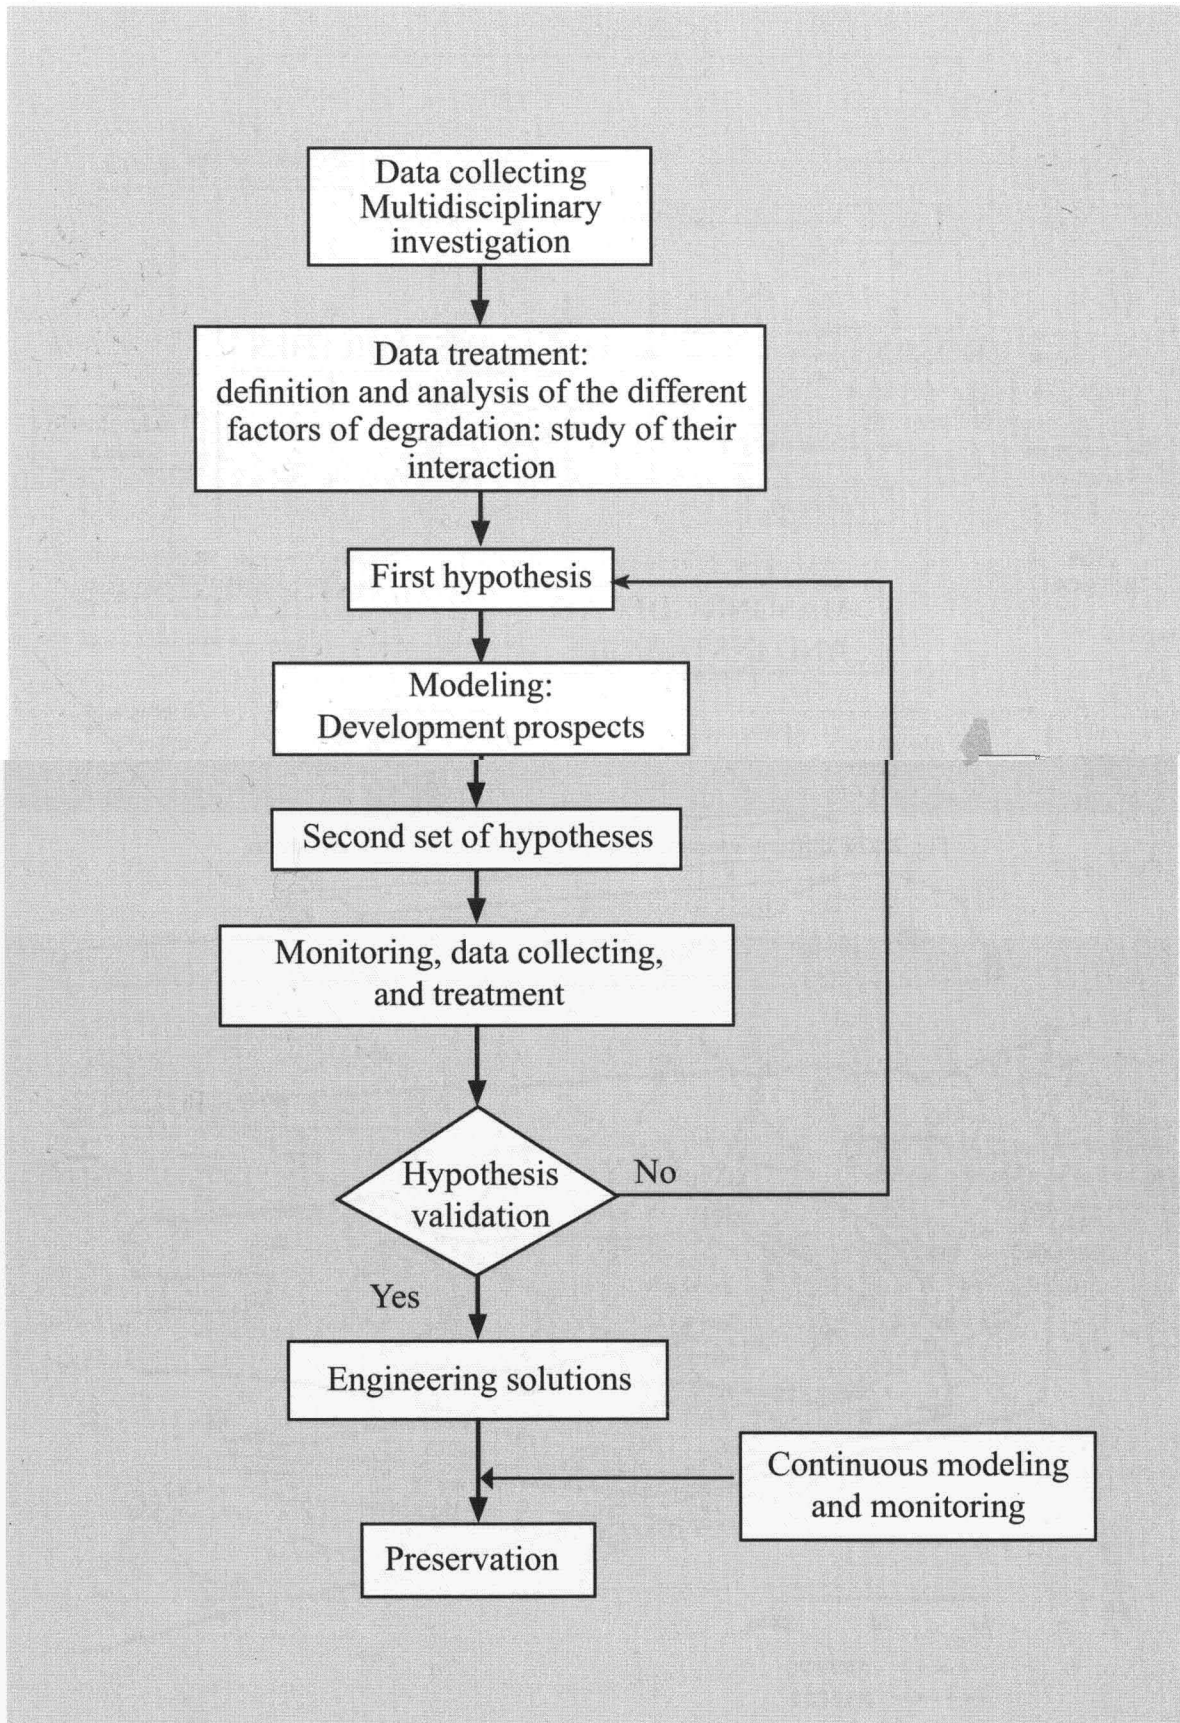
Fig. 1. Adopted Methodology.

Experience gained in the field of geotechnical engineering applied to civil and mining projects has been adopted so that it can be used in the preservation of monuments.² The investigative procedure is outlined in figure 1 and could be divided into a succession of main stages:

A. Carry out exploratory work and collect sufficient data on the site; it is a multidisciplinary investigation. The data collecting concerns:

B. Analyze the data and define the interaction between the different phenomena.

C. Establish the most probable hypothesis of behaviour. These later steps, B and C, require the most experience. It may be helpful to use the recently developing science, the 'dynamic of systems', to find out the consequences on the whole environment of the monument if a confined change of this environment occurs.

D. Modeling the structure and anticipate the future behaviour of the monument; this is necessary to check the hypothesis of behaviour. Modeling categories include: physical, analytical, and numerical.³

E. Select parameters to be observed, calculate their anticipated values, and measure them. Monitoring is usually planned so as to:

F. Modify the model to suit the actual conditions (according to the monitoring measurements) to forecast the future probable phenomena and the validity hypothesis.

G. Determine the most suitable engineering solution using modern tools of geotechnical engineering.

H. Carry out monitoring to check the efficiency of restoration.

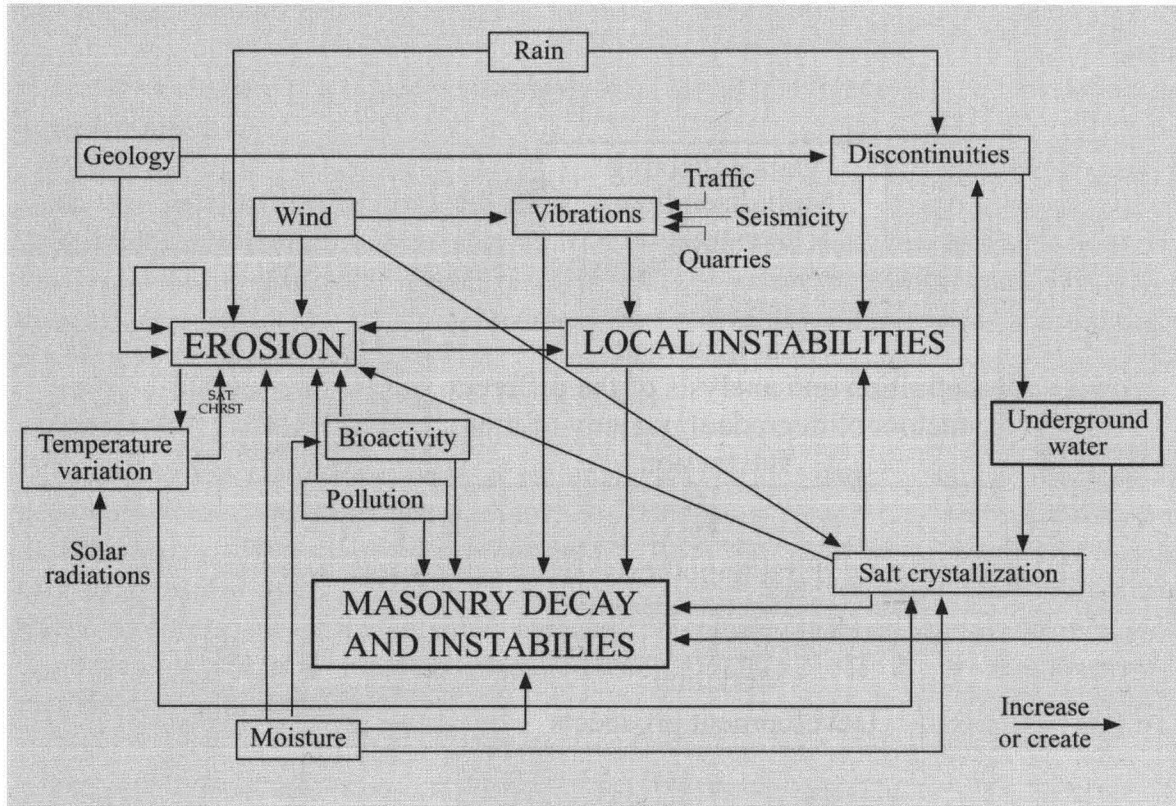
Fig. 2. The different interactions between the factors of degradation.

Figure 2 gives an example of the interaction between different factors of degradation focused on three categories:

- the local instabilities of the mother rock
- the erosion of the mother rock
- the decay and instabilities of the masonry
