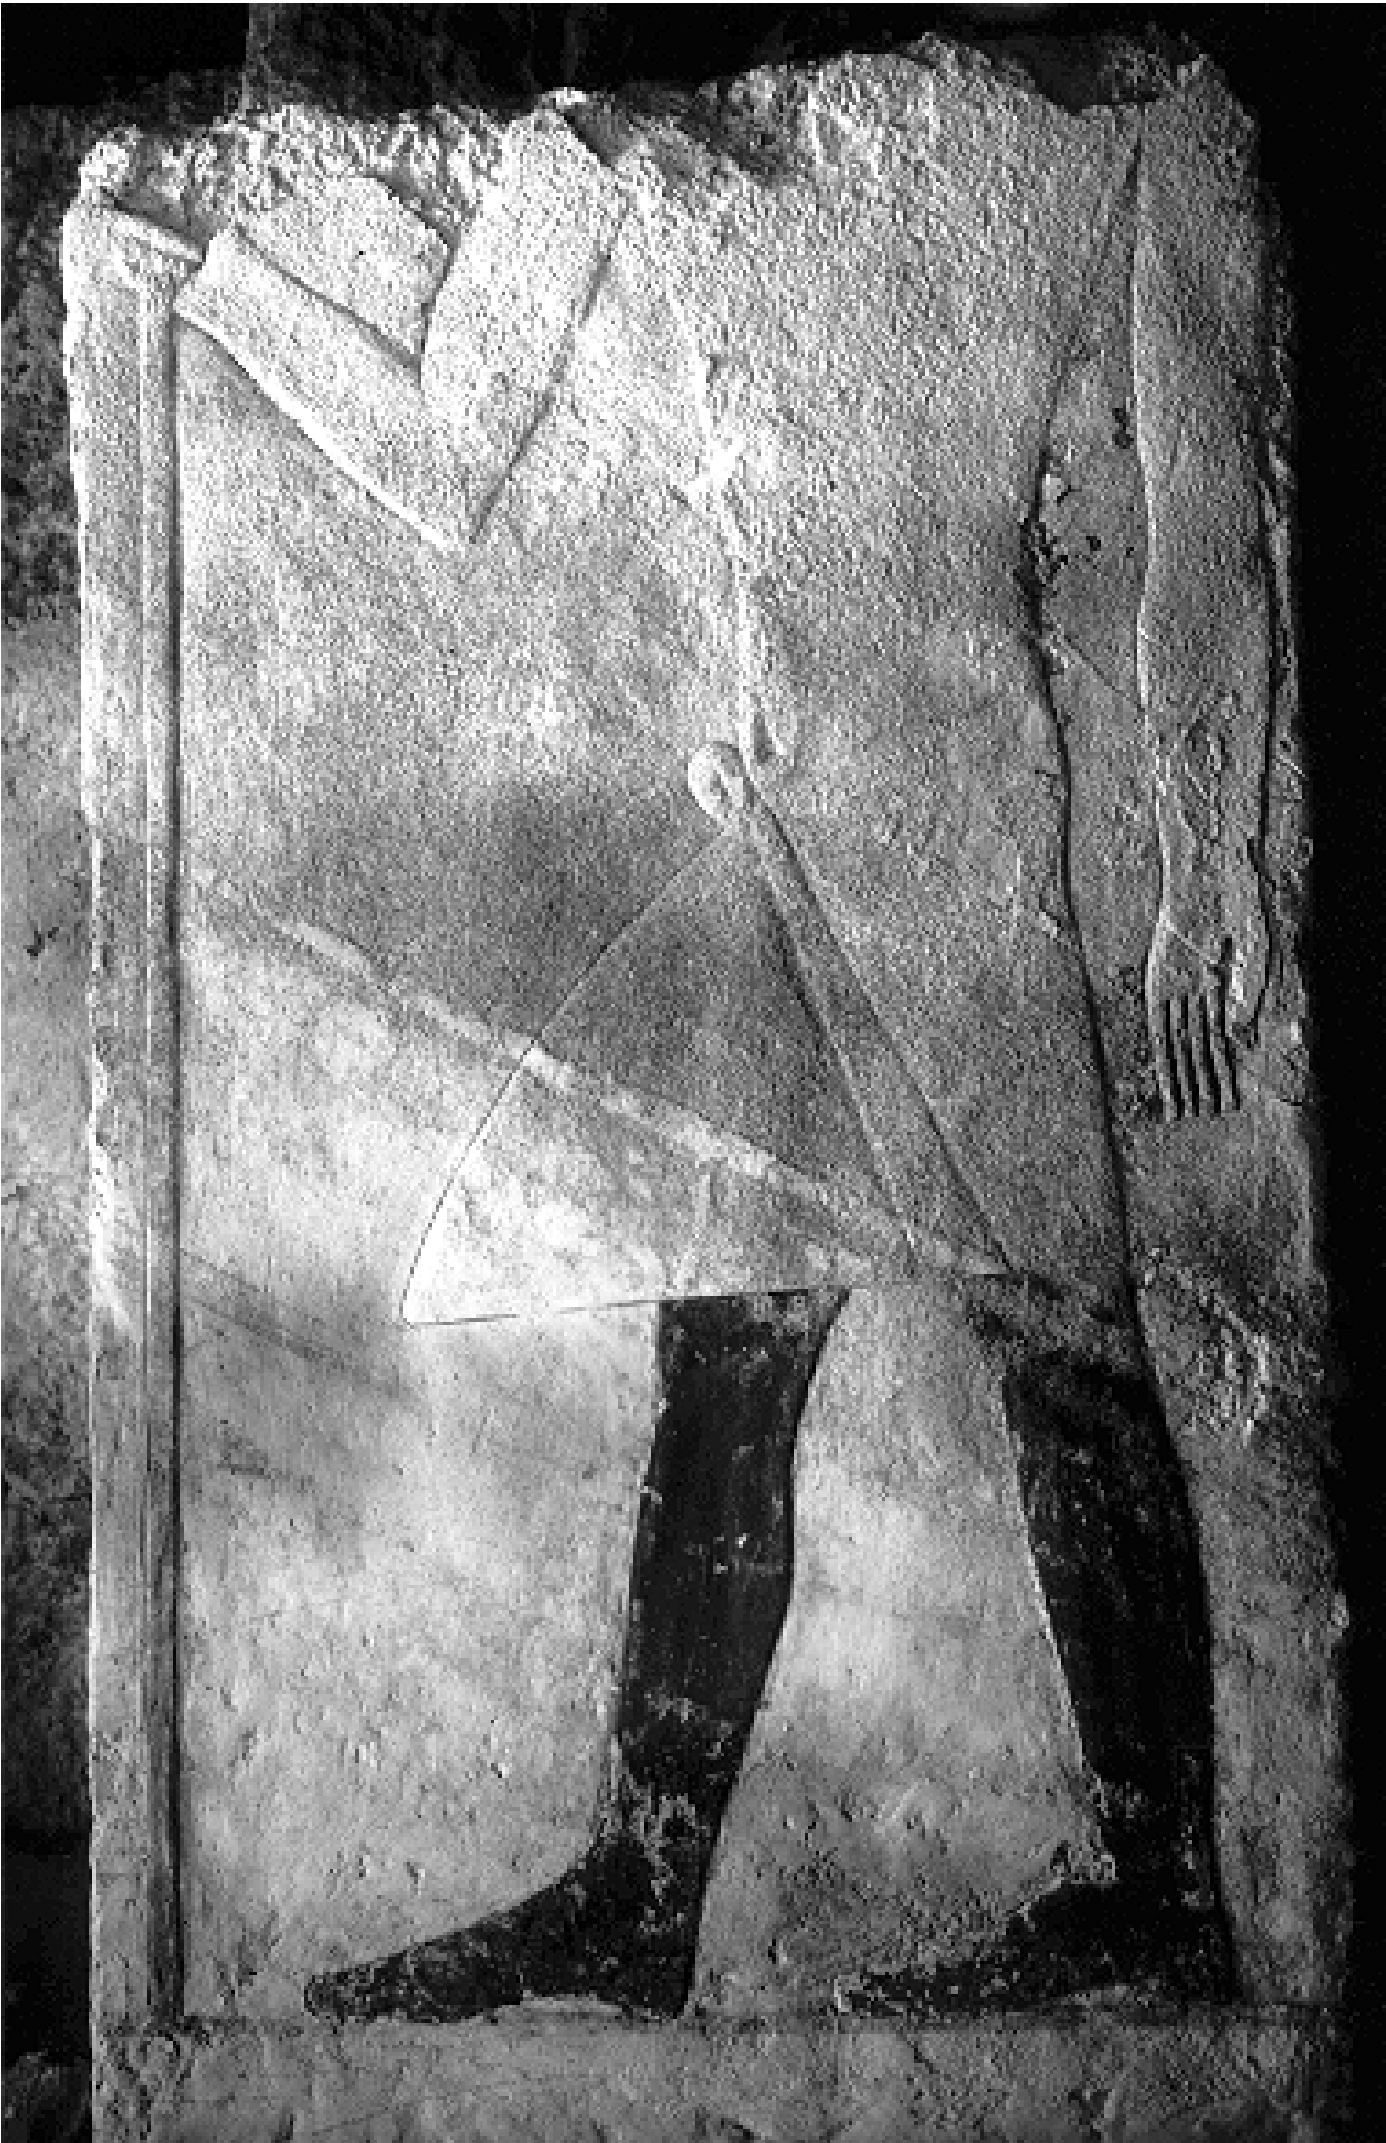
15. 2086: southern pilaster of the entrance. The tomb owner, Redi, is depicted in painted raised relief ( a 8014)

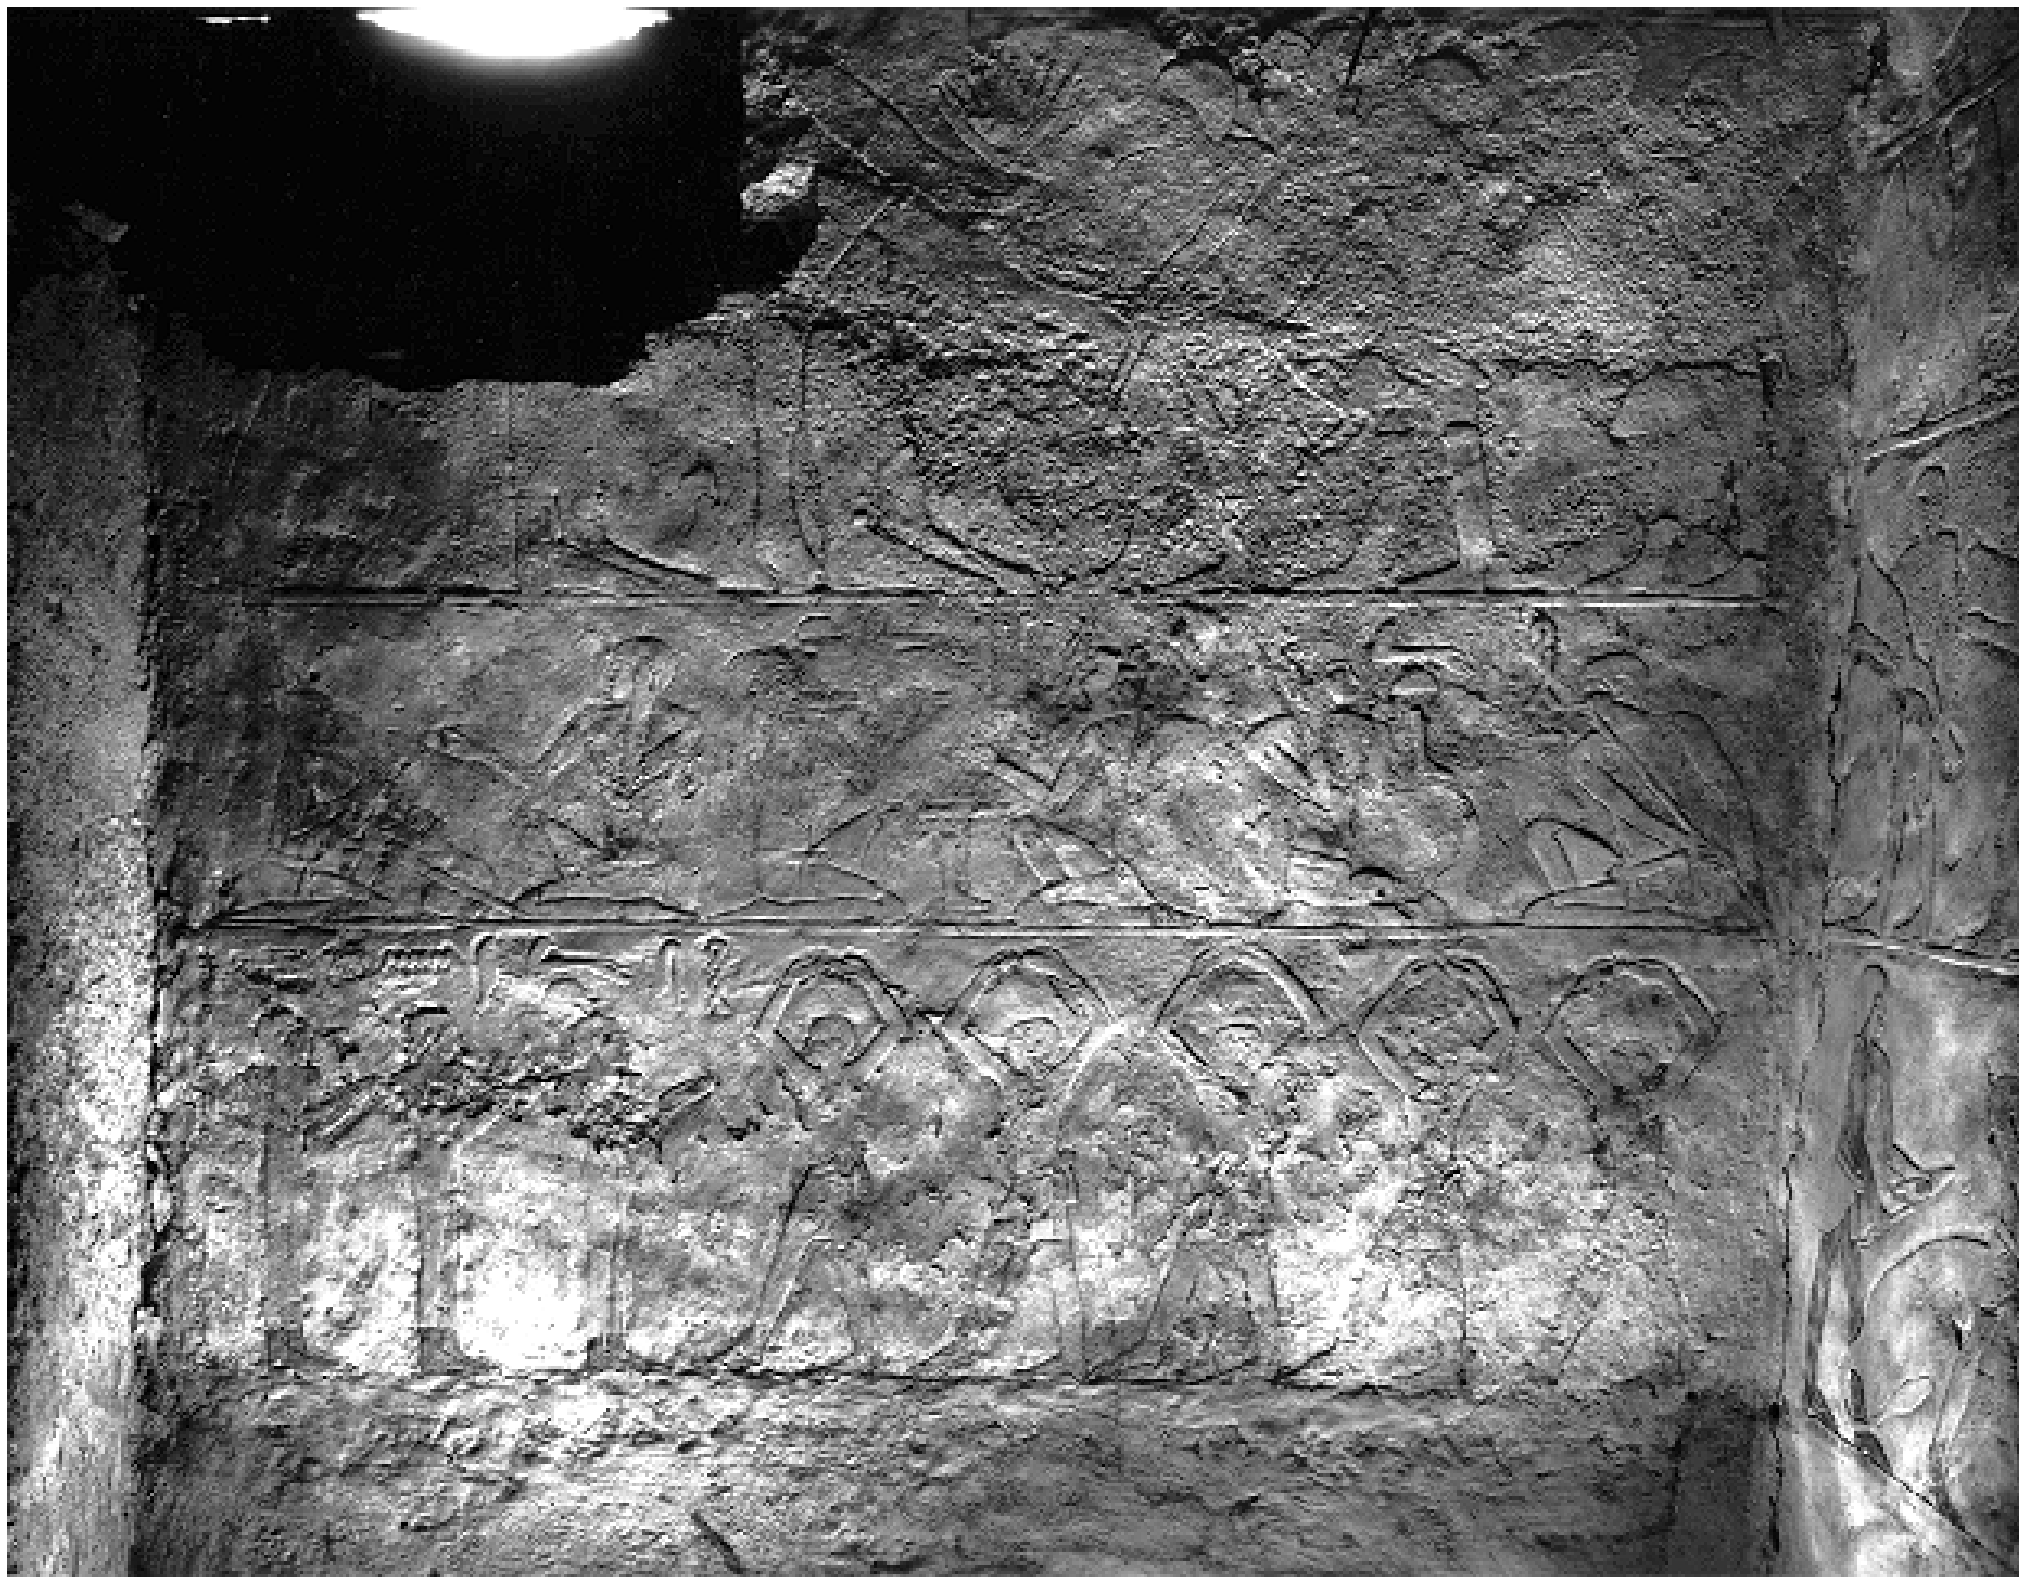
16. 2086: south wall. Redi is seated with a woman, receiving a lotus, and entertained by musicians and dancers (a 8021)

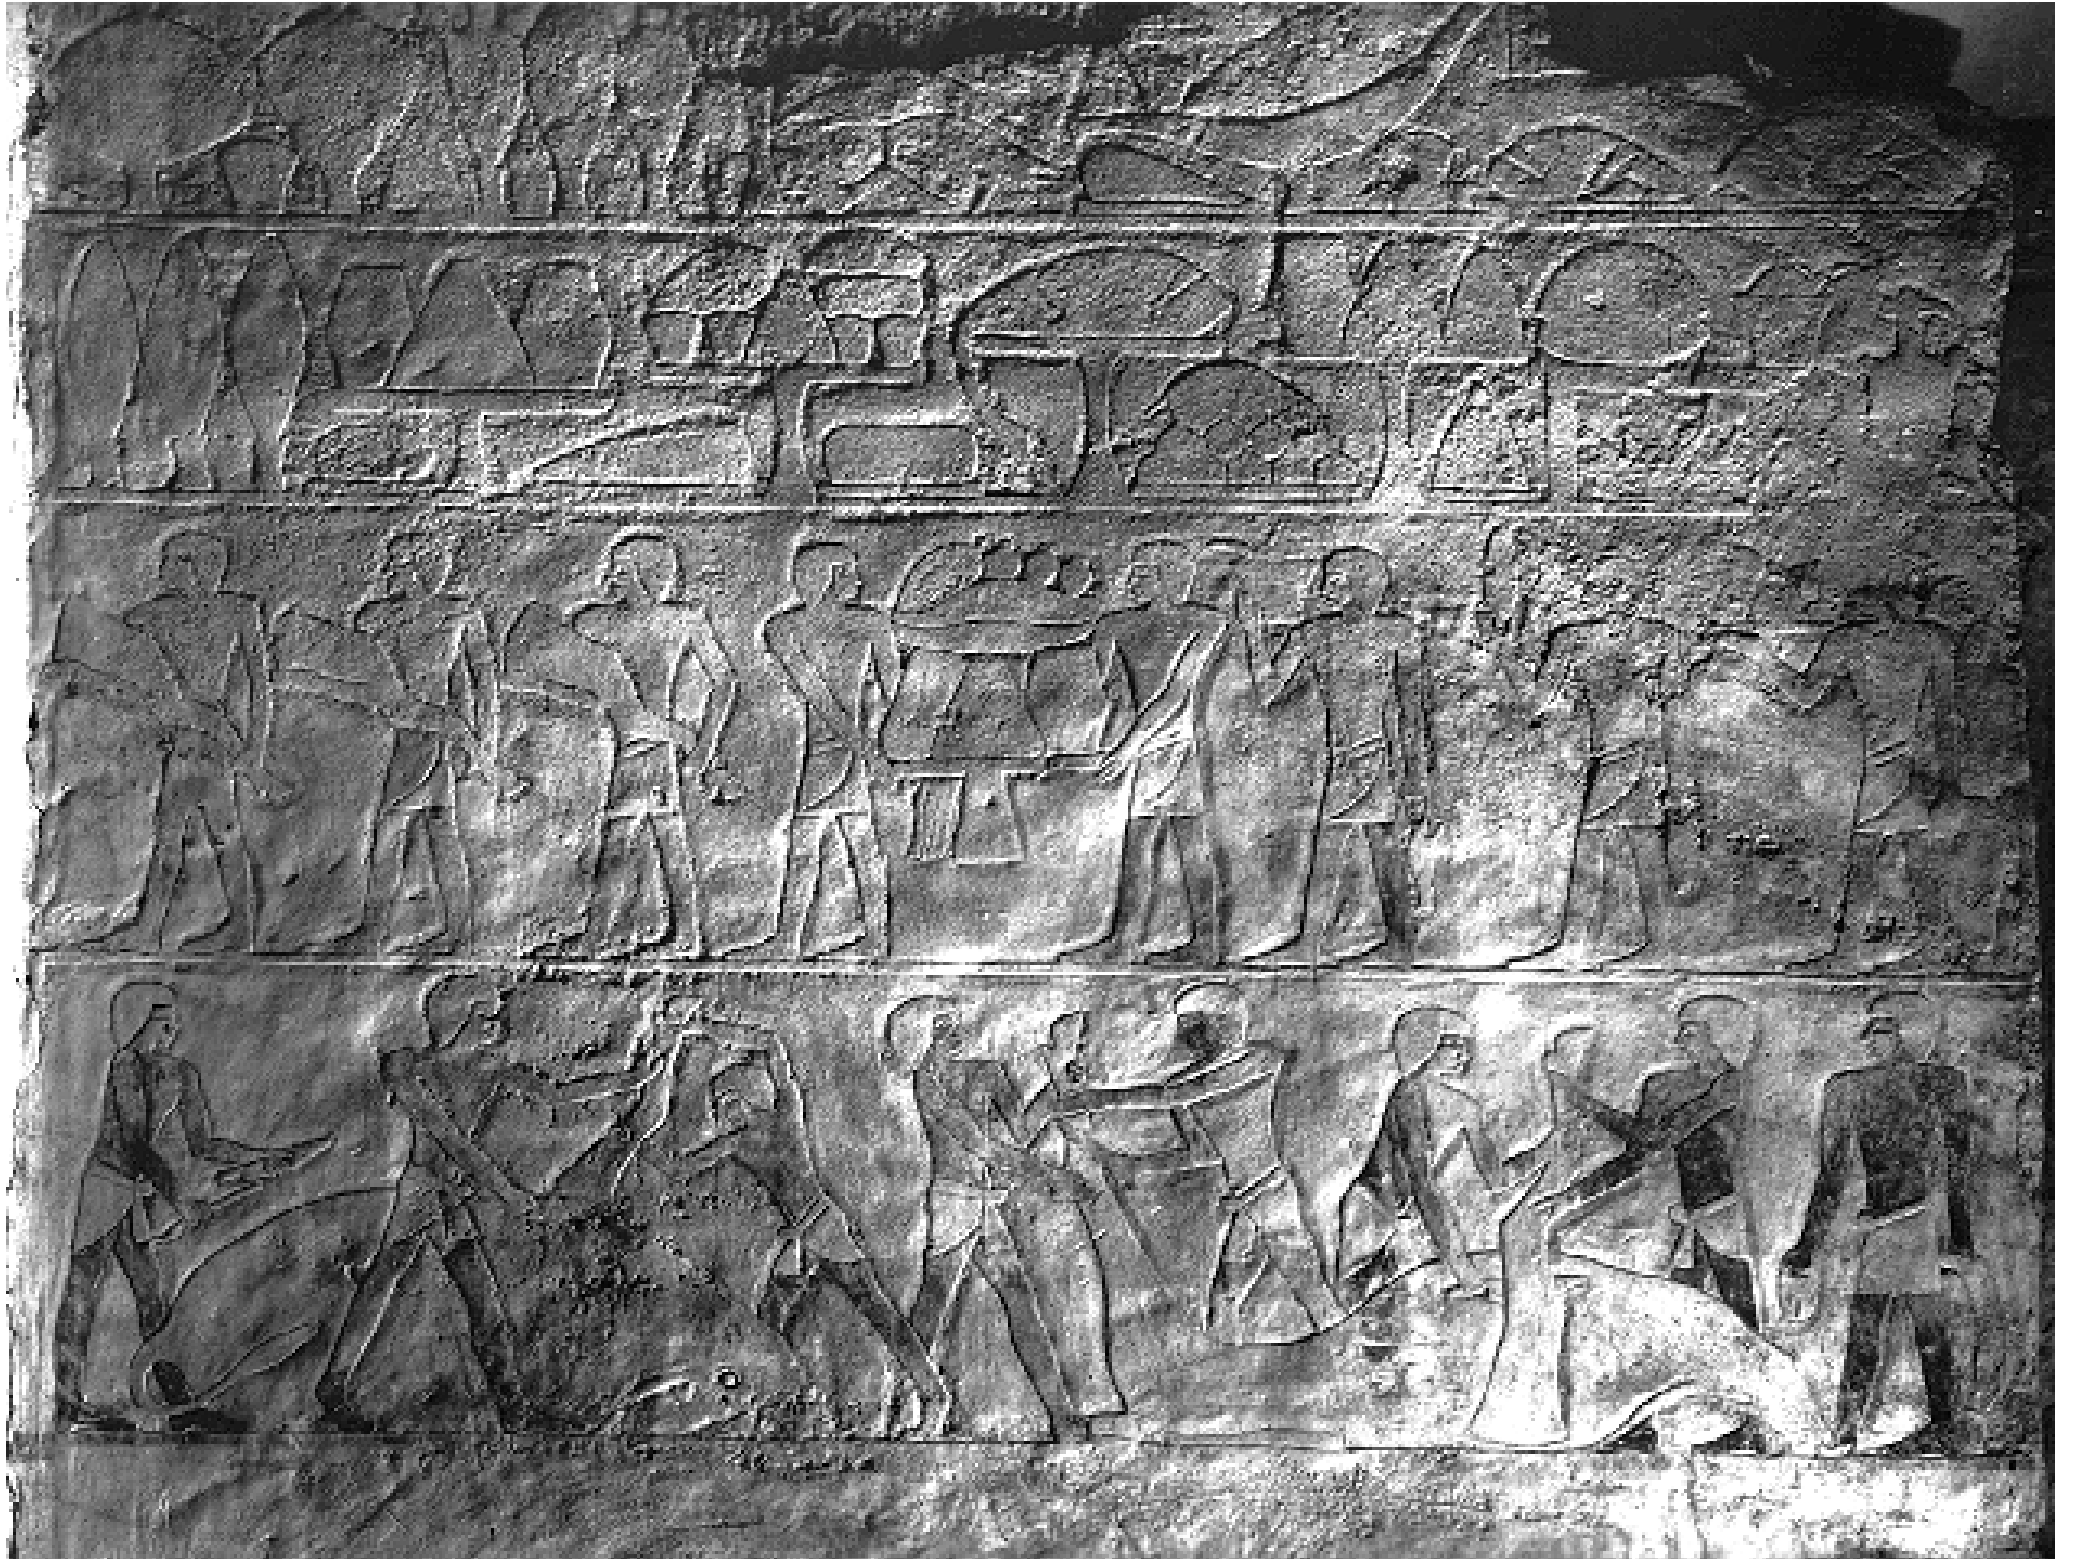
17. 2086: west wall south of recess. Scene of butchers, offering bearers, and offerings. Much less paint survives today (a 8020)

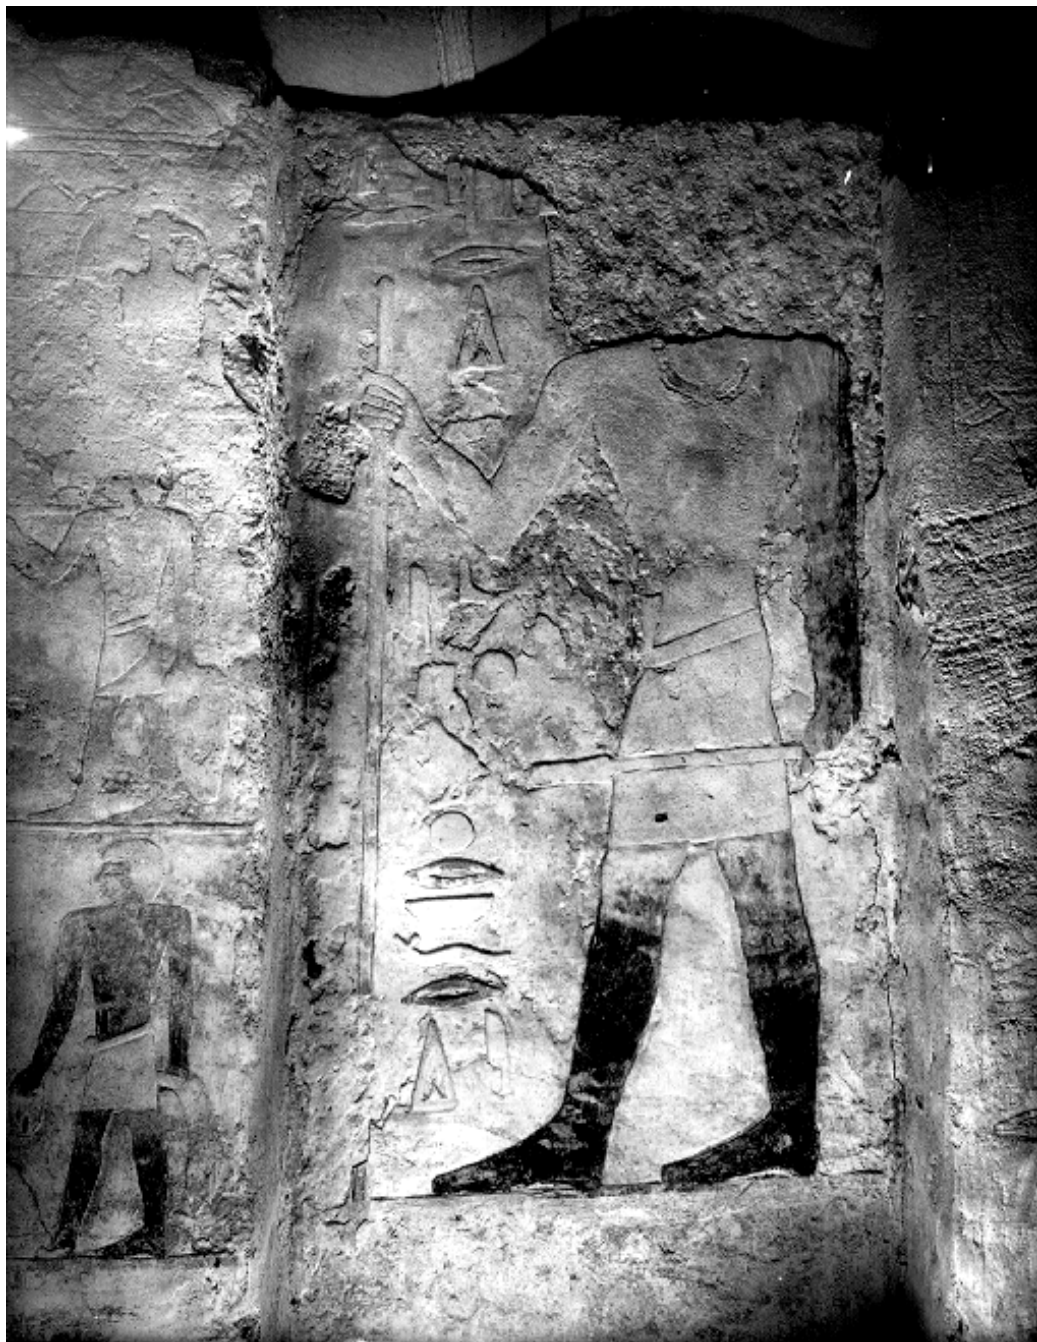
18a. 2086: niche in west wall. Headless figure of Redi striding left. To the left is a damaged text not recorded elsewhere, possible linking singers and *hntjw-s* (a 8015)

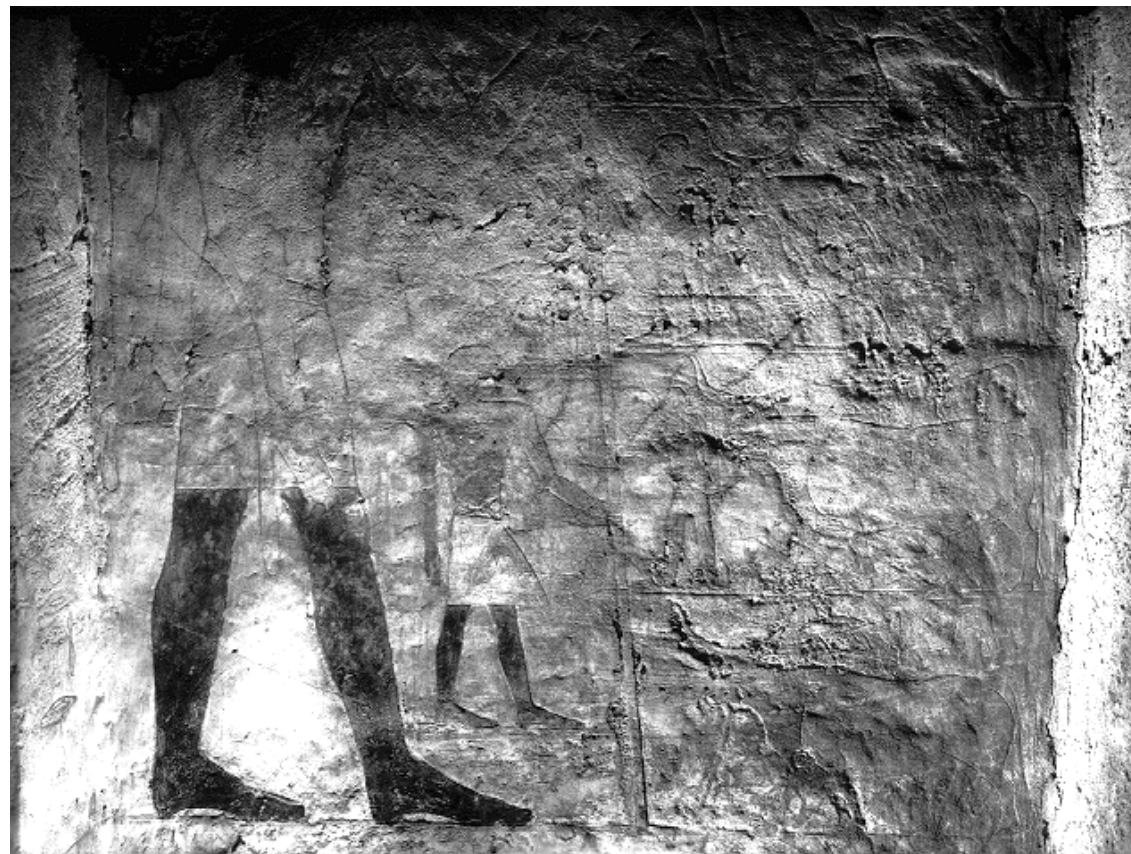
18b. 2086: north wall. Redi and his son Nen-ankh are depicted inspecting cattle and (probably) an oryx (a 8022)

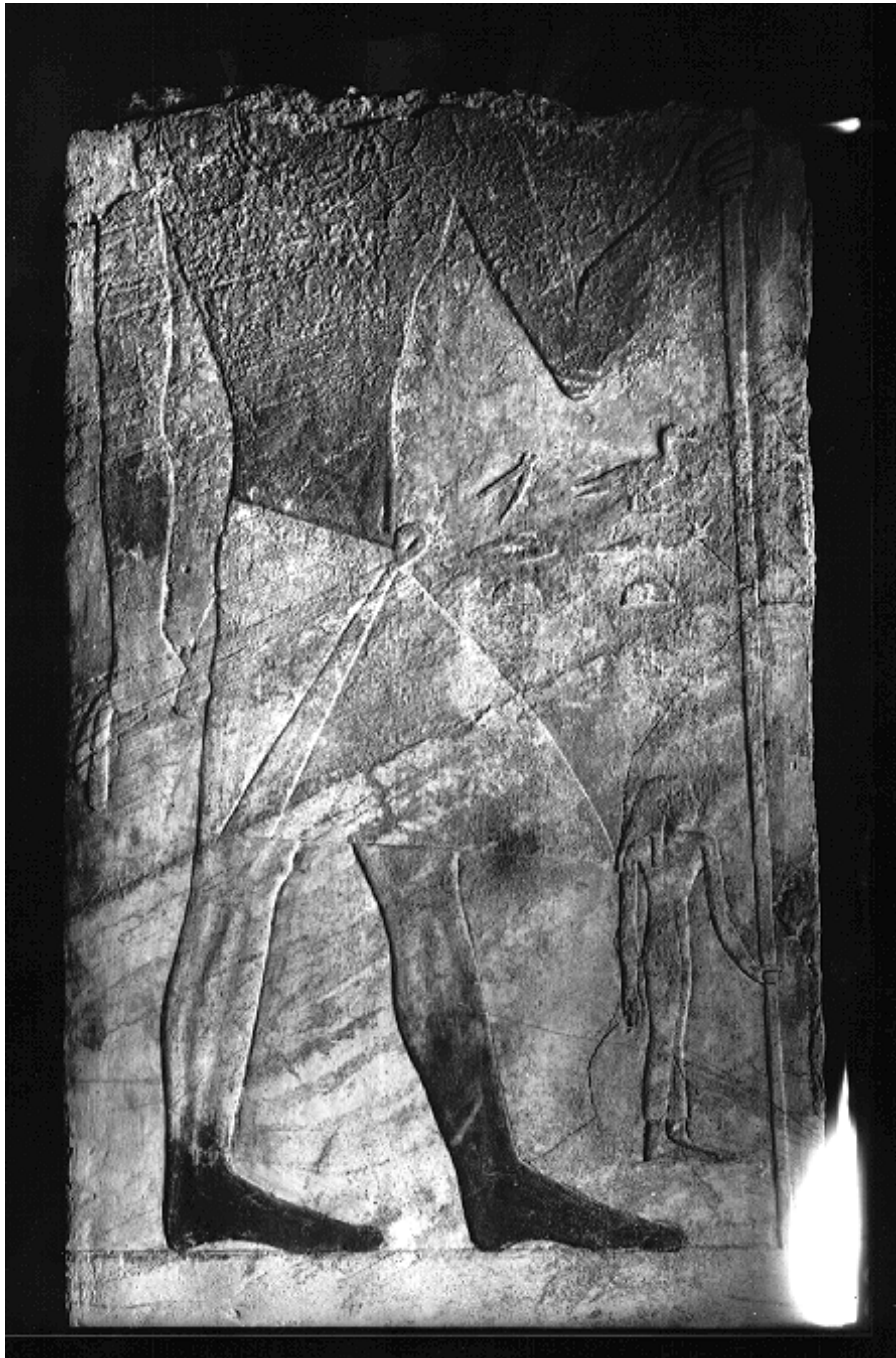
19a. 2086: north pilaster. Redi and his daughter Meret (a 8013)

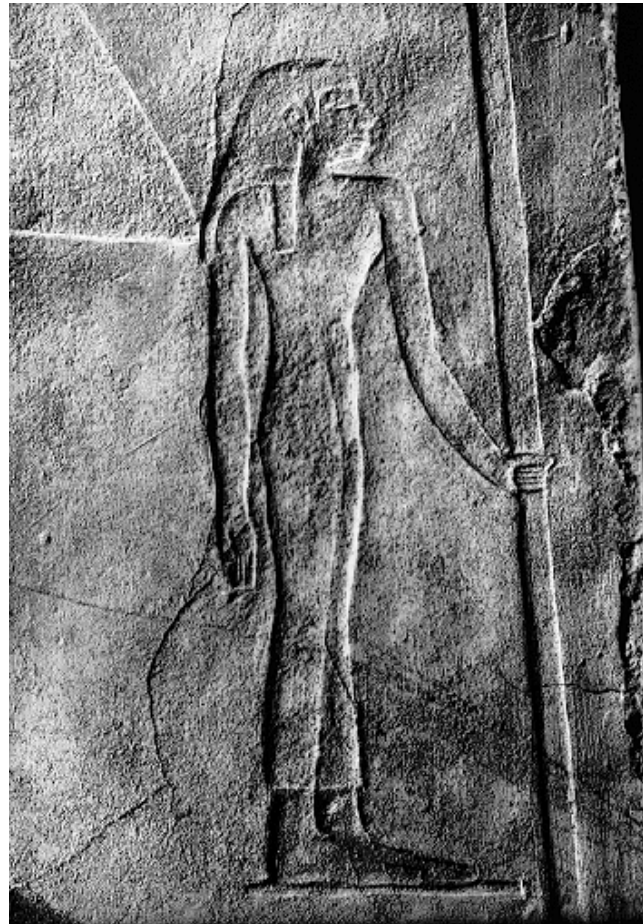
19b. 2086: north pilaster. Detail of daughter, Meret, now badly damaged (b 8961)

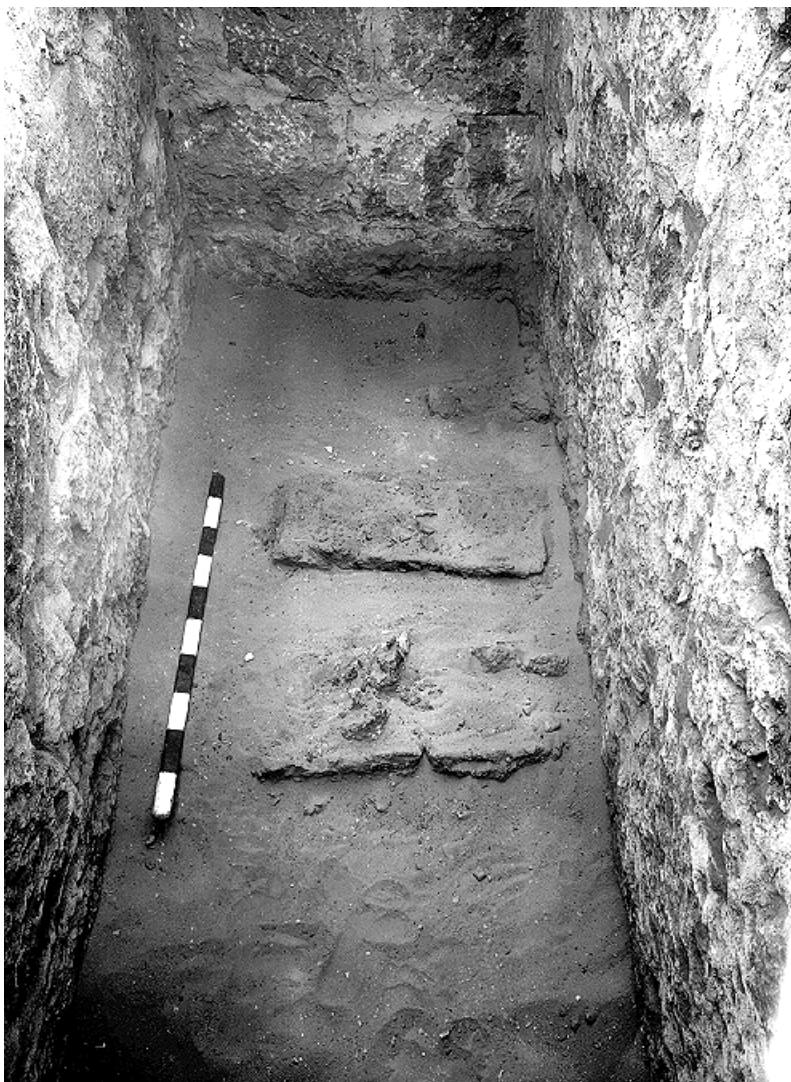
20a. 2086: serdab at time of excavation, from the north. The bases of three statues (two large and one small) of wood and painted gesso. Fragments of the statue itself can be seen on the nearest (a 8010)

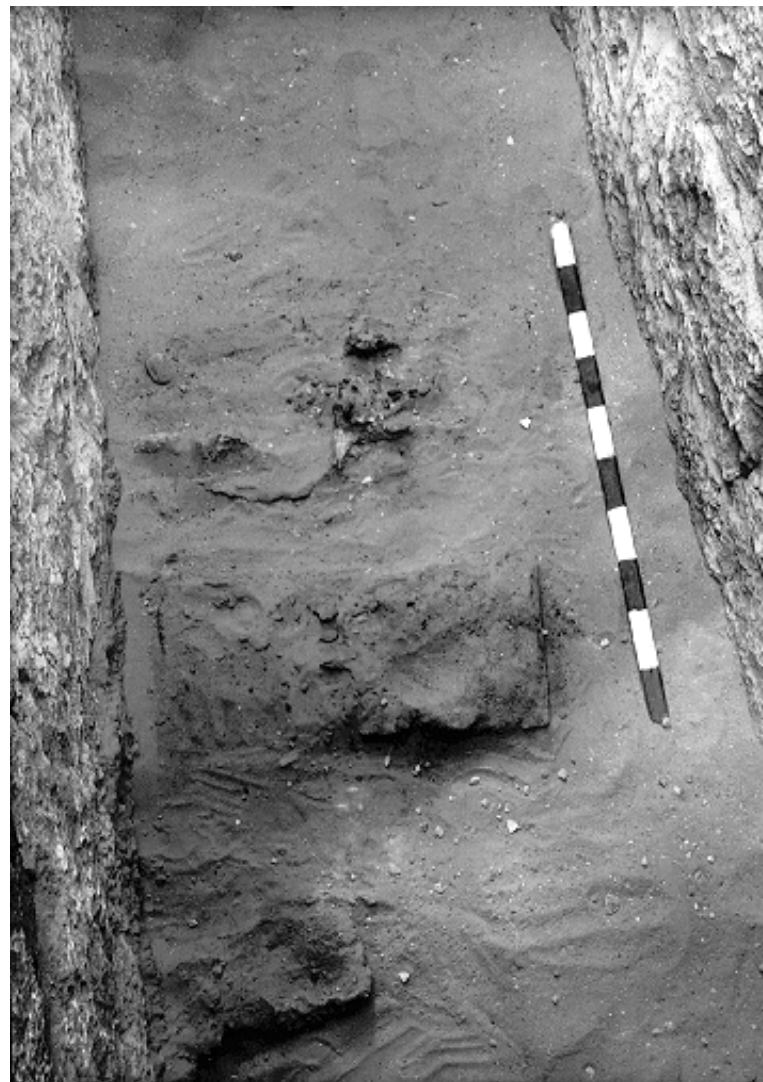
20b. 2086: serdab. Detail of three wooden statue bases (b 8958)

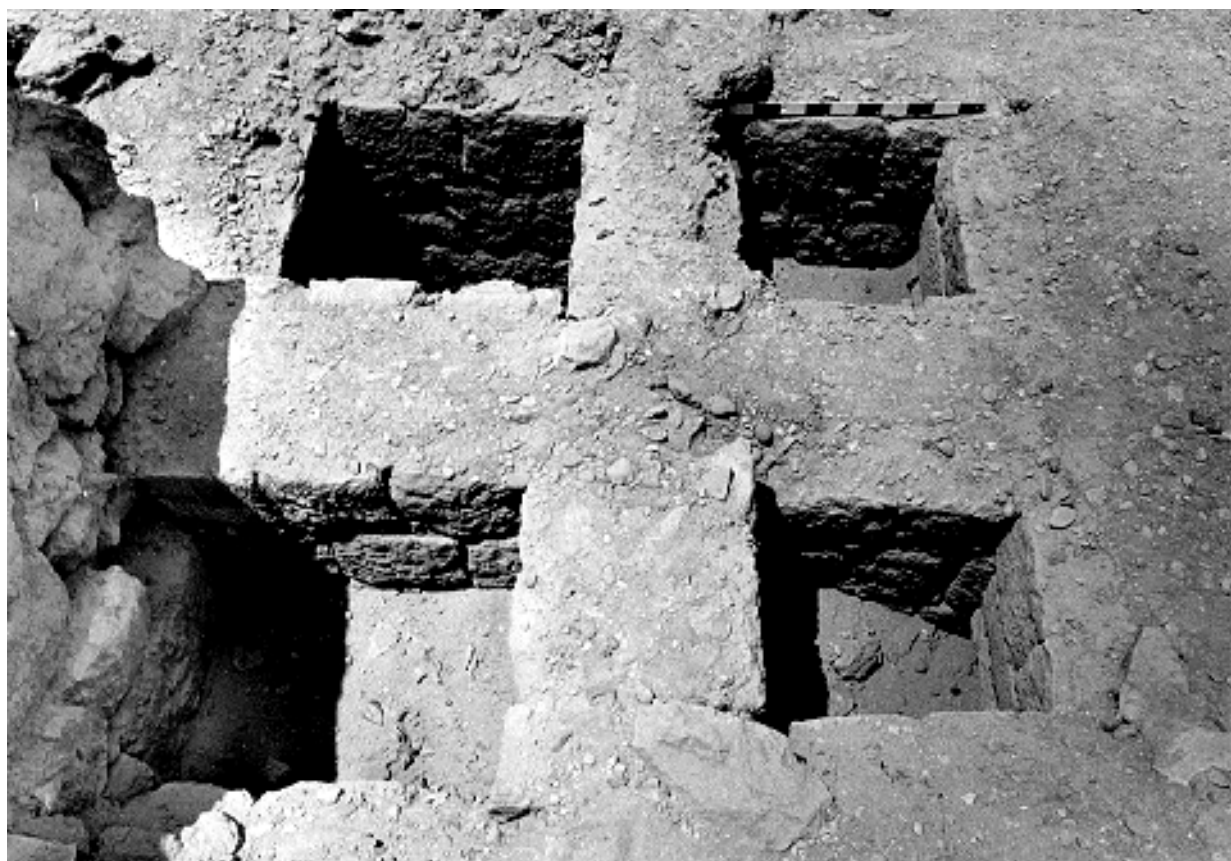
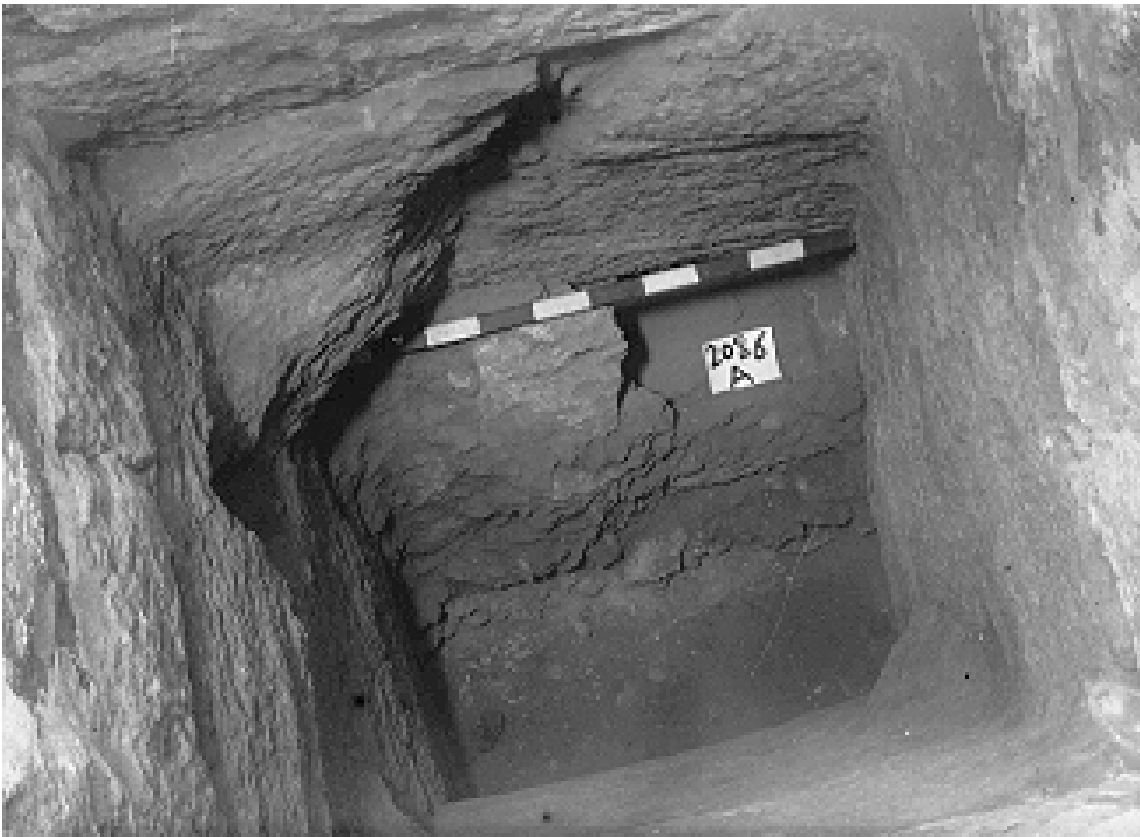
20c. 2086: the four shafts (clockwise from upper left) a, b, d, and c (rg 12-18, 1989)

21a. 2086 a: shaft and blocking, showing robbers' entrance (in which the label has been placed). The blocking is not typed, but described as "exterior wall of rubble bound with mud, resting on limestone debris; penetrated on east through upper part" (c 14155)

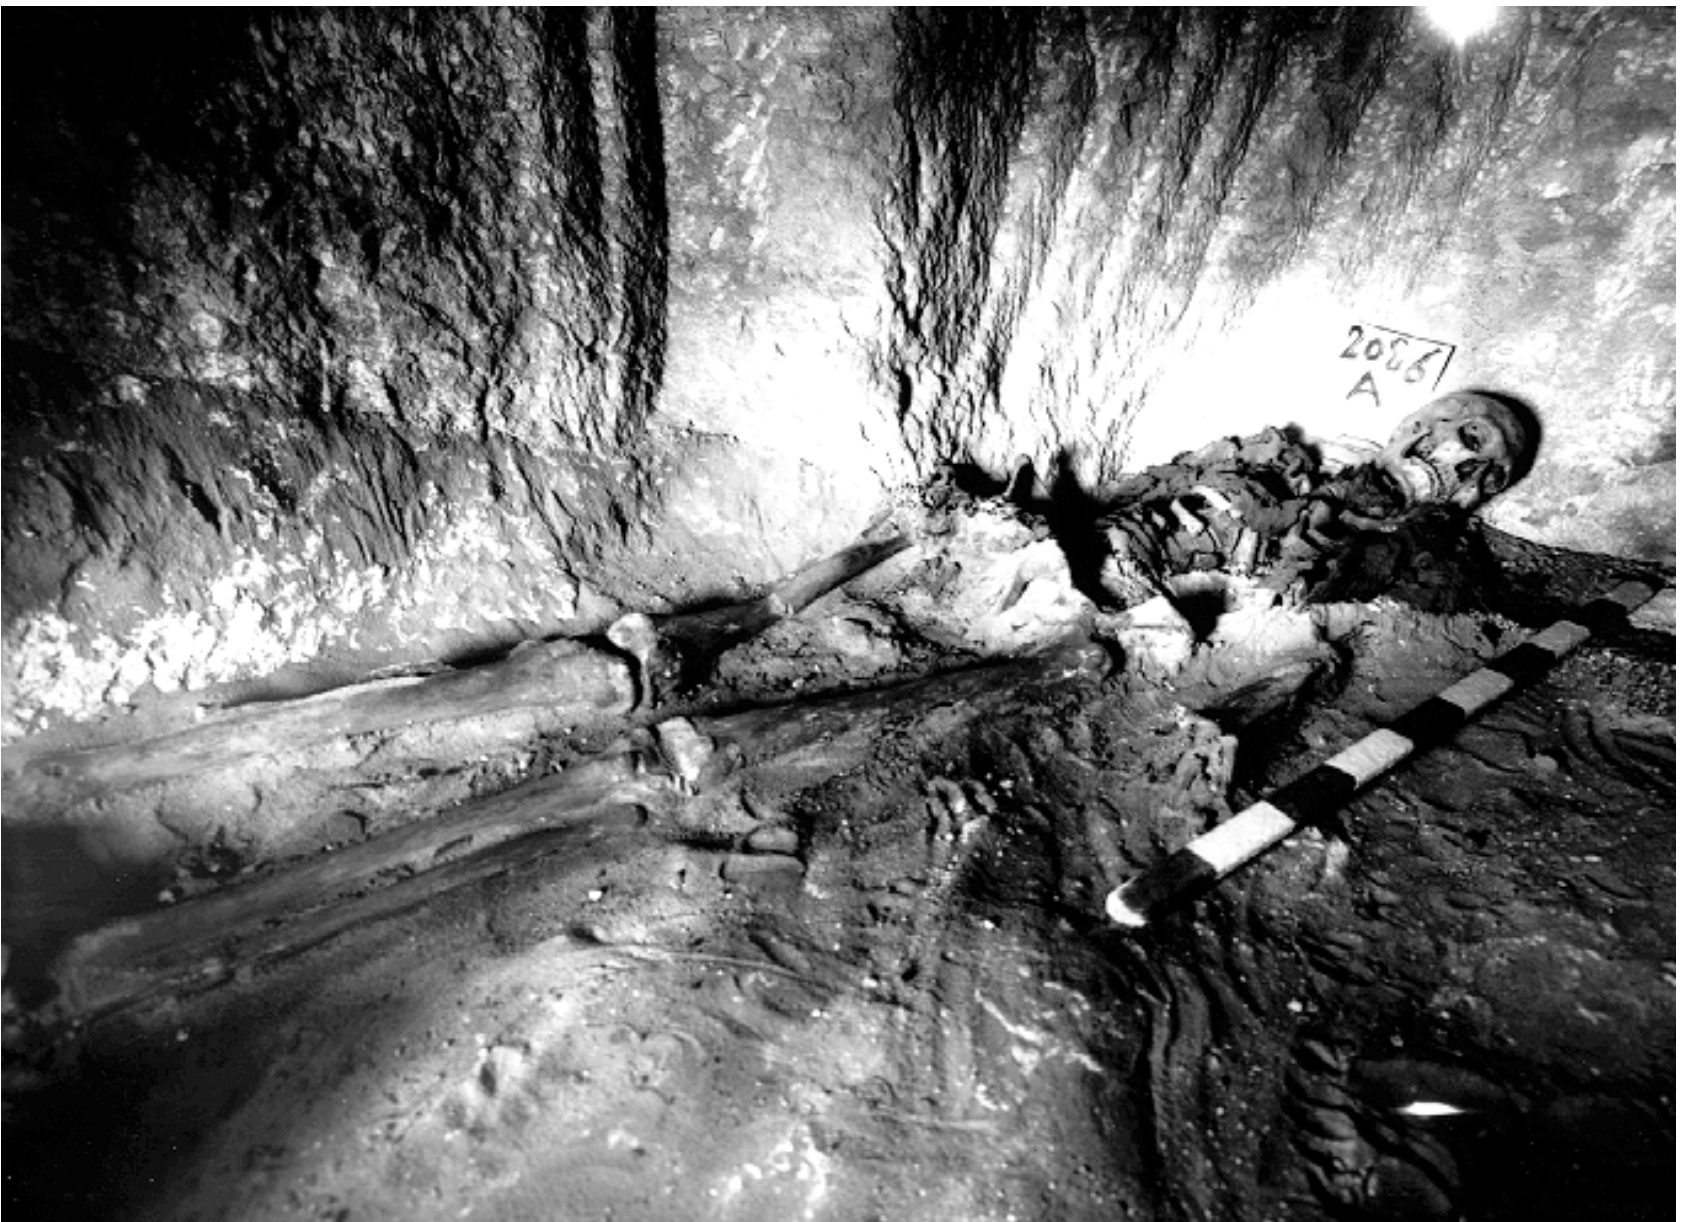
21b. 2086 a: extended, skeletally adult burial, presumably of Redi himself. (The well-developed supraorbital torus is consistent with a male). Note the remains of cloth wrappings on the chest and the roughly hewn walls of the burial chamber (a 8012)

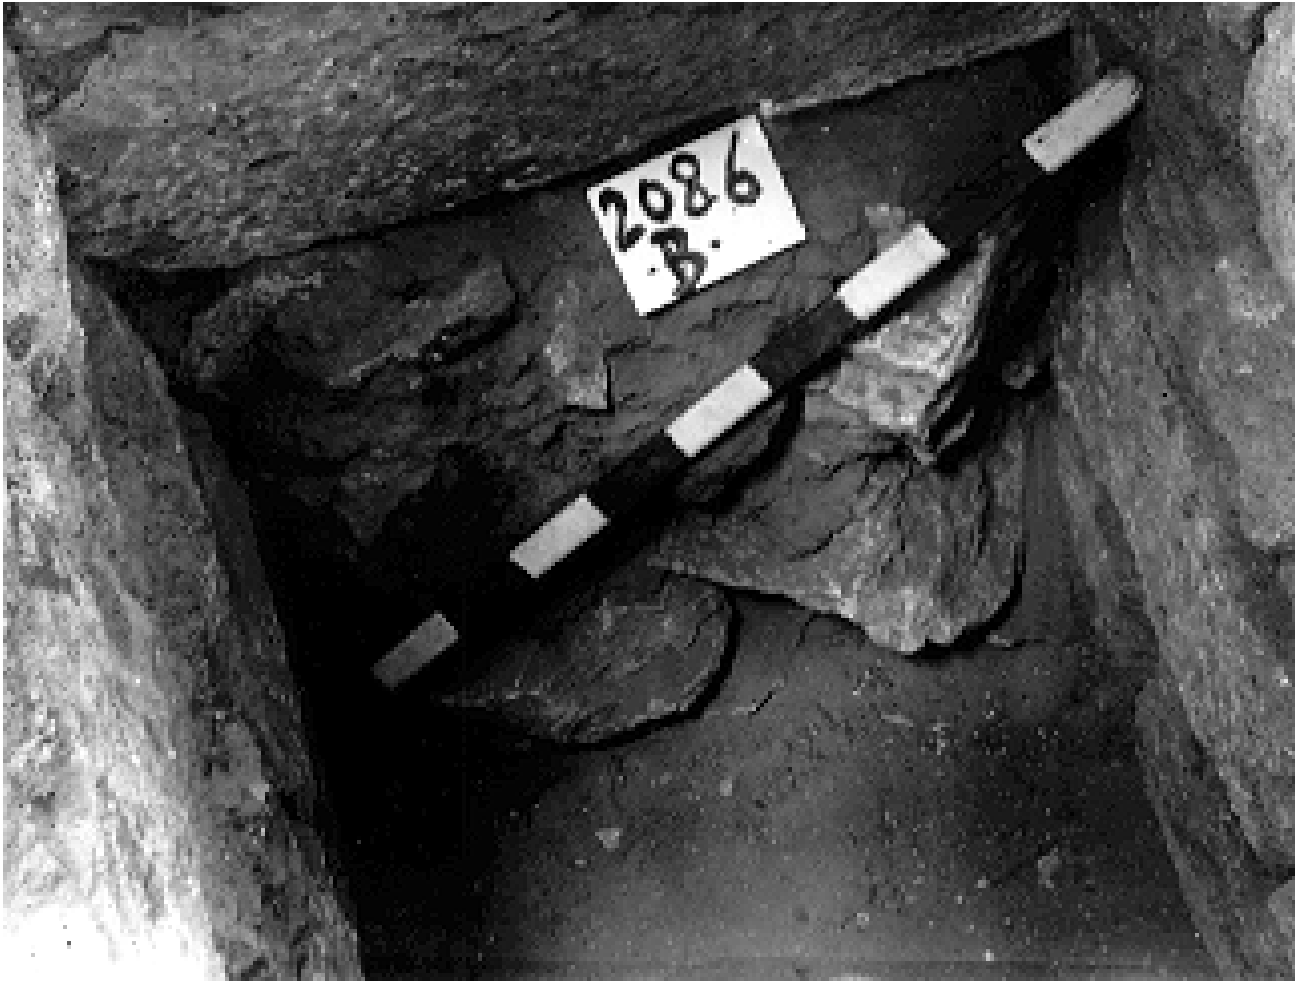
22a. 2086 b: intact blocking of rubble bound with mud, Reisner's type v d(2) (c 14156)

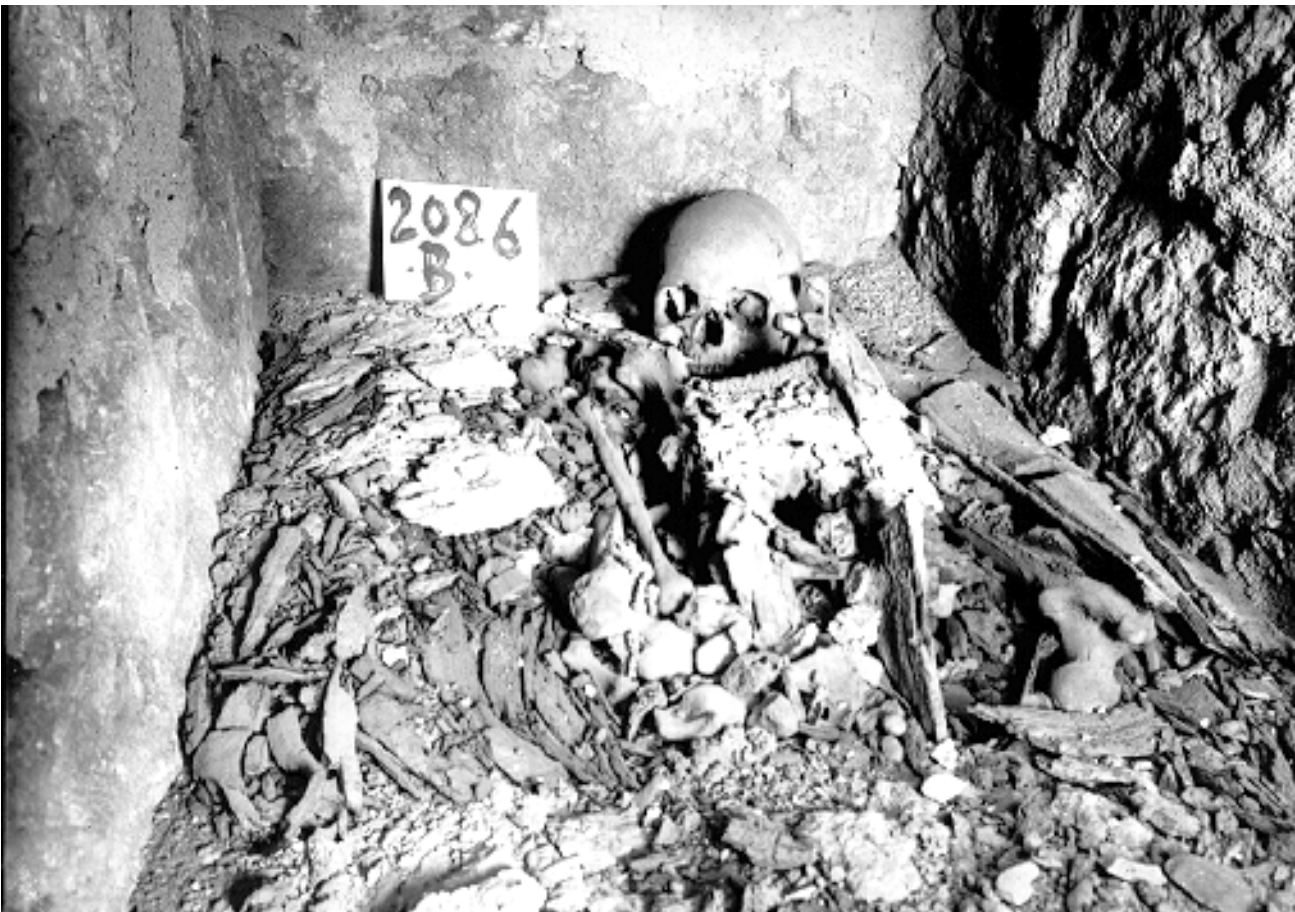
22b. 2086 b: tightly contracted burial, possibly female, surrounded by the remains of a small wooden box coffin (b 8960)
