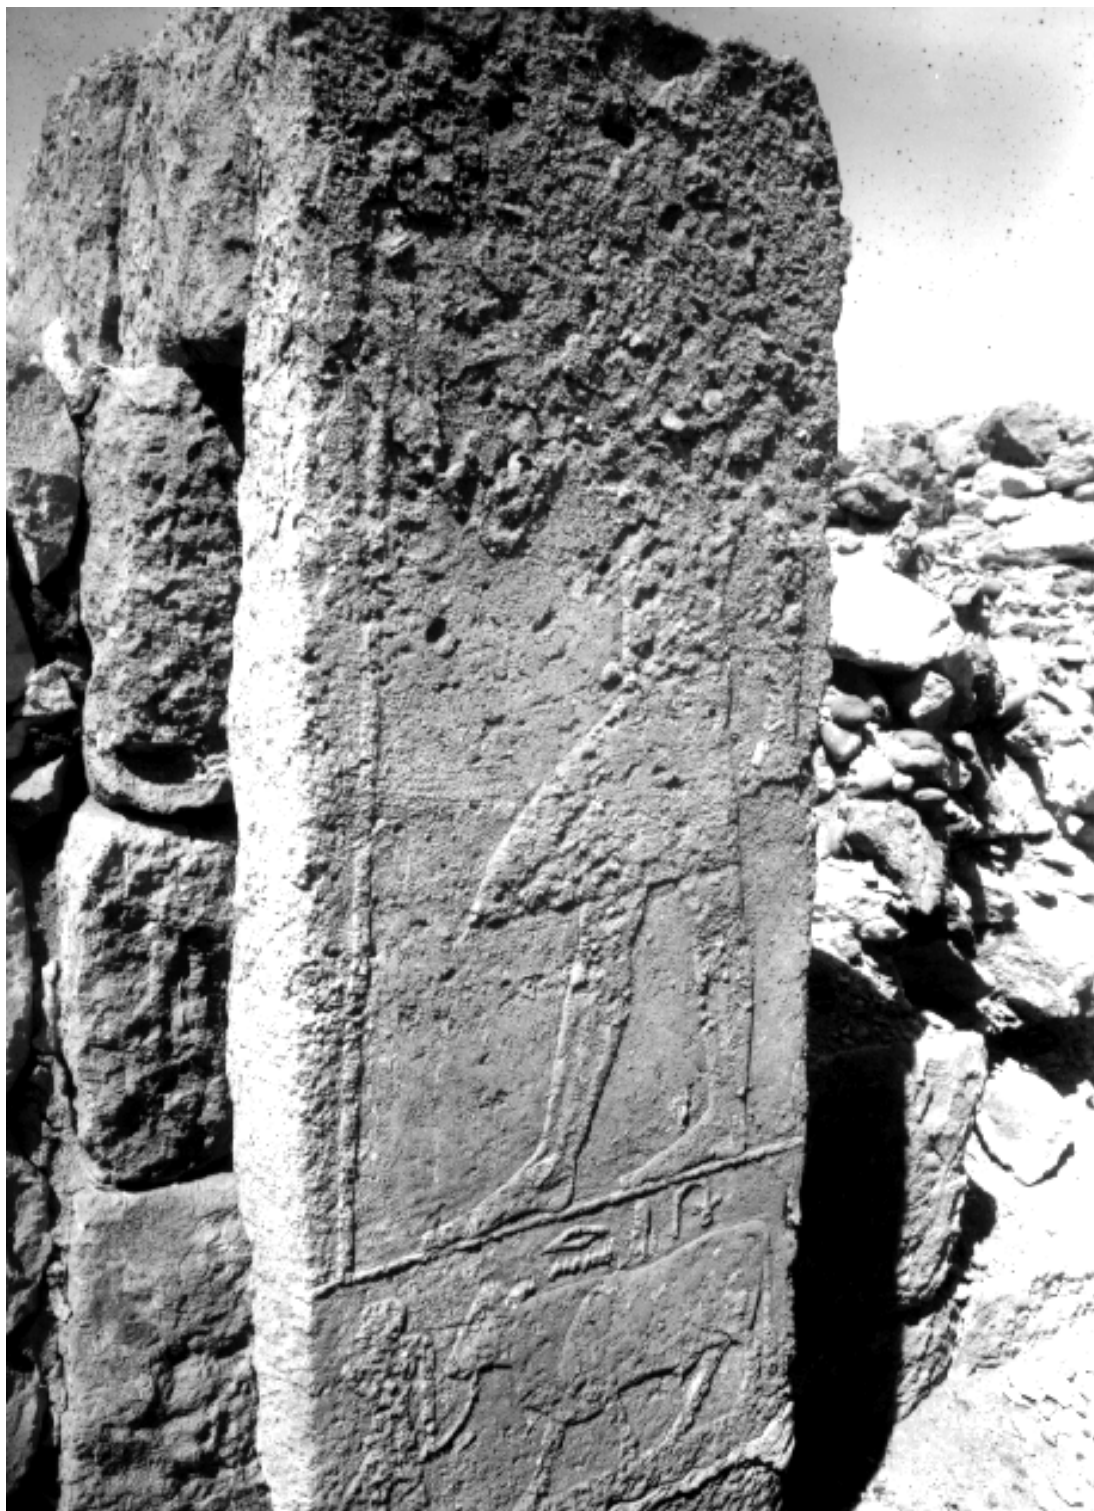
23a. 2087: west doorjamb, depicting anonymous owner and a servant leading an ox. Oddly, the ox is shown leaving the chapel rather than entering it, which perhaps indicates some relationship with the adjacent tomb 2088 (a 8309)

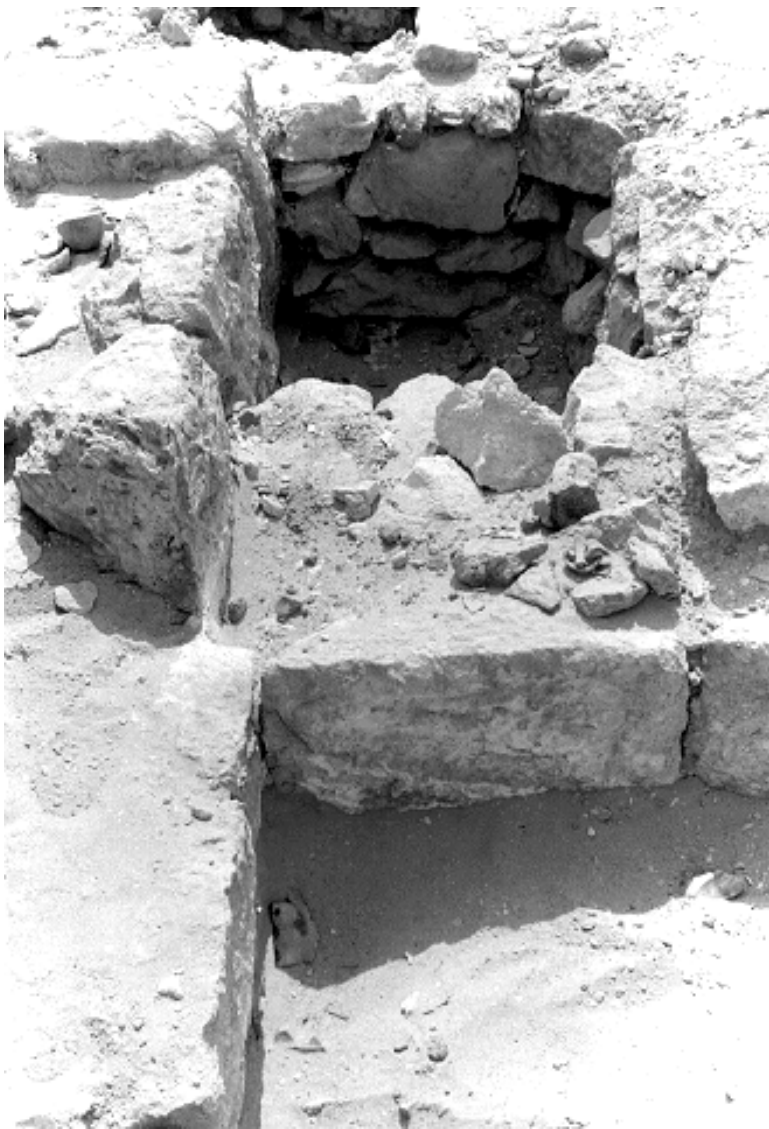
24a. 2087: Northeast corner of corridor (in foreground). Behind the east wall is the later mastaba 2084 and its shafts g and c (at the very top of the plate). The north wall (at left) is the exterior wall of the Phase ii addition to 2086. The jog in this wall where it meets the east wall, as well as some plaster noted on the north wall under the fill of 2084 suggests that the chapel of 2087 may have had a different form before the construction of 2084 (amr, 1990)

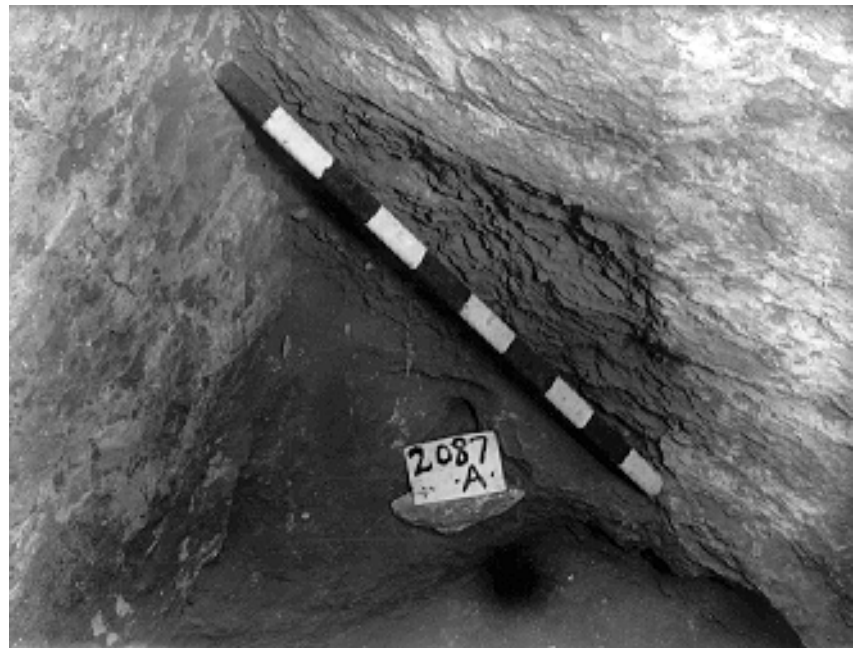
24b. 2087 a: blocking of rubble bound with mud, Reisner's type iv d(2) (c 14157)

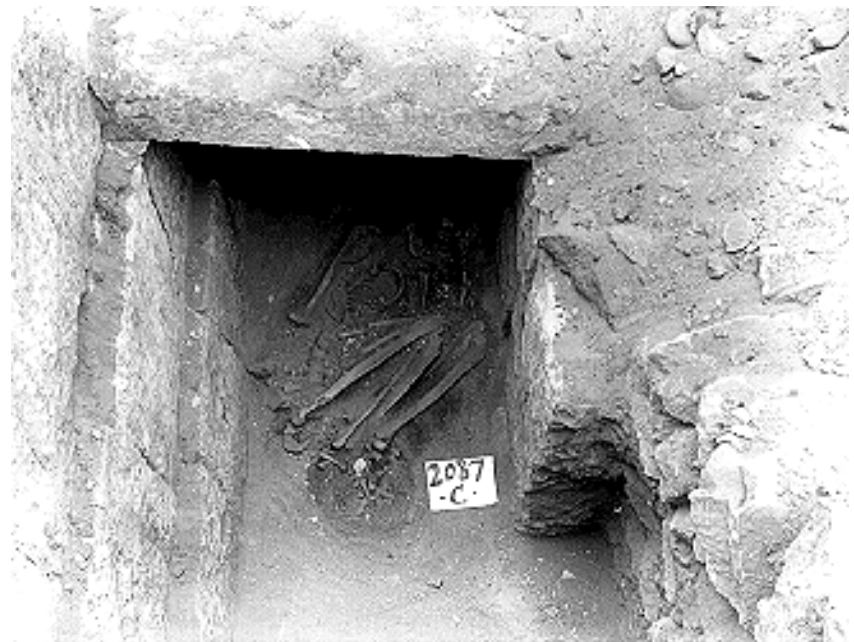
24d. 2087 c: skeletally adult burial, shown after the removal of the two southern roof blocks (c 14164)

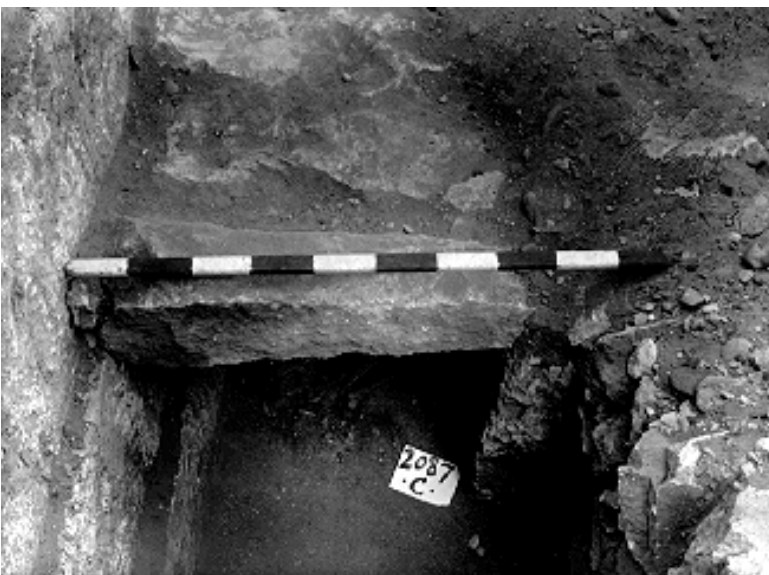
24c. 2087 c: chamber, showing the construction of the roof against the stepped eastern face of serdab 1 of 2088 (c 14158)

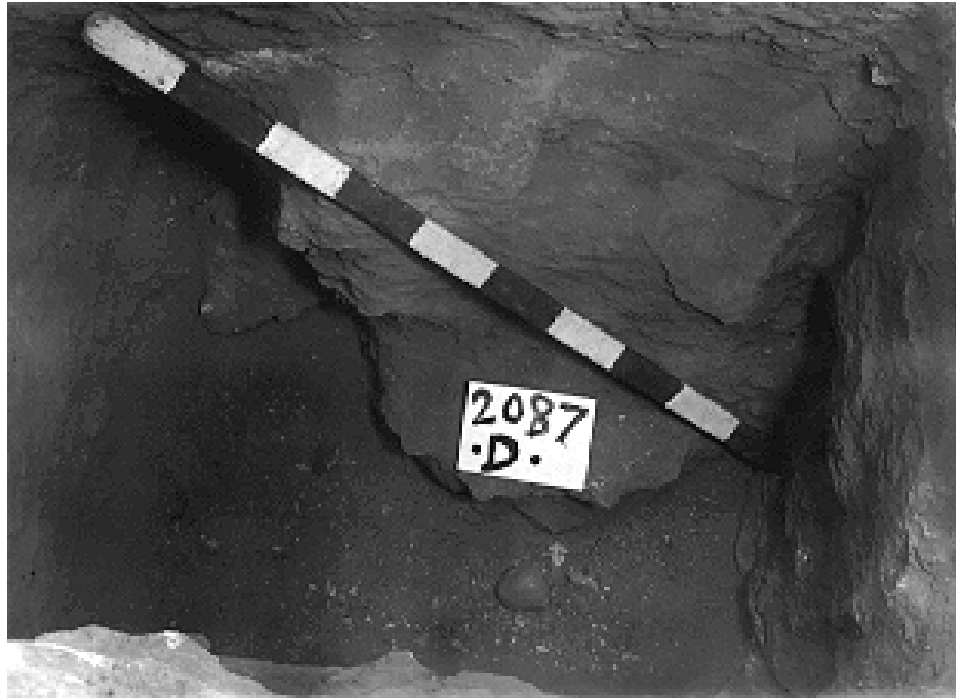
25a. 2087 d: intact blocking of leaning slabs resting on low wall of rough masonry bound with mud, Reisner's type v c(2) (c 14159)

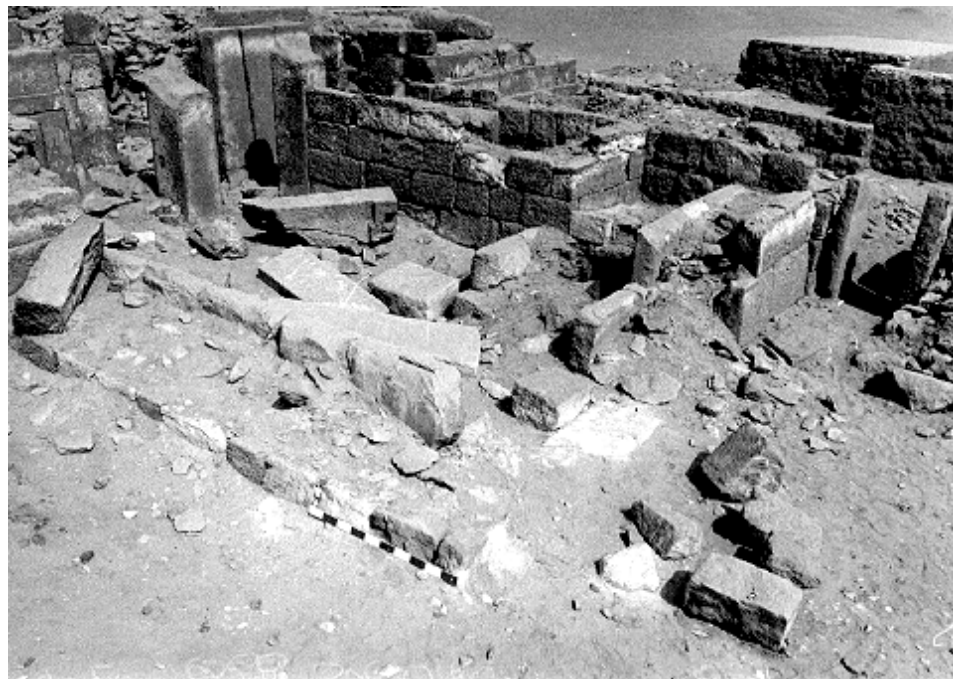
25c. 2088: courtyard from the southeast, showing the abutment of its serdab 2 against the northern pillar of its portico and the south face of 2087. Between serdab 2 and the east wall of the courtyard was built the intrusive mastaba 2088b; the dark square is the entrance to its chamber. The loose blocks in the courtyard are mostly from the west wall of the inner chapel. The south end of the portico's lintel (see also pl. 30a) lies between the pillars; the mortise on its underside faces the viewer (rg 14-2, 1989)

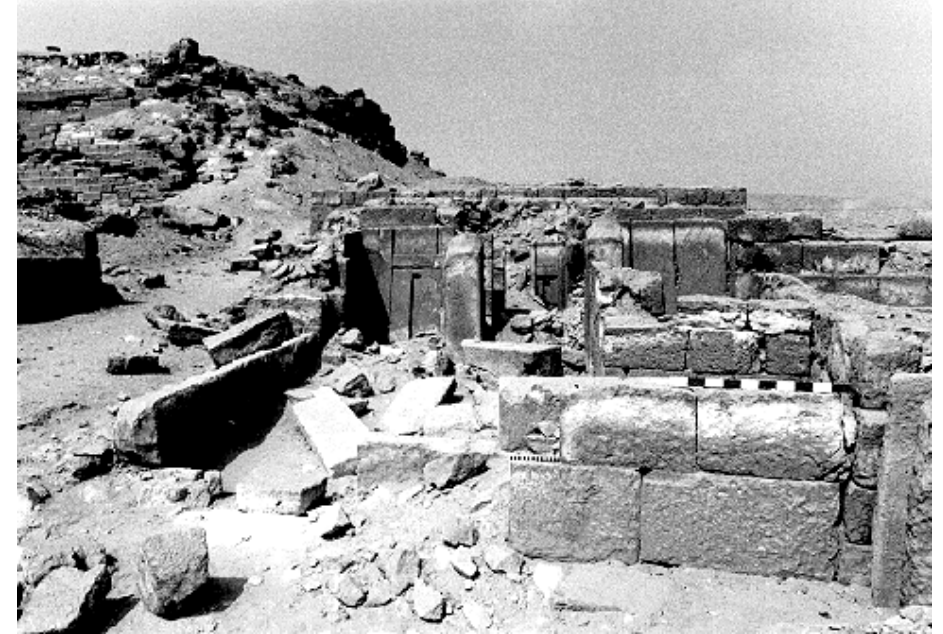
25b. 2088: courtyard from the east. The horizontal white streak across the enclosure wall in the foreground and also across the ashlar facing the back of the portico represent a softer layer in the limestone, and suggest that all these blocks were quarried together. The smaller false door in the center of the is the northern false door in the inner L-shaped chapel; the walls surrounding it have been dismantled (rg 14-7, 1989)

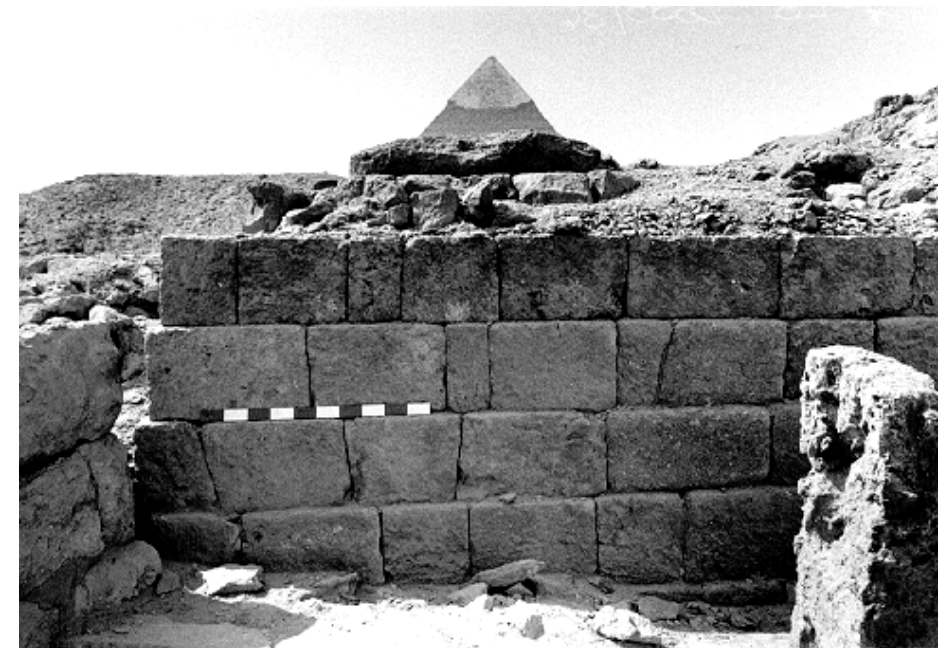
25d. 2088: stepped northern facade and the abutment of serdab 1. A roof block of serdab 1 is centered under the tip of the pyramid of Khafre; under its right end begins the stepped joint that represents the original stepped facade of the mastaba against which serdab 1 was built. At left is the southwest corner of 2086, and at right the badly weathered door of 2099. The intact serdab of 2099 was found in this corner (rg 7-28, 1989)

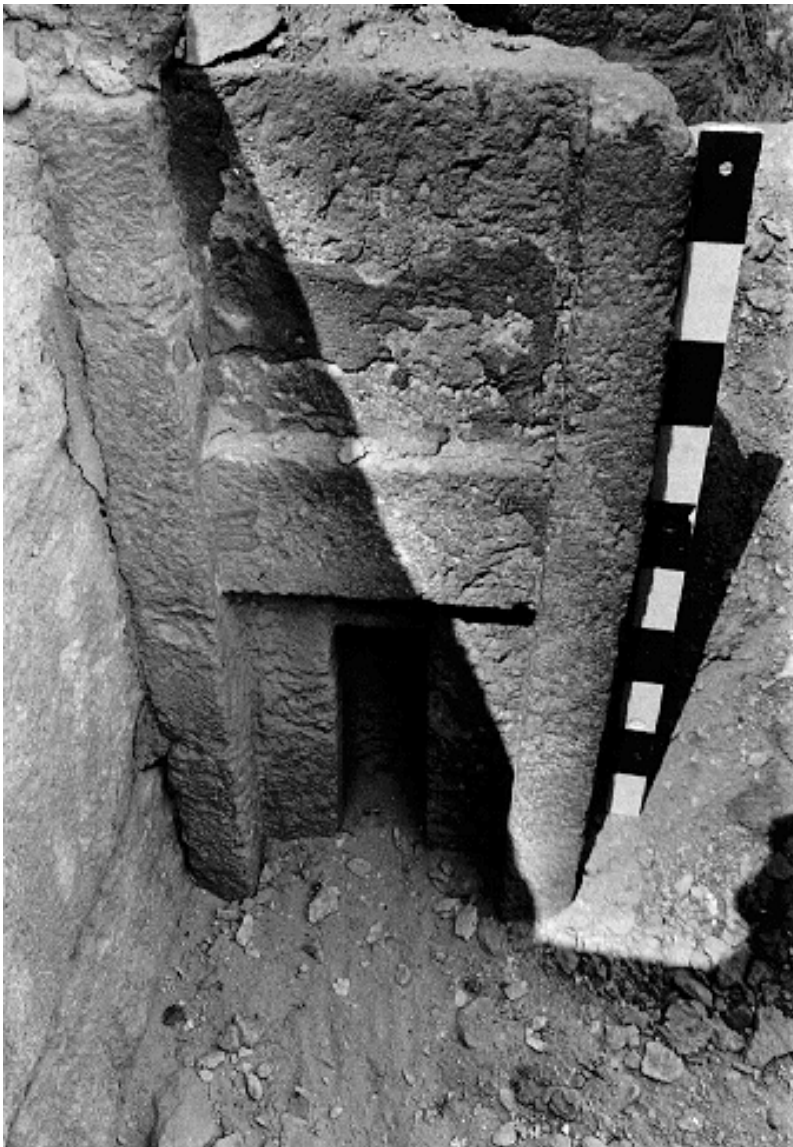
26a. 2088: southern false door of L-shaped chapel. The coarse, weathered plaster that still clings to the stone probably originally supported a finer decorated layer. Note the unusual depth of its recesses (rg 14-17, 1989)

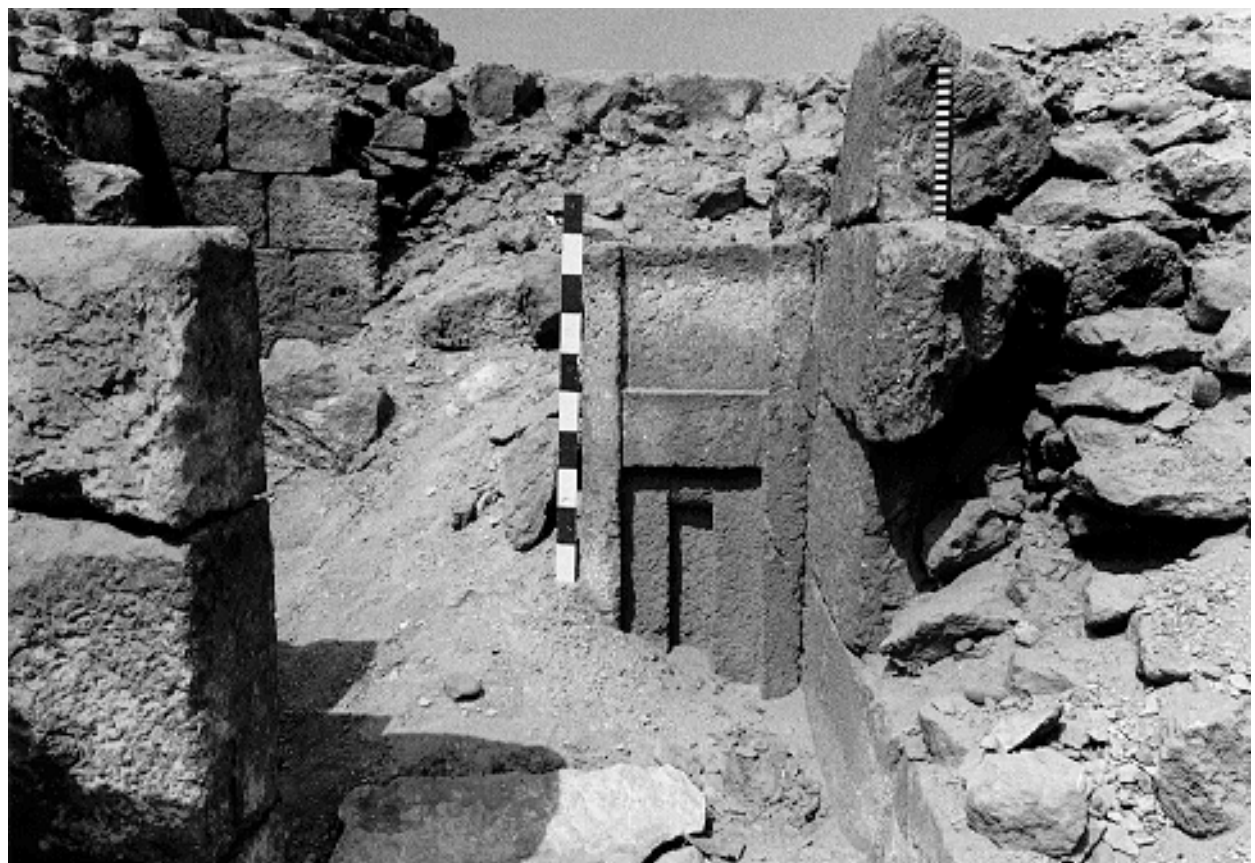
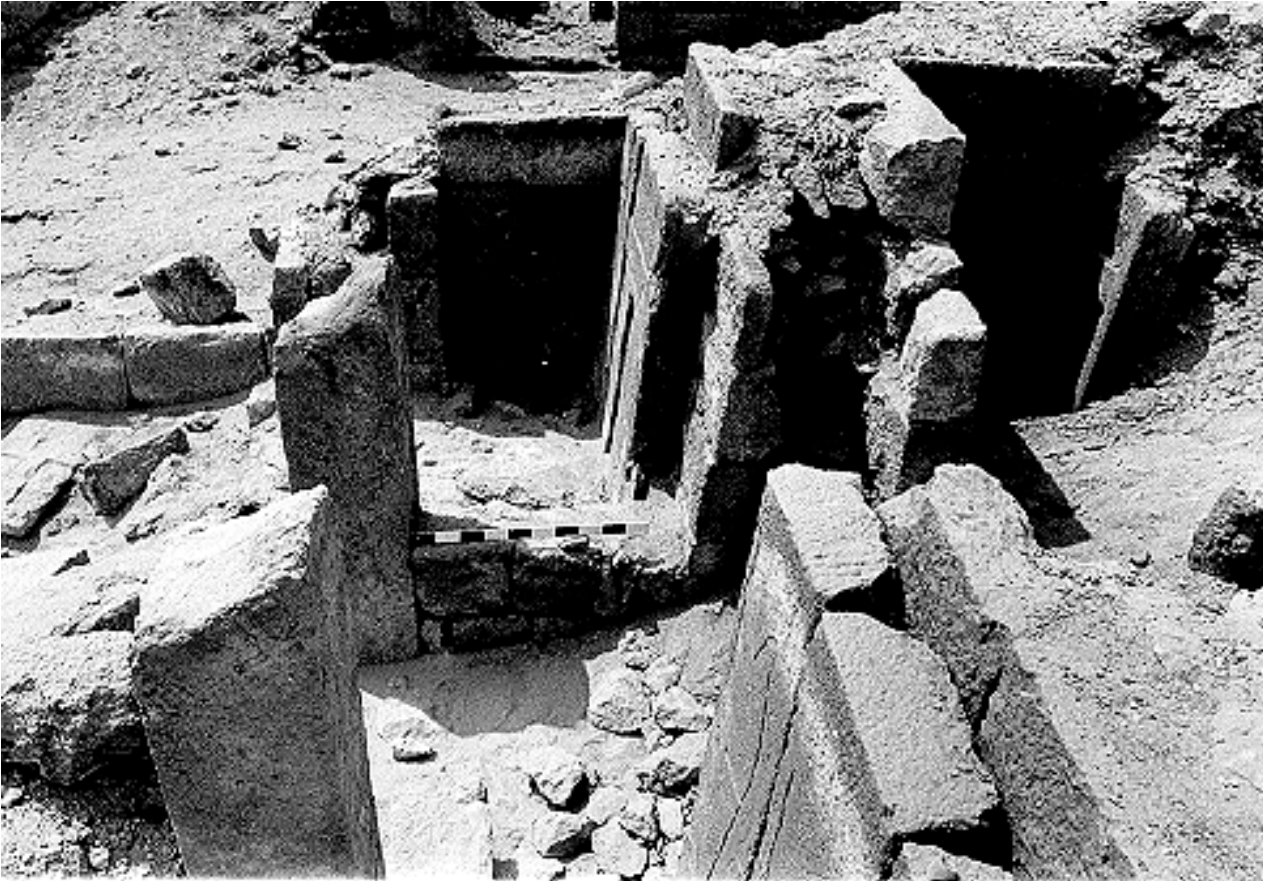
26c. 2088: northern false door and the north wall of the L-shaped chapel (to the right). The west wall between the two false doors was dismantled in antiquity; its blocks are scattered in the courtyard. (The masonry visible behind and left of the false door is the west wall of the principal shaft) (rg 14-15, 1989)

27a. 2088: portico from the north, showing the ashlar block facing added to make its back face somewhat more vertical. (The false door, however, retained the angle of the underlying facade.) The wall under the photo scale is part of the intrusive mastaba 2088a. The L-shaped chapel and its southern false door can be seen to the right (rg 14-24, 1989)

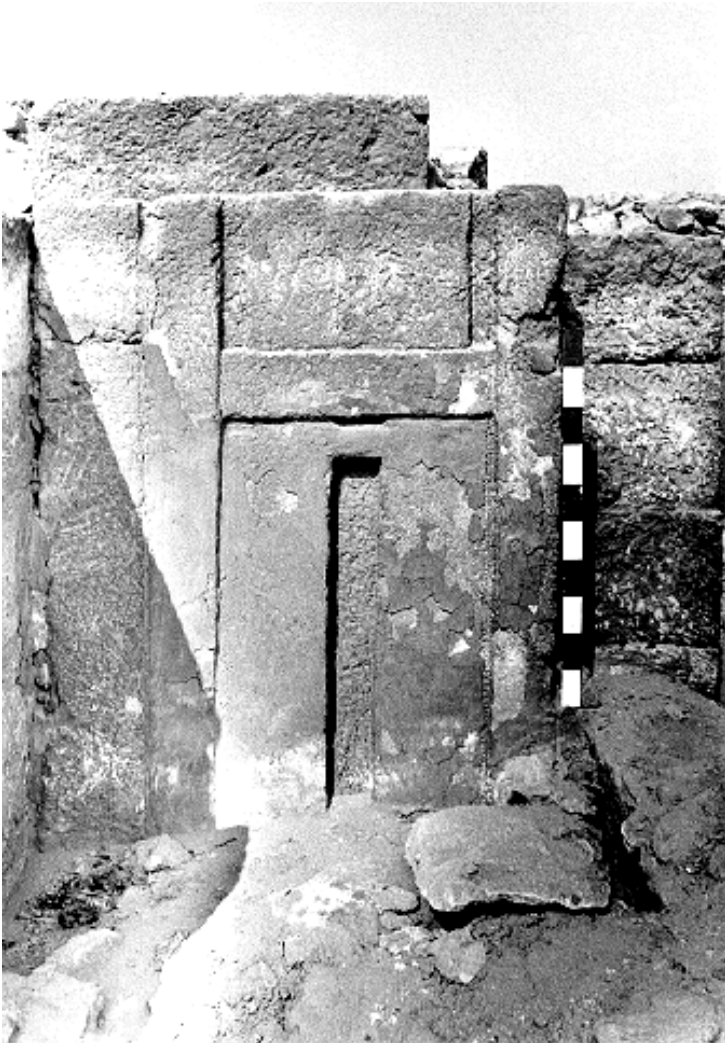
27b. 2088: undecorated false door in the portico. The wall at left (under the photo scale) is the exterior wall of the intrusive mastaba 2088a, which was built in front of this false door (rg 14-10, 1989)

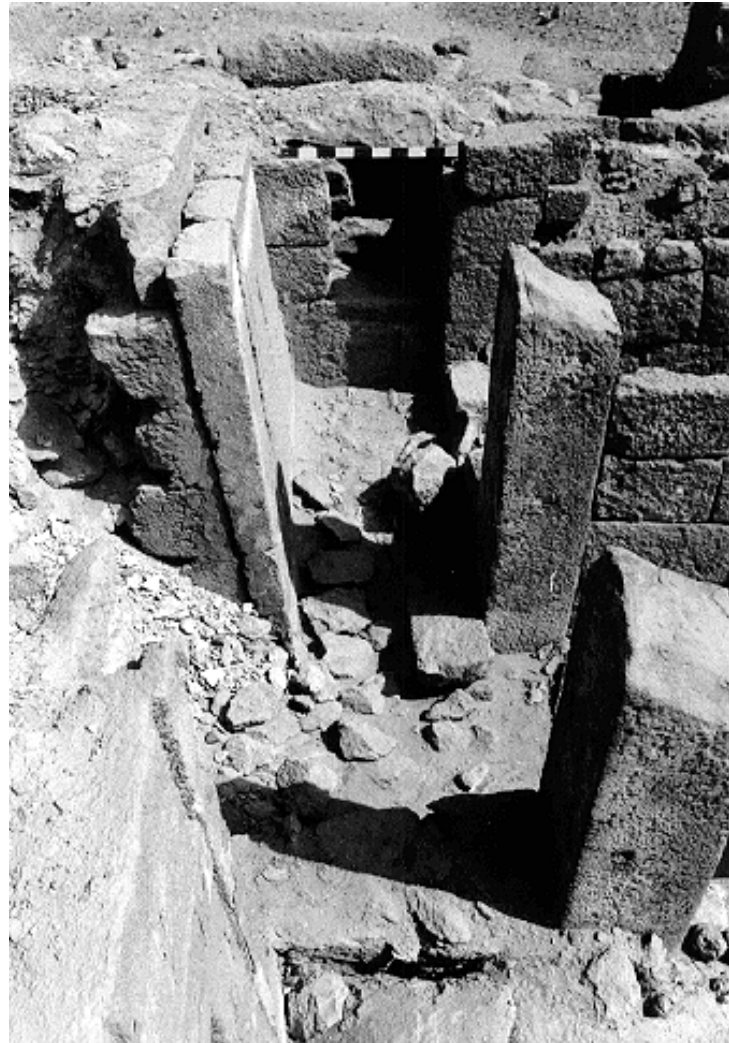
27c. 2088: portico from the south and the ashlar fill blocks laid against the more sharply angled original facade. At the north end of the portico, under the photo scale, was the slot giving access to serdab 1 (now considerably enlarged). Serdab 2, incorporating the northern pillar, is to the right (rg 7-25, 1989)

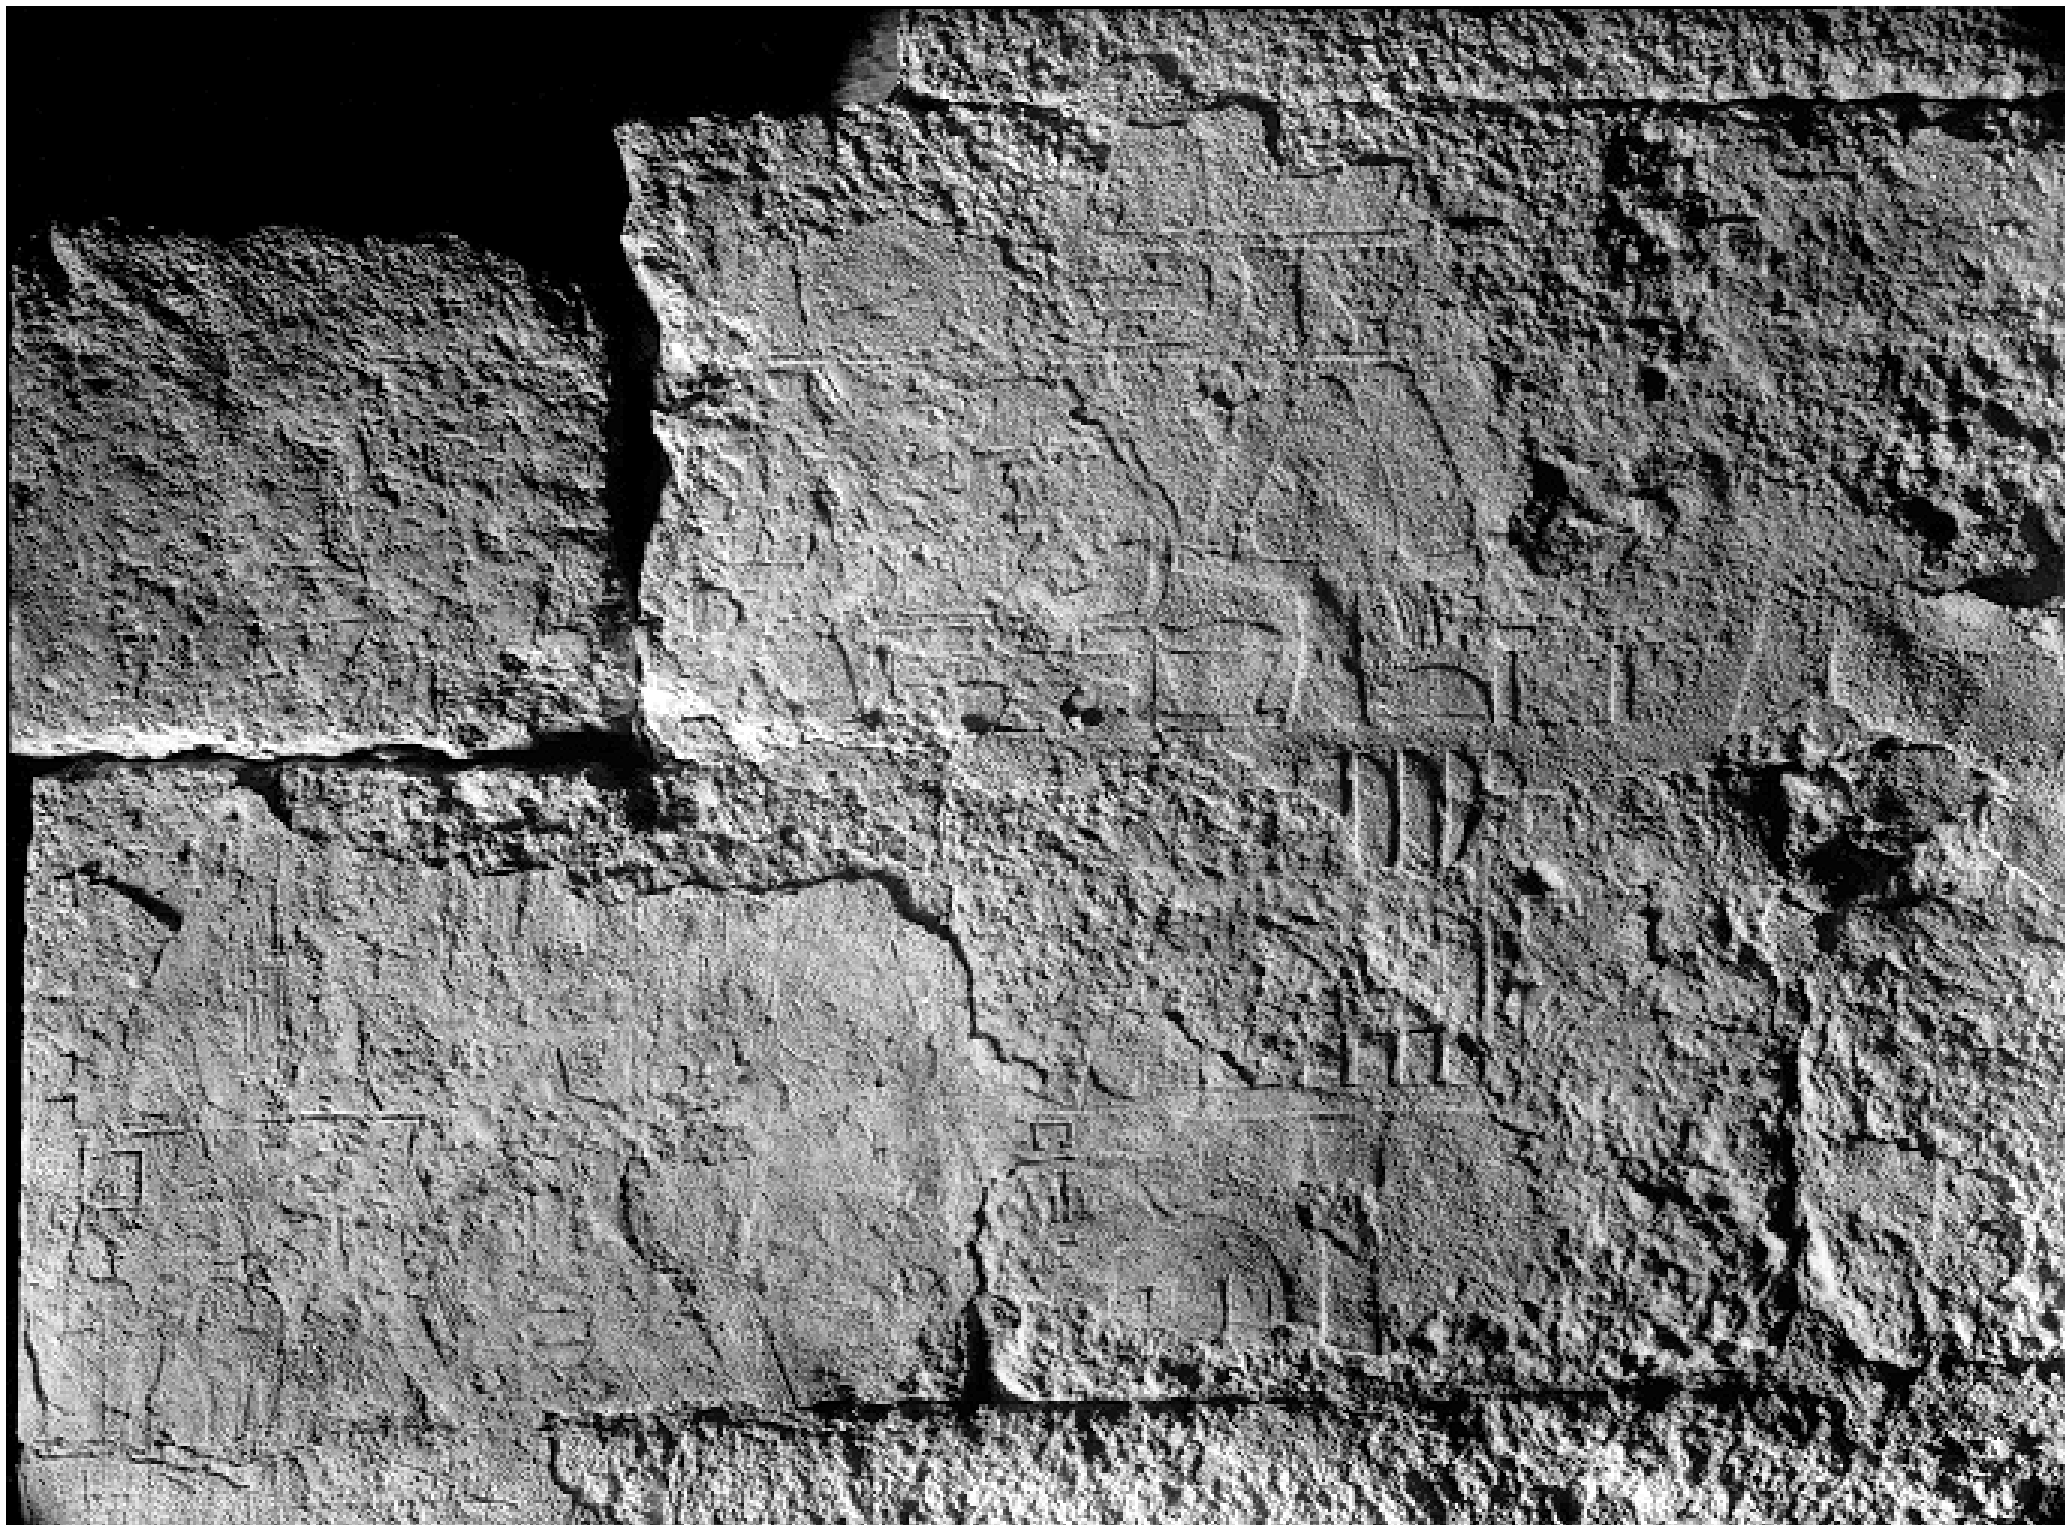
28. 2088: east wall of chapel. Ka-khent is seated at right before a pile of loaves; several children, two of them playing harps, are seated at the lower left. The vertical edge visible under Kakhent's chair is probably the front of the legs of his wife, who was originally represented seated beside him (a 8068)
