Plates

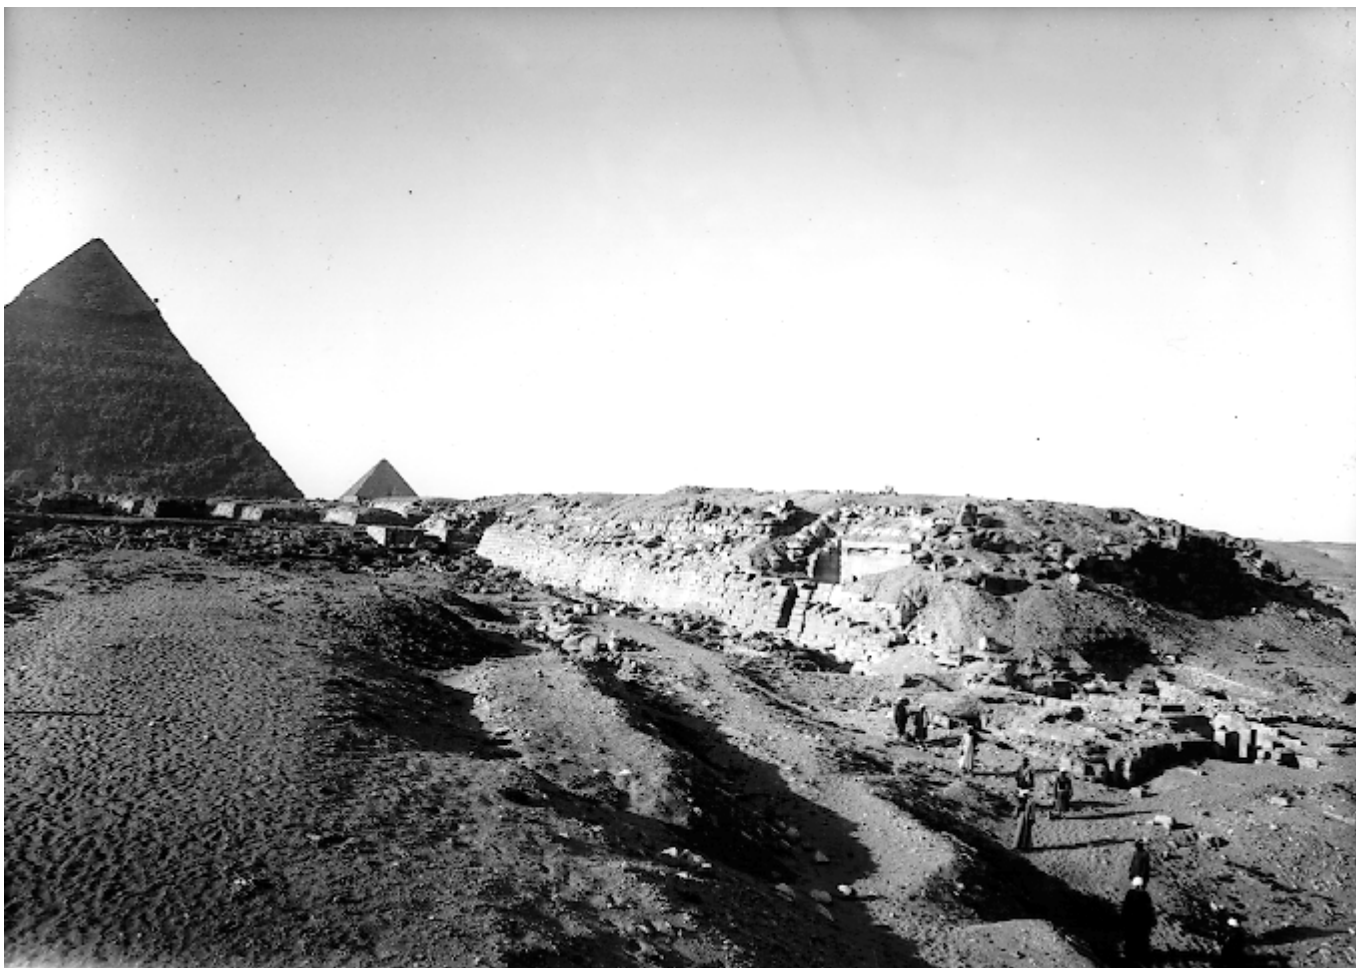
2a. An overview of the cluster from the northeast on March 28, 1938, when only its southwest part had been excavated. Behind the workmen and the mastabas is the massive mastaba g 2000. Further south are the pyramids of Khafre (left) and Menkaure (a 7972)

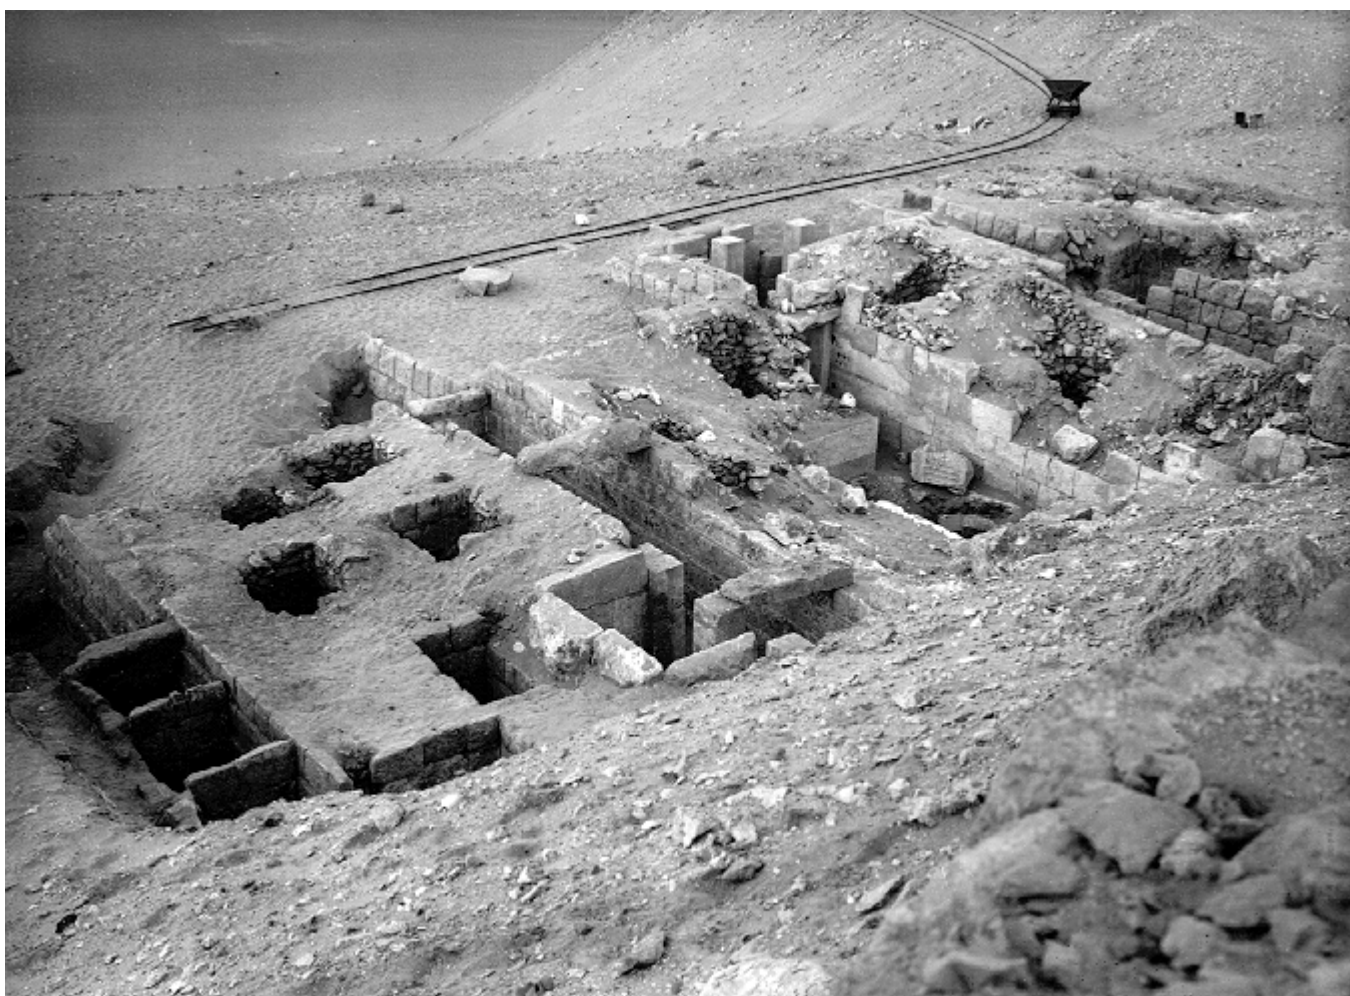
2b. The southwest corner of the cluster from the top of g 2000 on September 14, 1936. From left: 2094, with subsidiary shafts to the west and some corridor roof blocks still in place; 2092+2093, with 2096 and pillared court to the north; and 2091, the large gap in its western face marking the position of its principal shaft. Note the painted decoration (three running men and the wide red band below) adjacent to the north doorway of 2092+2093; and also the loose block from 2097 atop 2096 (near the end of the railway tracks; the serdab slot is visible on the face toward the camera) (a 7692)

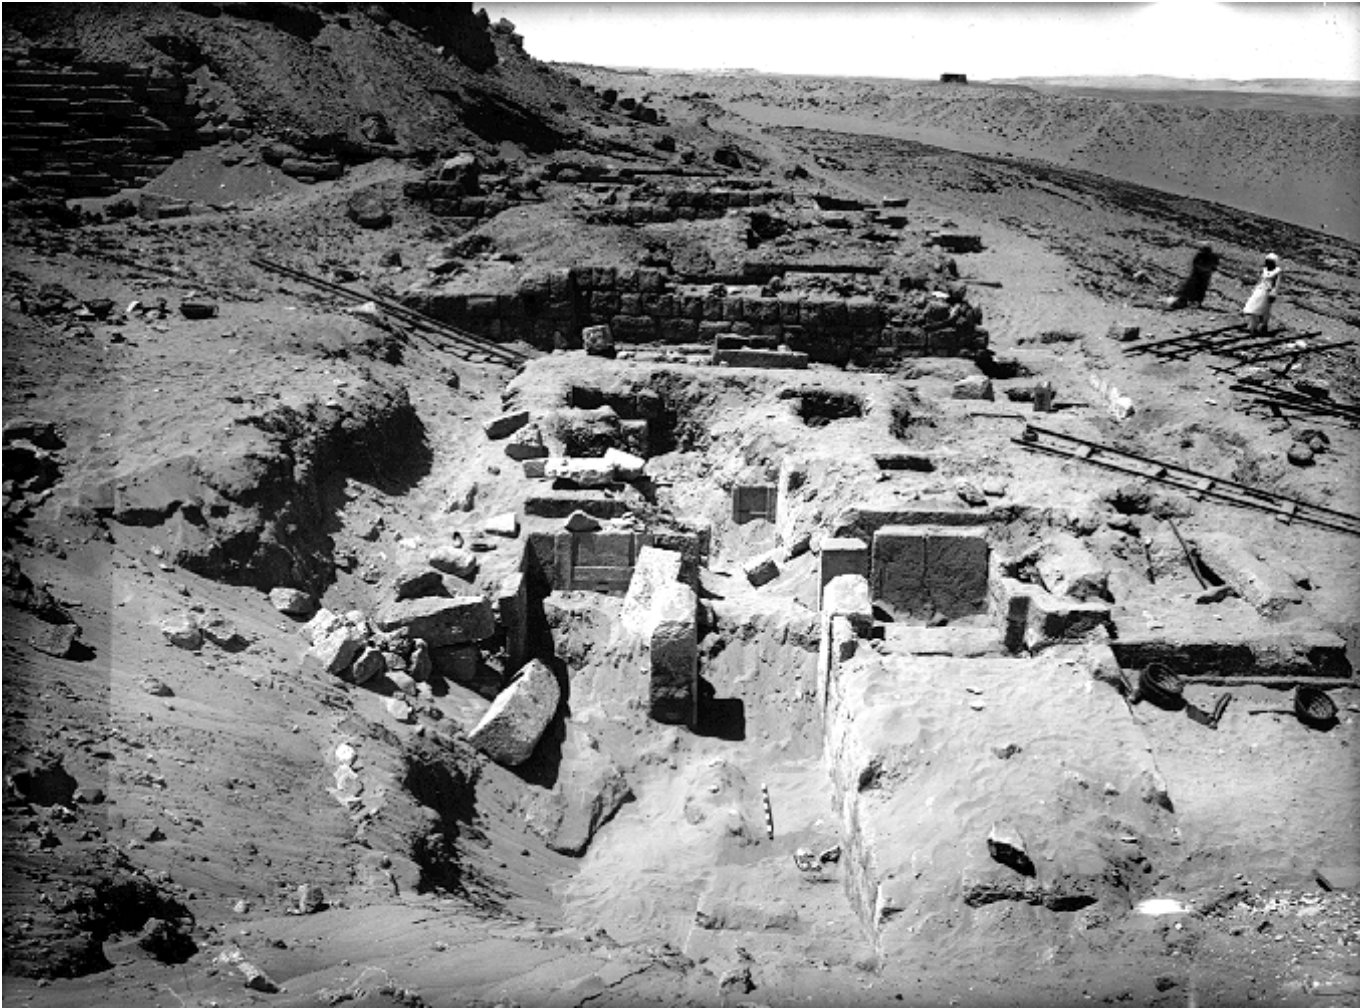
3a. View from the "big dump," April 8, 1938, looking west into the chapel of 2088. The models in the foreground include the base of the double model. Sunk relief is visible on the southern pillar and the back wall of the portico. The door and northern false door align clearly with the lintels of the door and false door of 2089 behind them. Further west lie 2091 and at left, the north face of g 2000 (a 7981)

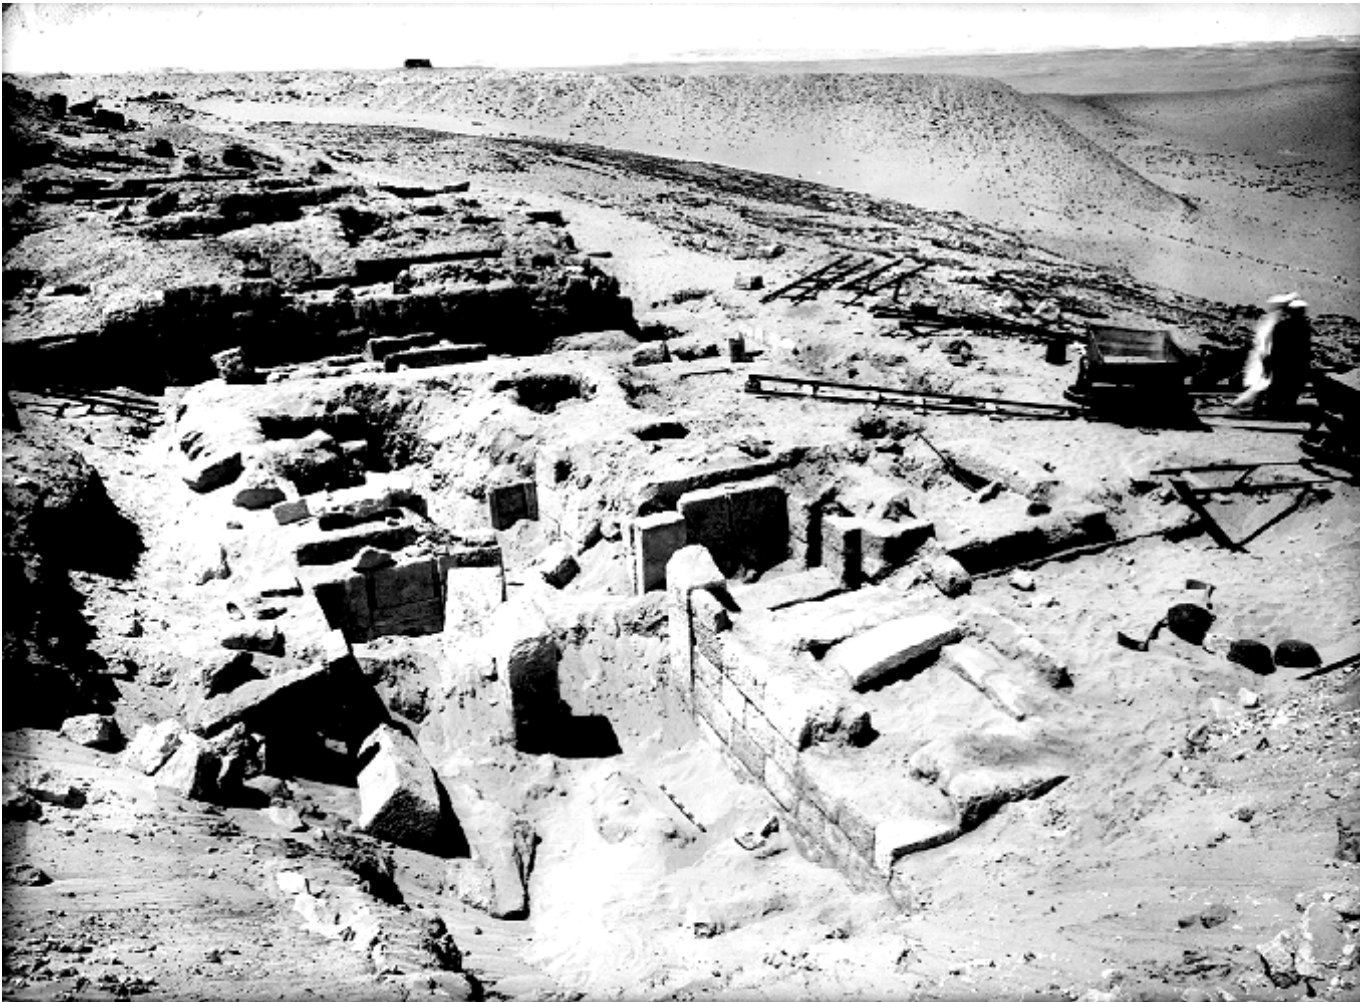
3b. View from the "big dump" after the clearance of the roof of serdab 2 of 2088, April 8, 1938. At least five roof blocks seem to have been in place at the time of excavation (a 7983)

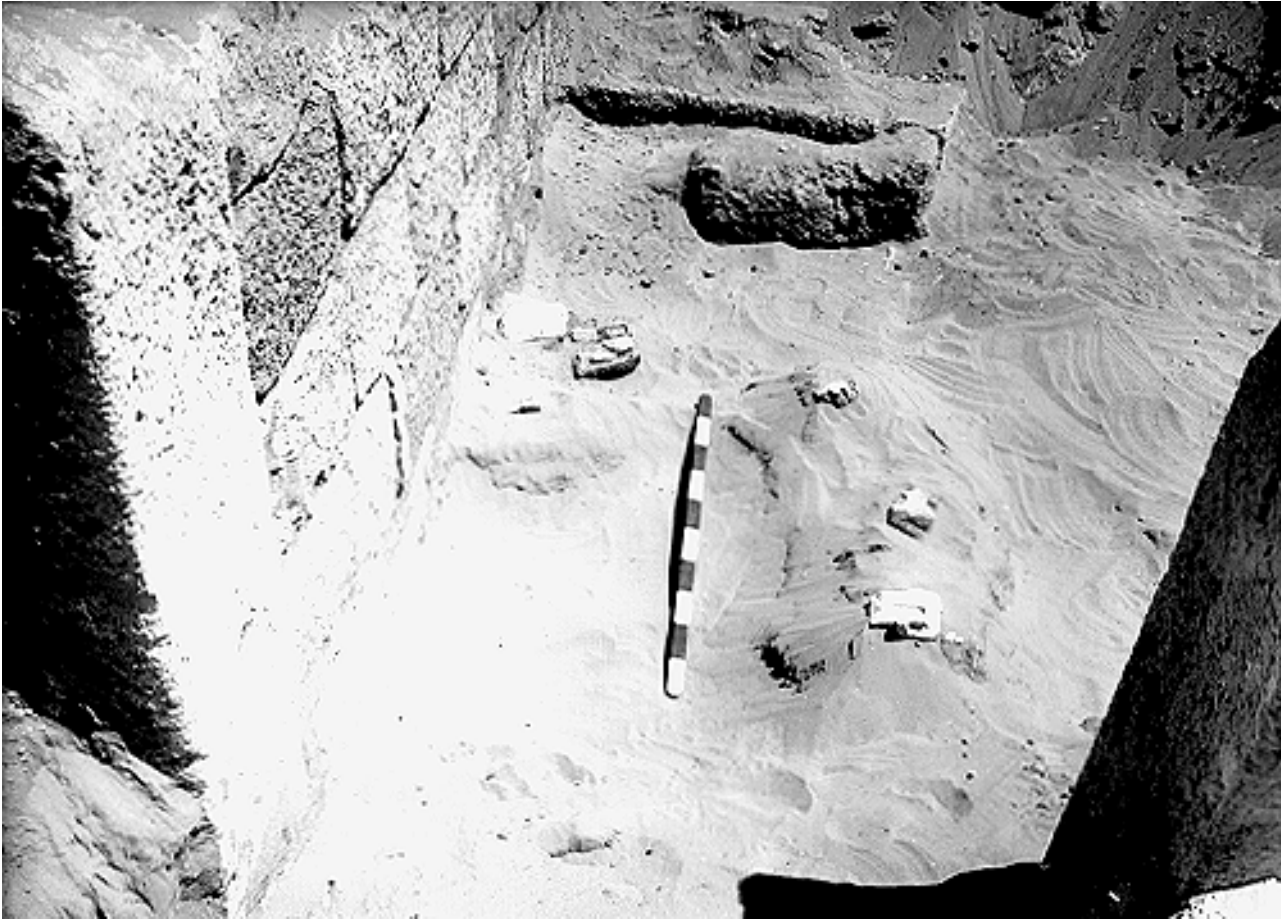
4a. Detail of model fragments outside serdab 2 of 2088. The pillar at left is the northern pillar of the portico, which was incorporated into the exterior wall of the serdab (b 8954)

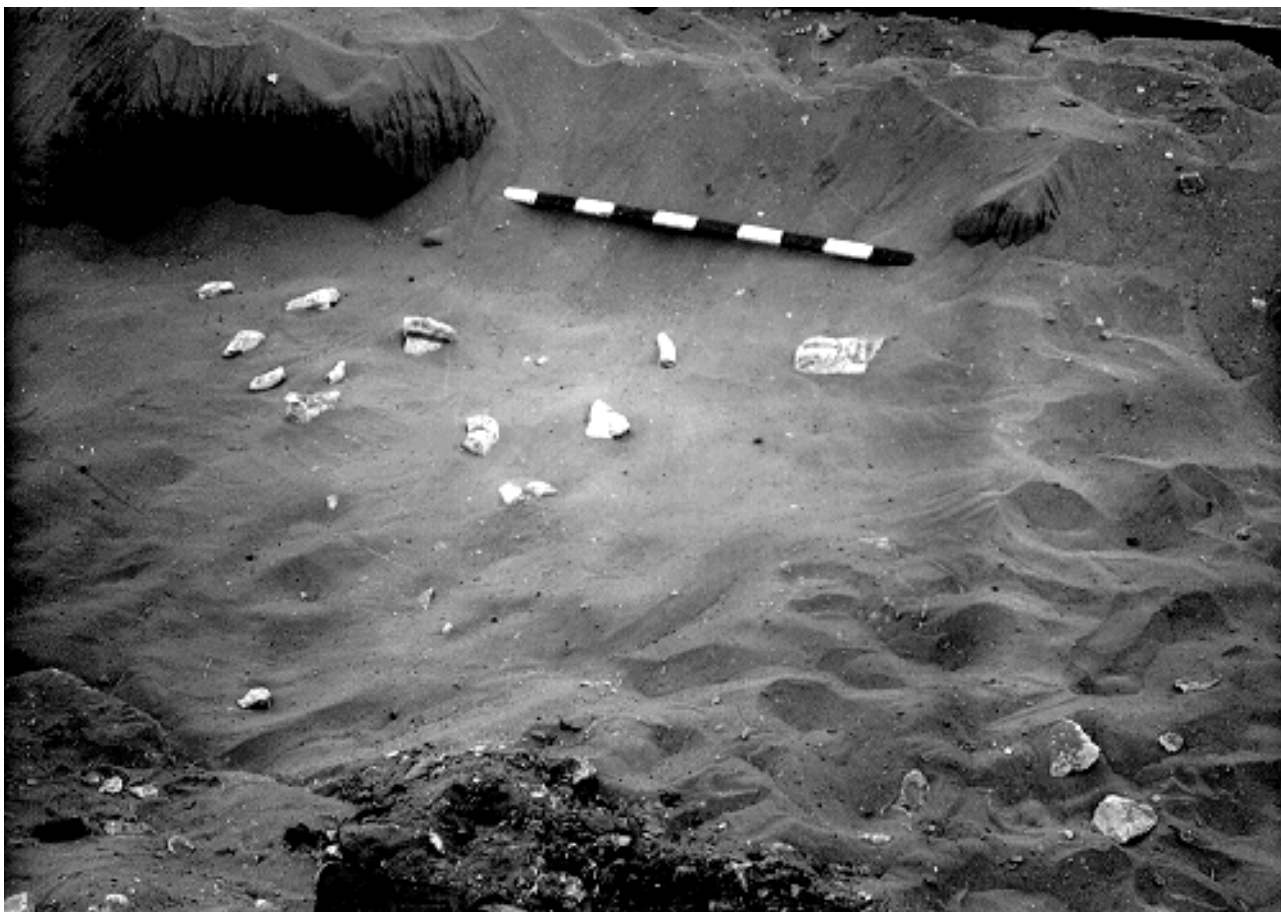
4b. More model fragments from 2088 S2. This photograph was most probably taken in the courtyard of 2088; however, the presence of railway tracks at the top of the picture is disturbing (b 9063)

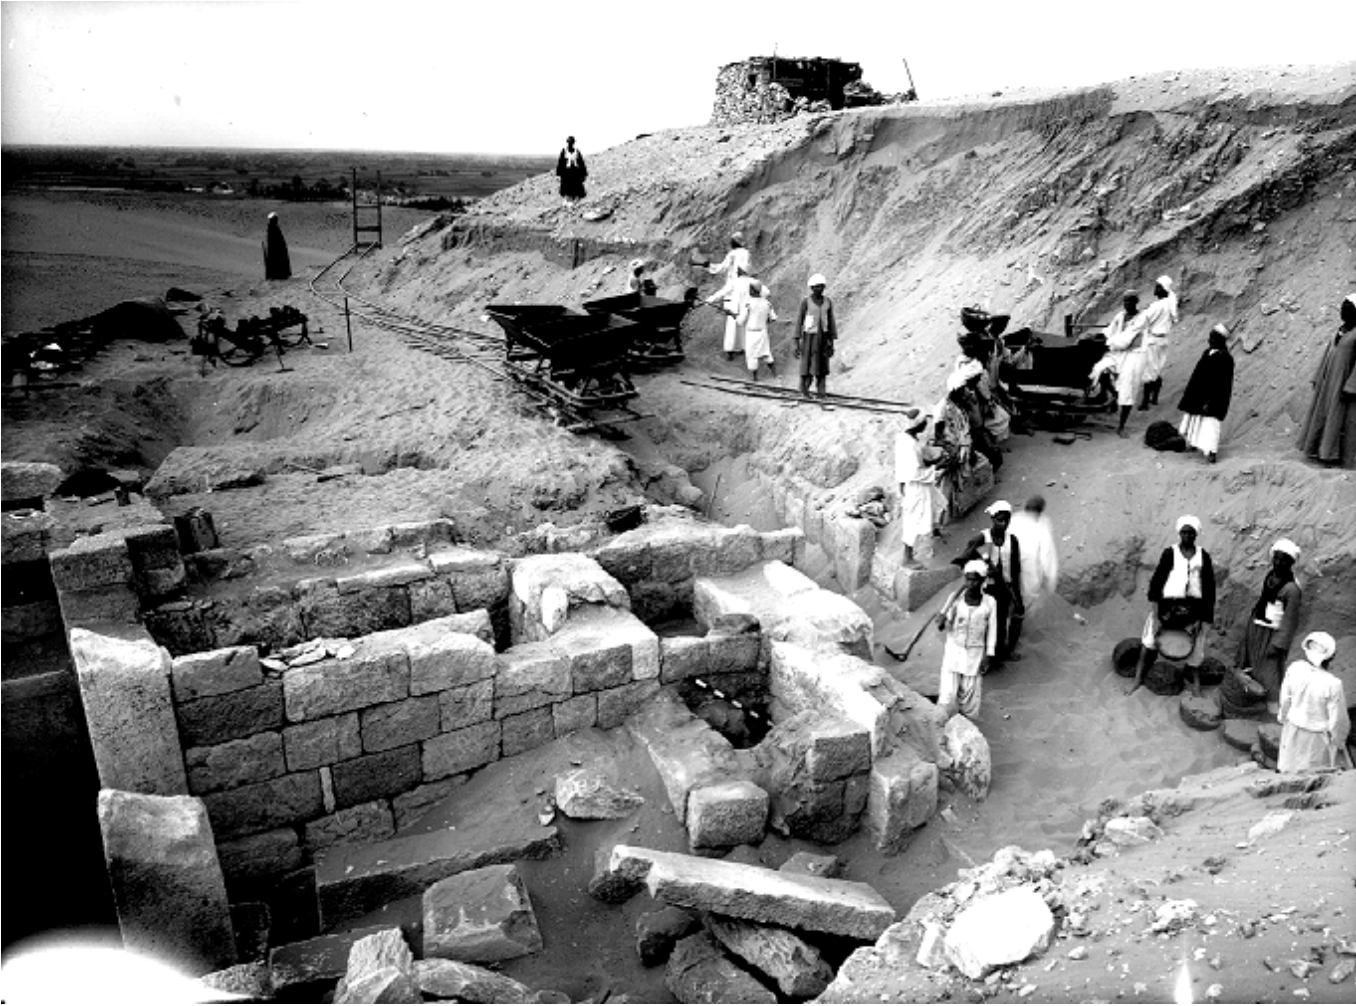
5a. Serdab 2 of 2088 and, left of it, subsidiary 2088a, taken on April 15, 1938. The doorjambs leading to 2087 have been partially exposed behind the spur wall of 2088. The courtyard in the foreground is filled with loose blocks, including one of the jambs that originally flanked its entrance. To the left, two pillars and a pilaster of the original portico are visible (a 7990)

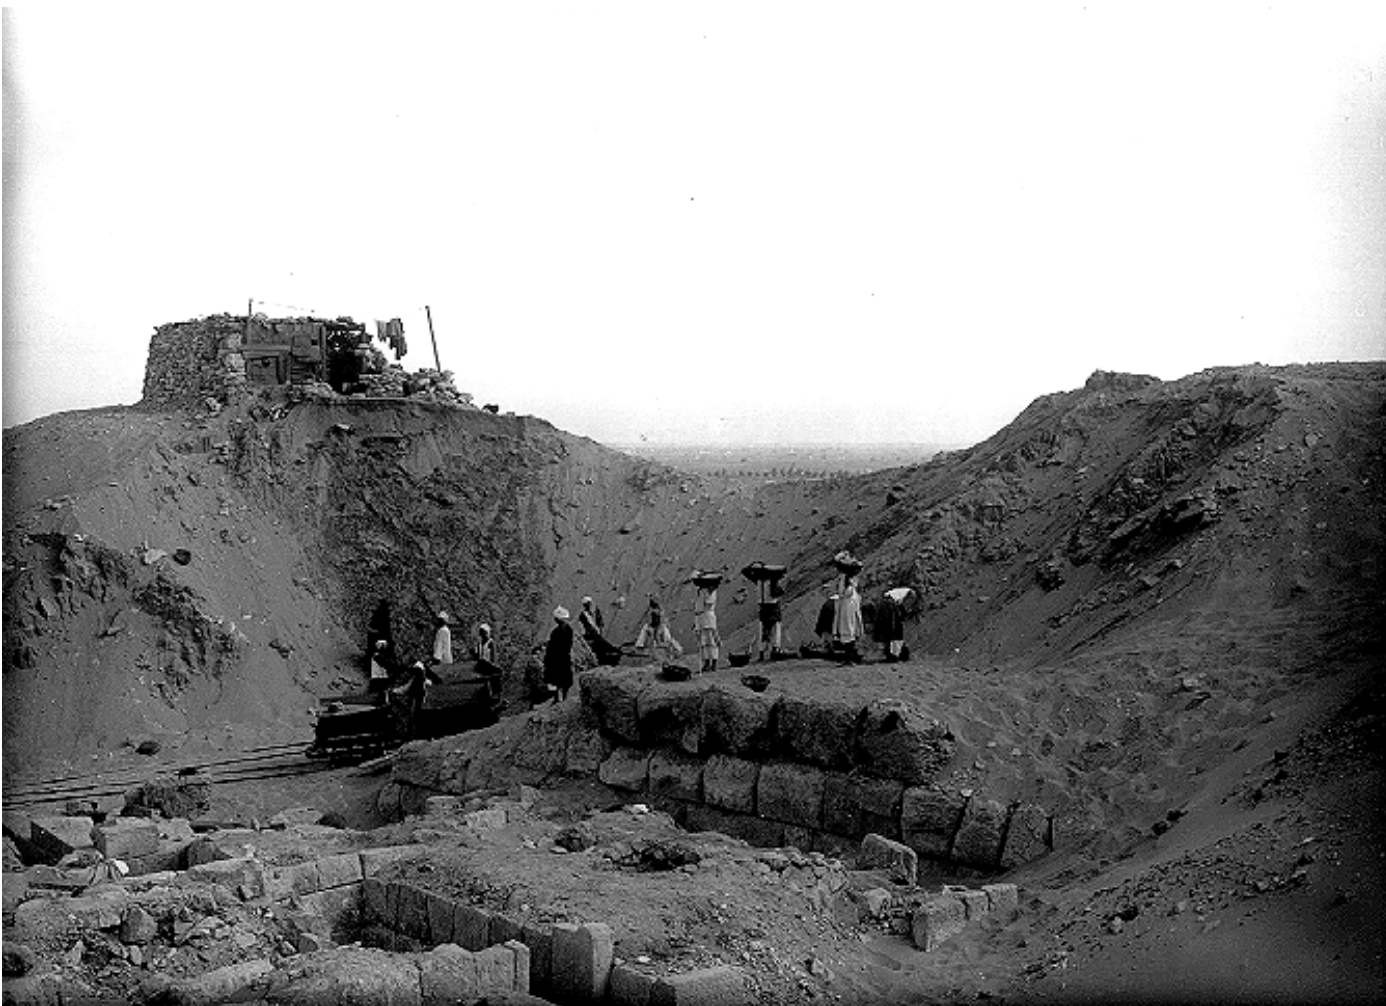
5b. The removal of the "big dump" over 2230, February 11, 1939. The jambs and corridor of 2087 are visible in the foreground. Note larger blocks ("w-masonry" of the west facade of 2230 and the extensive weathering of its top course (a 8099)

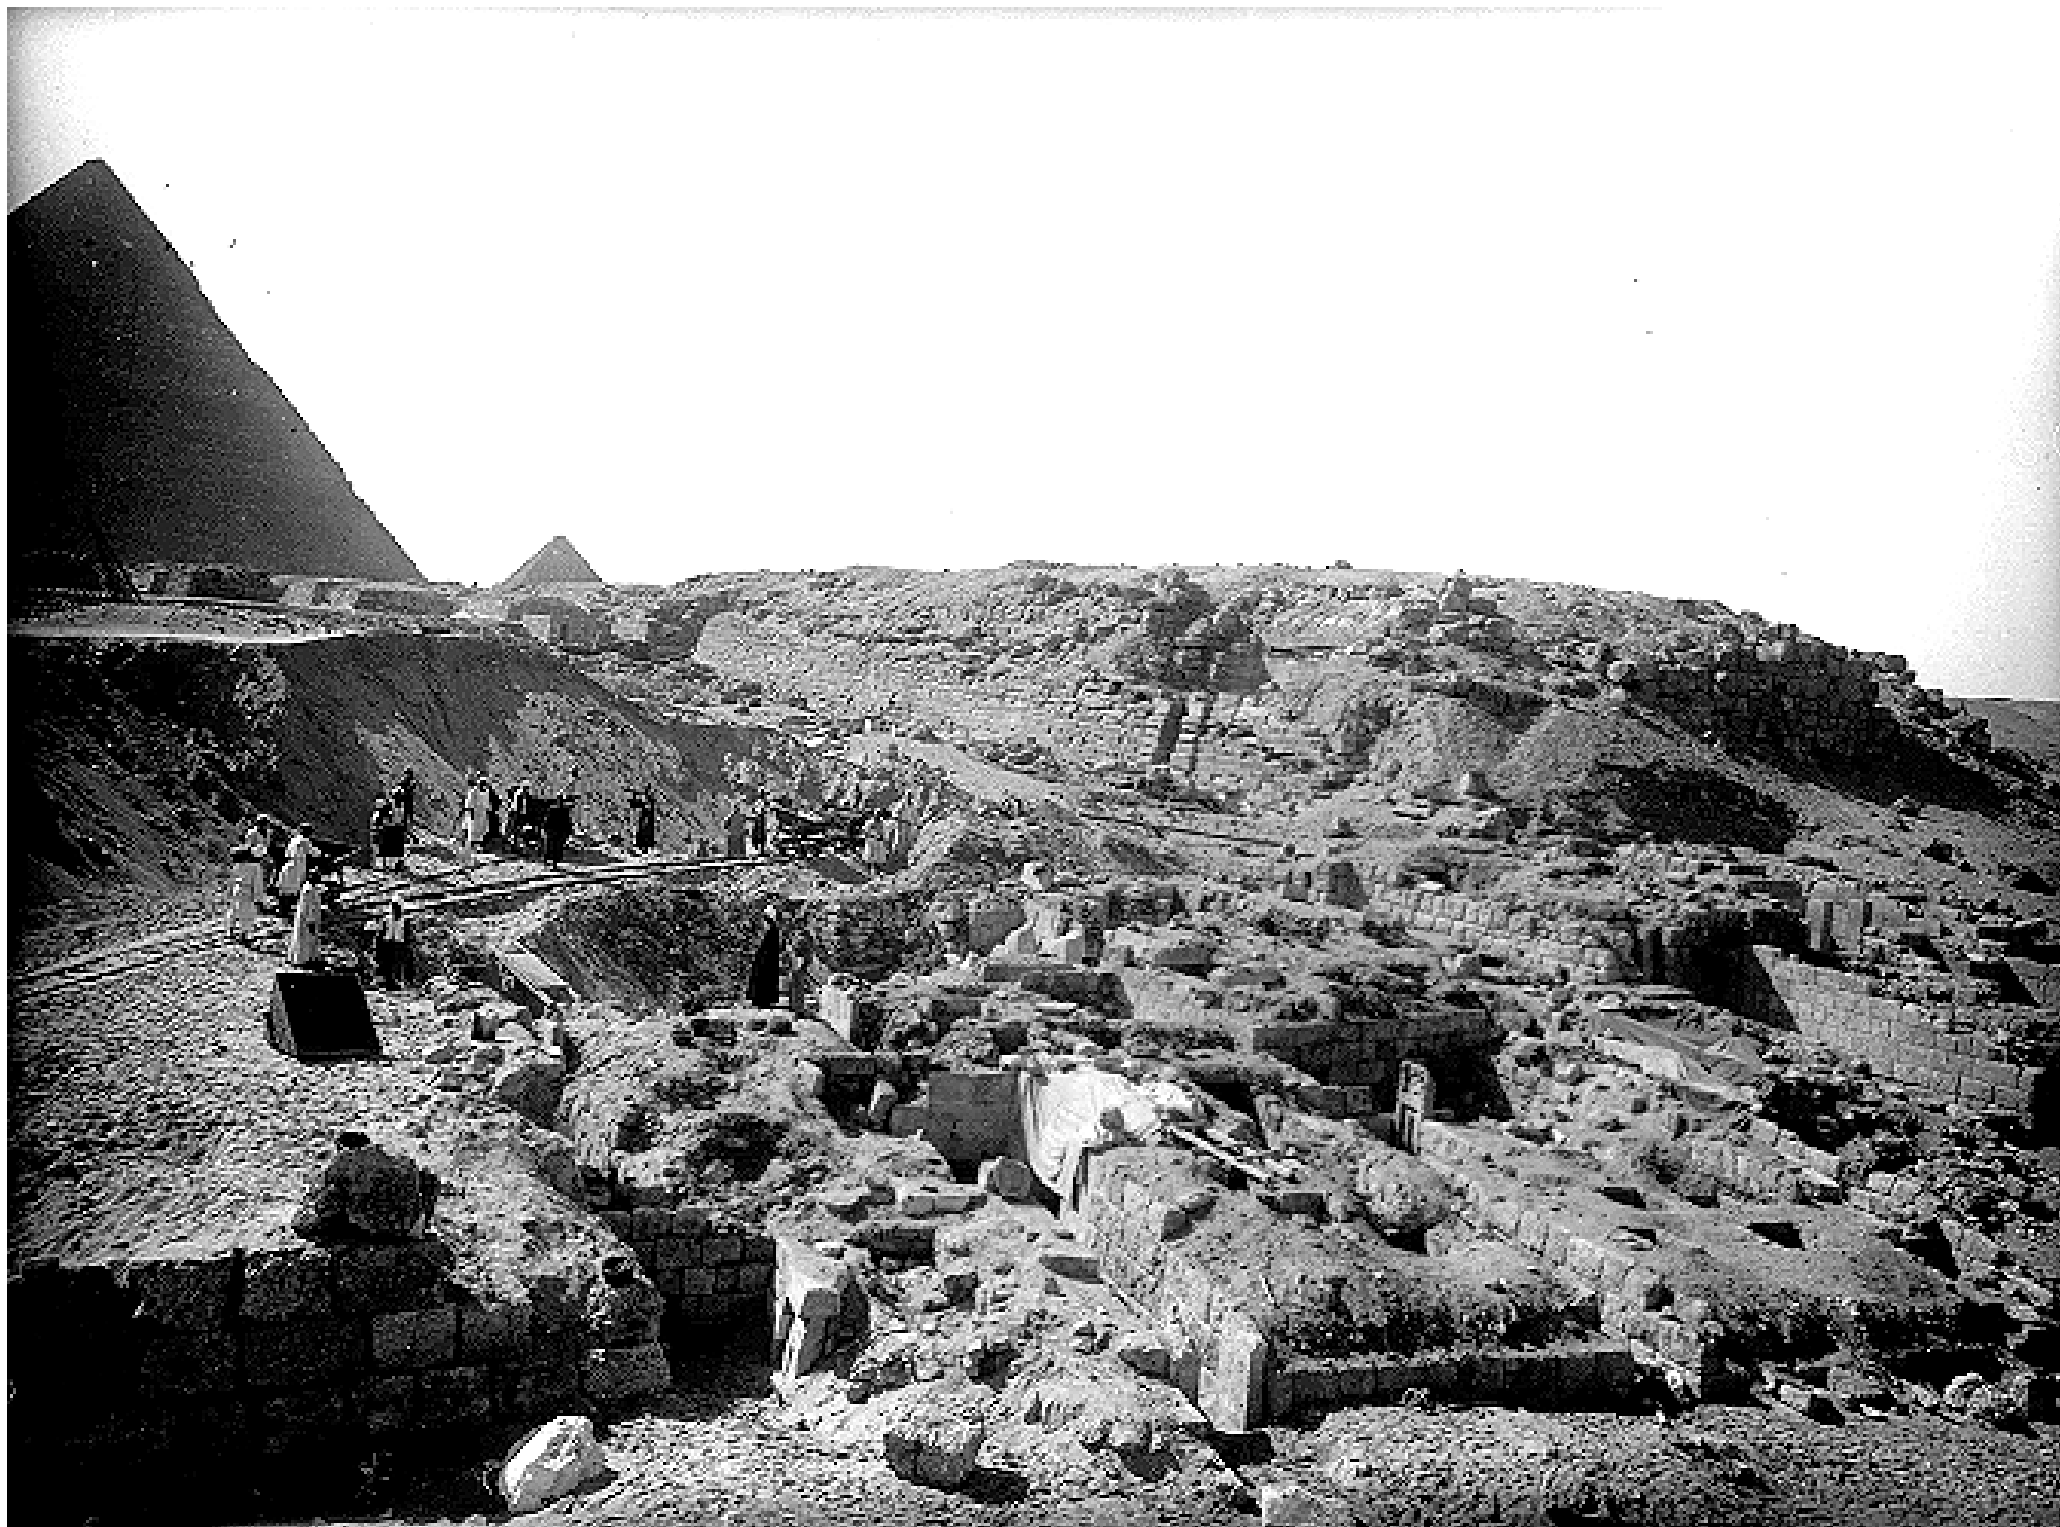
6. View of the cluster from the northeast, February 17, 1939, with the pyramids of Khafre and Menkaure and g 2000 in the background. (The tombs south of the cluster are being excavated.) Two architectural details are preserved only in this photograph: the masonry wall just beyond the false door of 2085 in the foreground just left of center; and the northern false door of Tjezet, a slot and drum lintel cut into the east facade of 2097' (below the two pillars, near the right edge of the photo). The latter is the only monument in the cluster dedicated to a woman (a 8112)

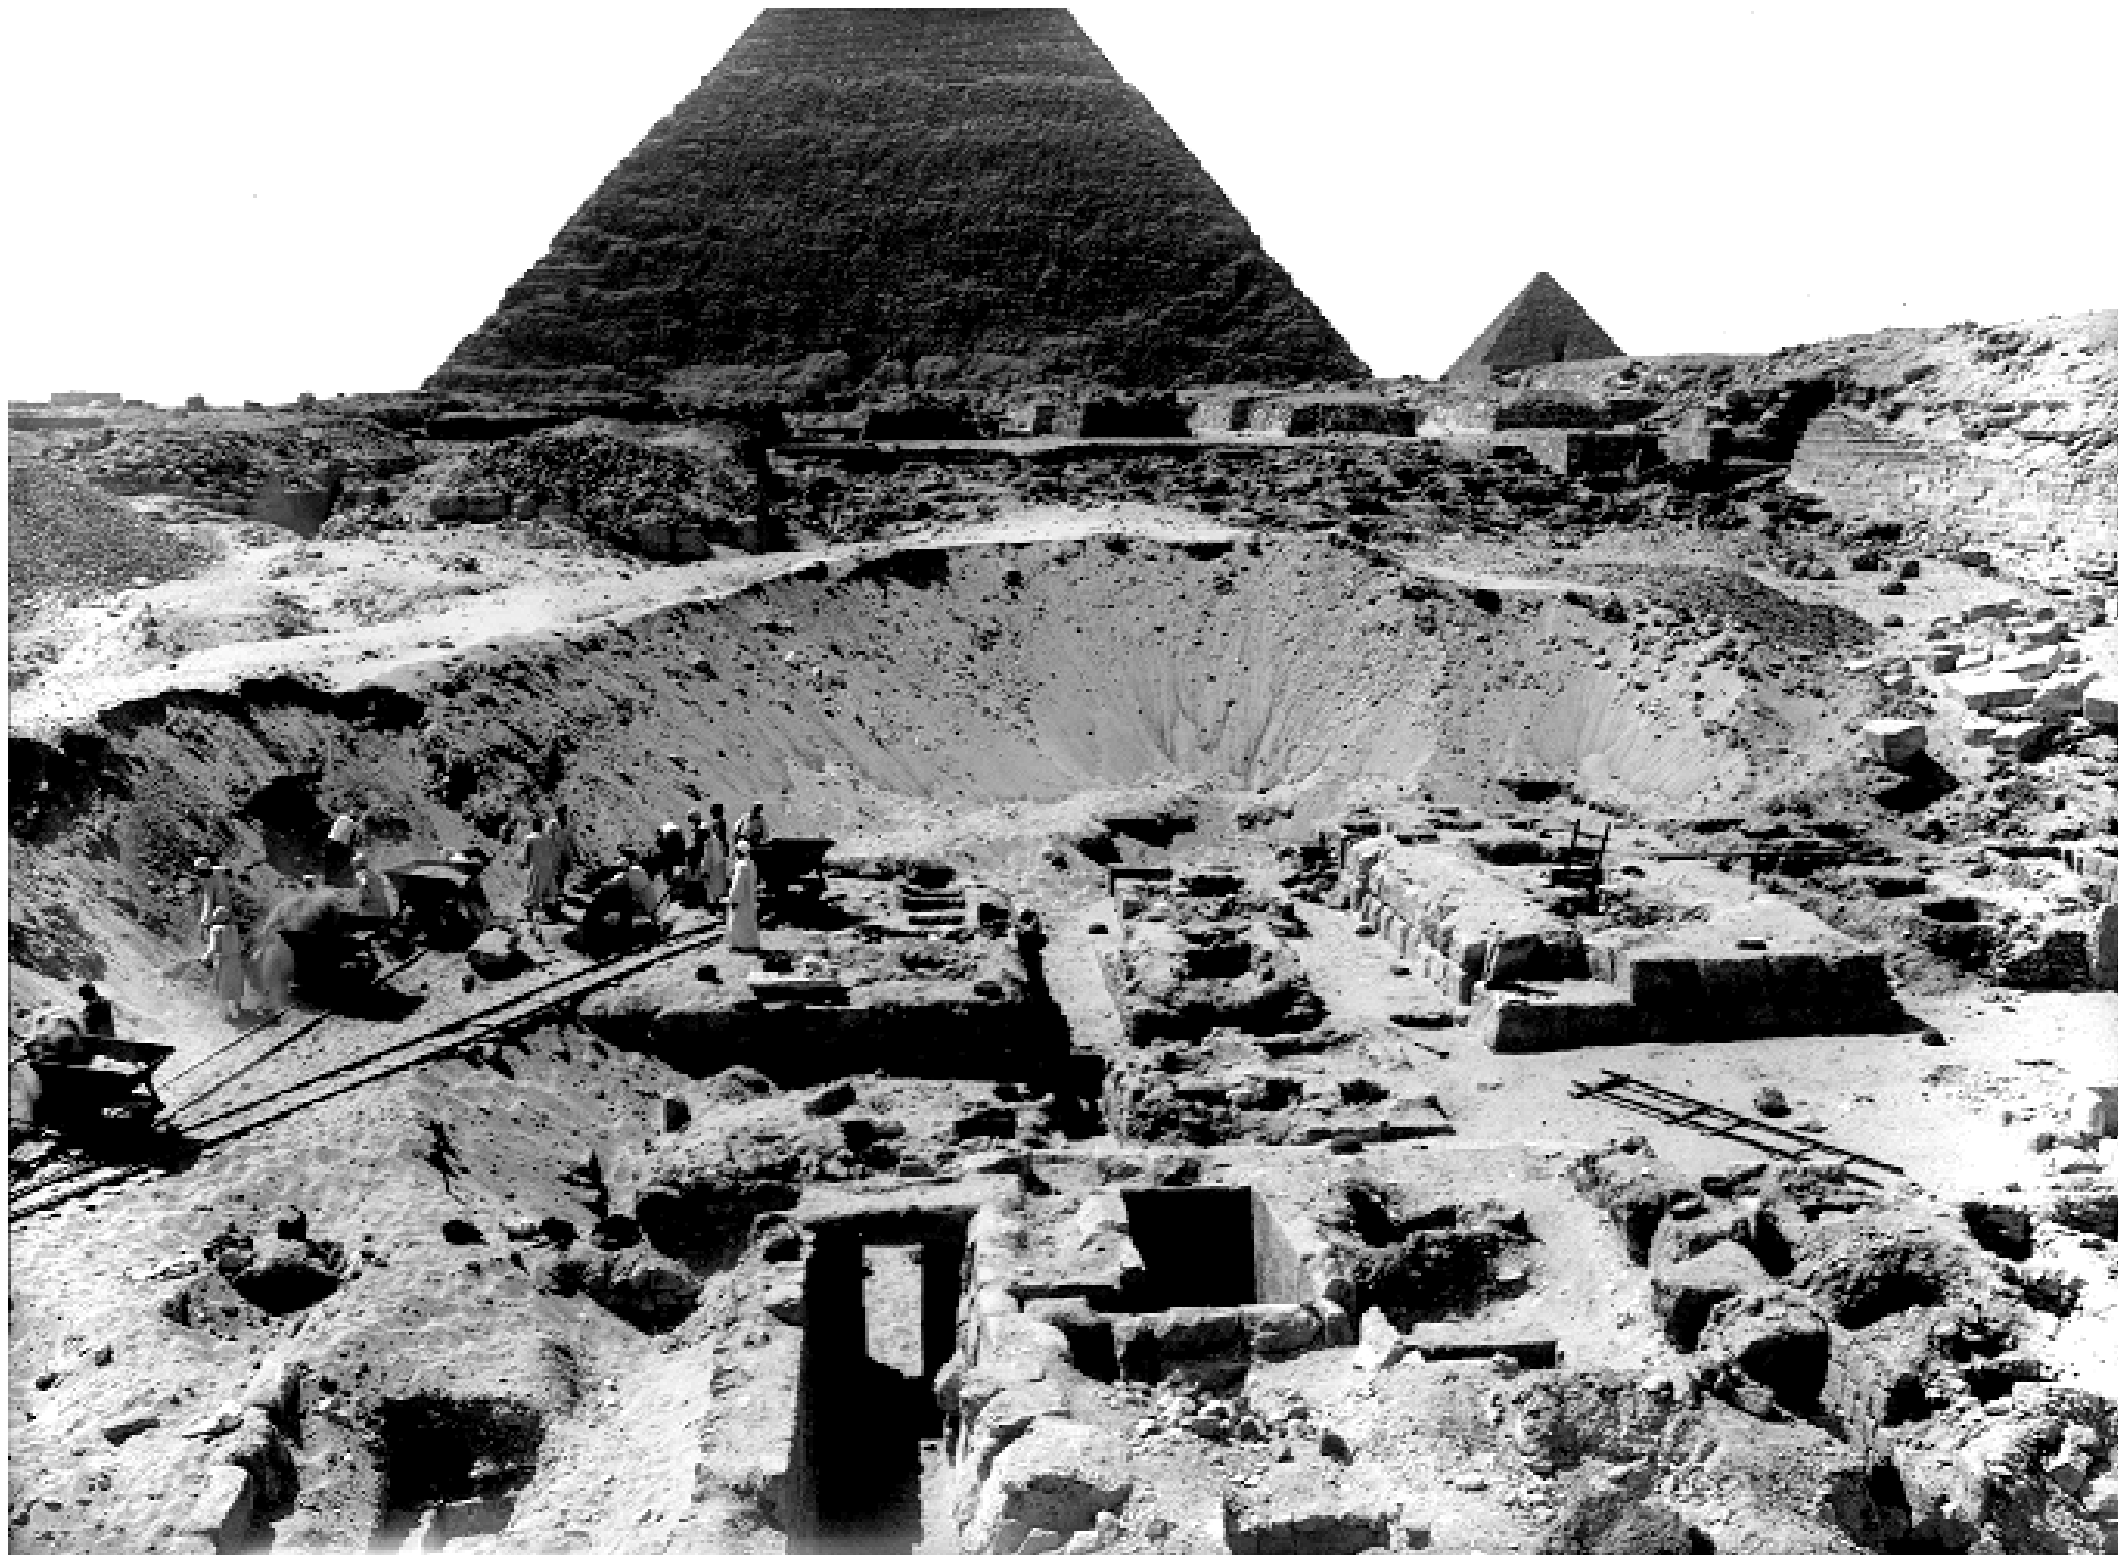
8. View south from the surviving northern end of the "big dump," April 7, 1939. Centered in the foreground is the corridor of 2230+2231; beyond that mastaba is the path and more mastabas to the south. In the background are the pyramids of Khafre and Menkaure (a 8204)

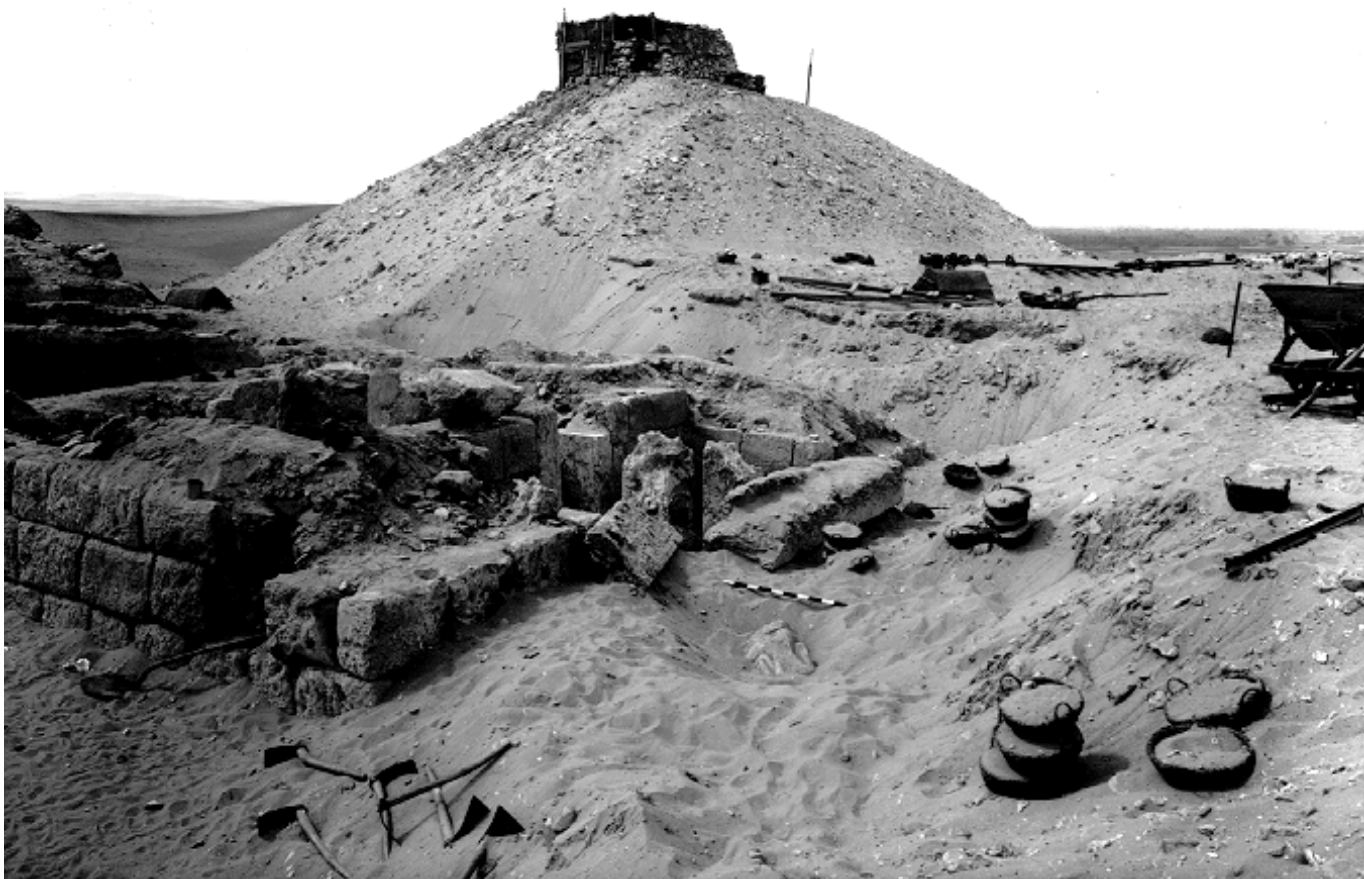
10a. The excavation of 2240, taken on April 26, 1939. In front of the portico is a fallen lintel; a headless statue of a seated scribe lies in situ to the east. In the background is the surviving northern end of the "big dump" (a 8219)

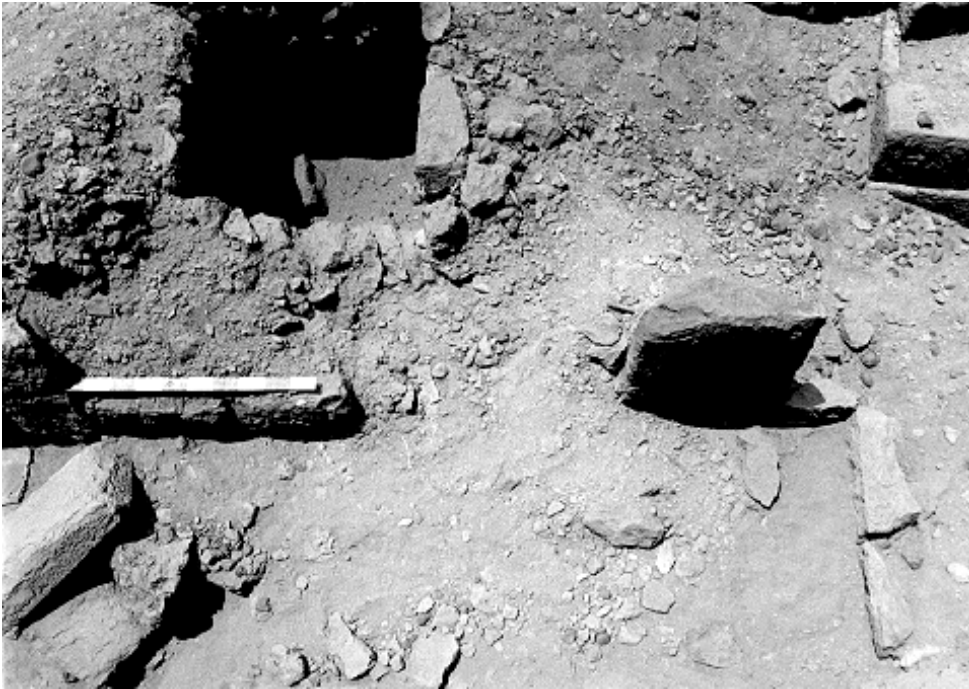
11a. 2084: Corridor chapel (foreground) with gap and partially buried ashlar probably representing cult place. Shaft d is at upper left, and the stepped facade of 2085, against which 2084 was built, is at upper right (rg 12-32, 1990)

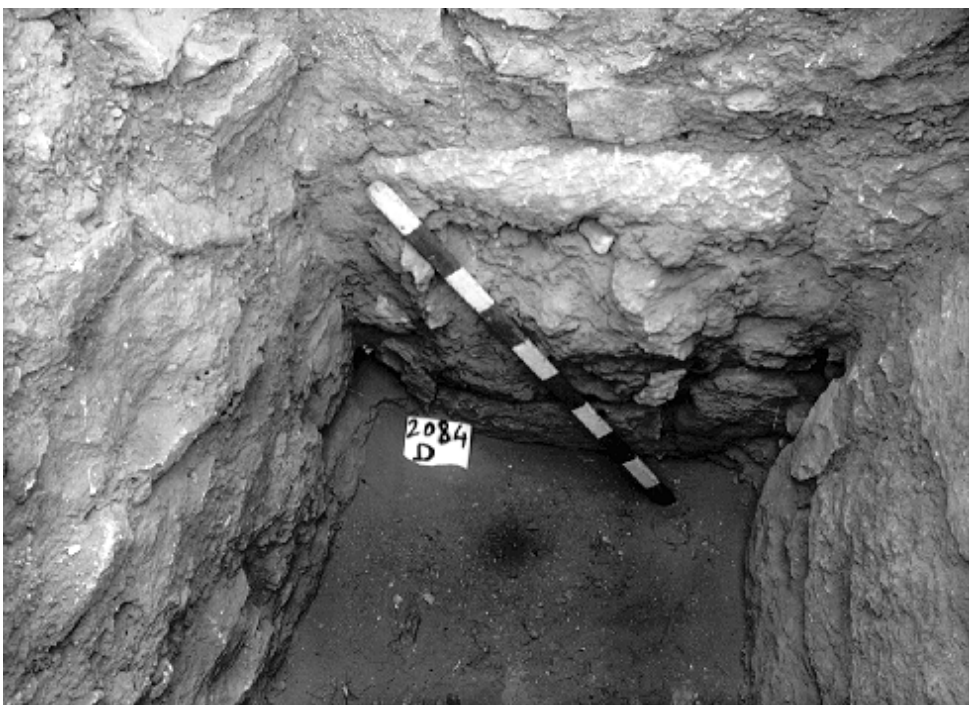
11c. 2084 d: blocking of the chamber. This is Reisner's blocking type iii d(2), an internal wall of rubble bound with mud (b 9065)

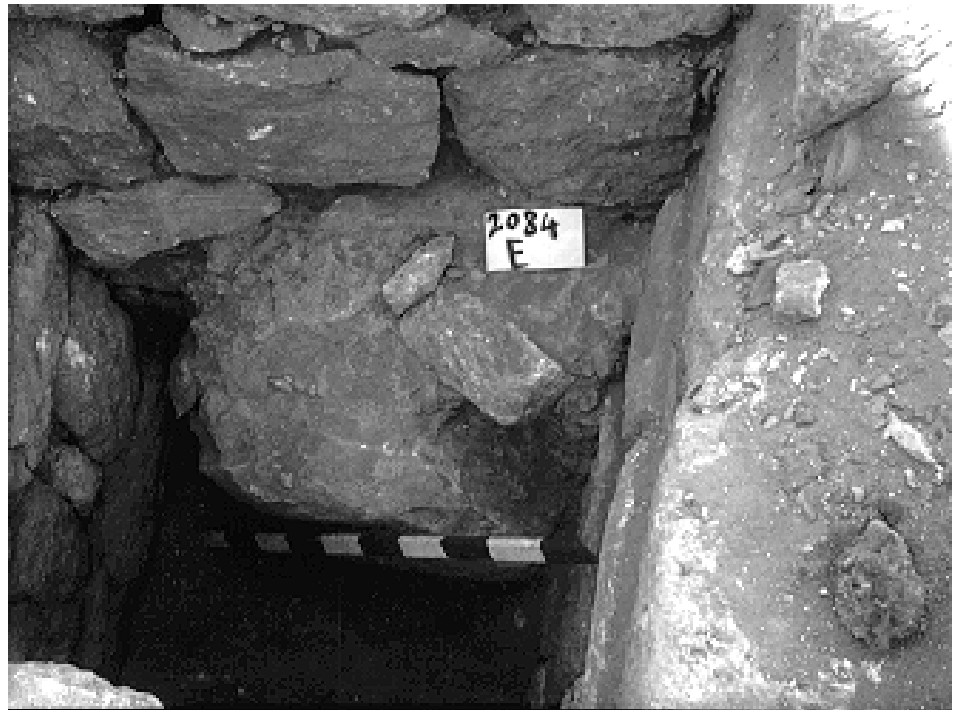
12a. 2084 e: shaft and an example of Reisner's blocking type iv e(2), a vertical slab with a rubble and mud wall built above it (c 14283)

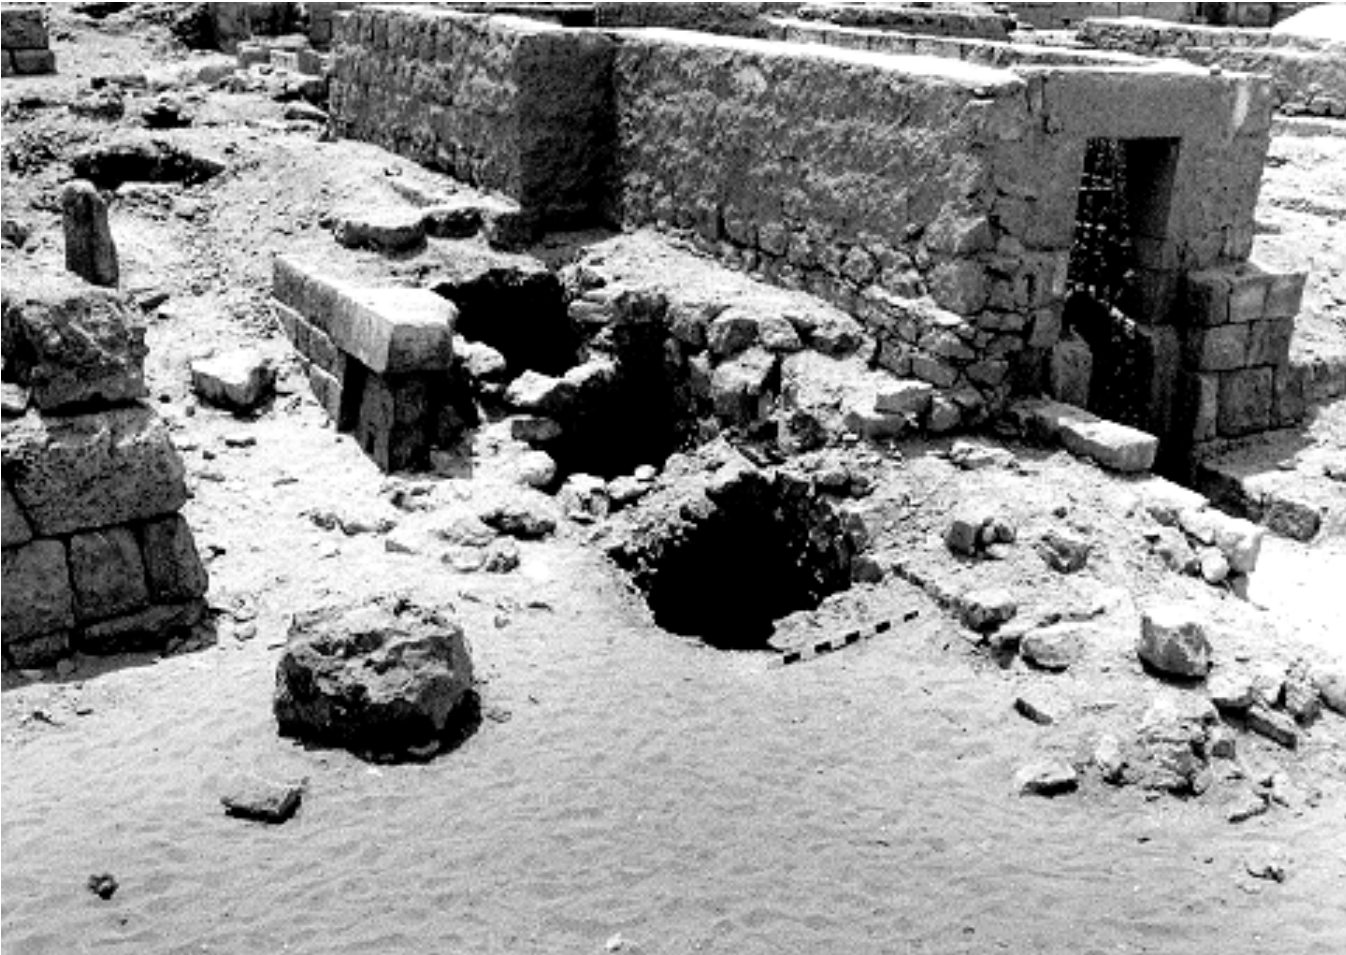
13a. 2085: from the northeast, with partially buried false door and entrances to shafts a, b, and c; the fourth shaft, d, is no longer visible. Note the relative levels of the false door lintel of 2085 and the lower parts of the doorjambs of 2086 to the west. (The enclosure of 2086 is modern reconstruction, built over the western facades of 2085 and 2084; but the height is approximately that of the original mastaba) (rg 12-25, 1989)
