Plates

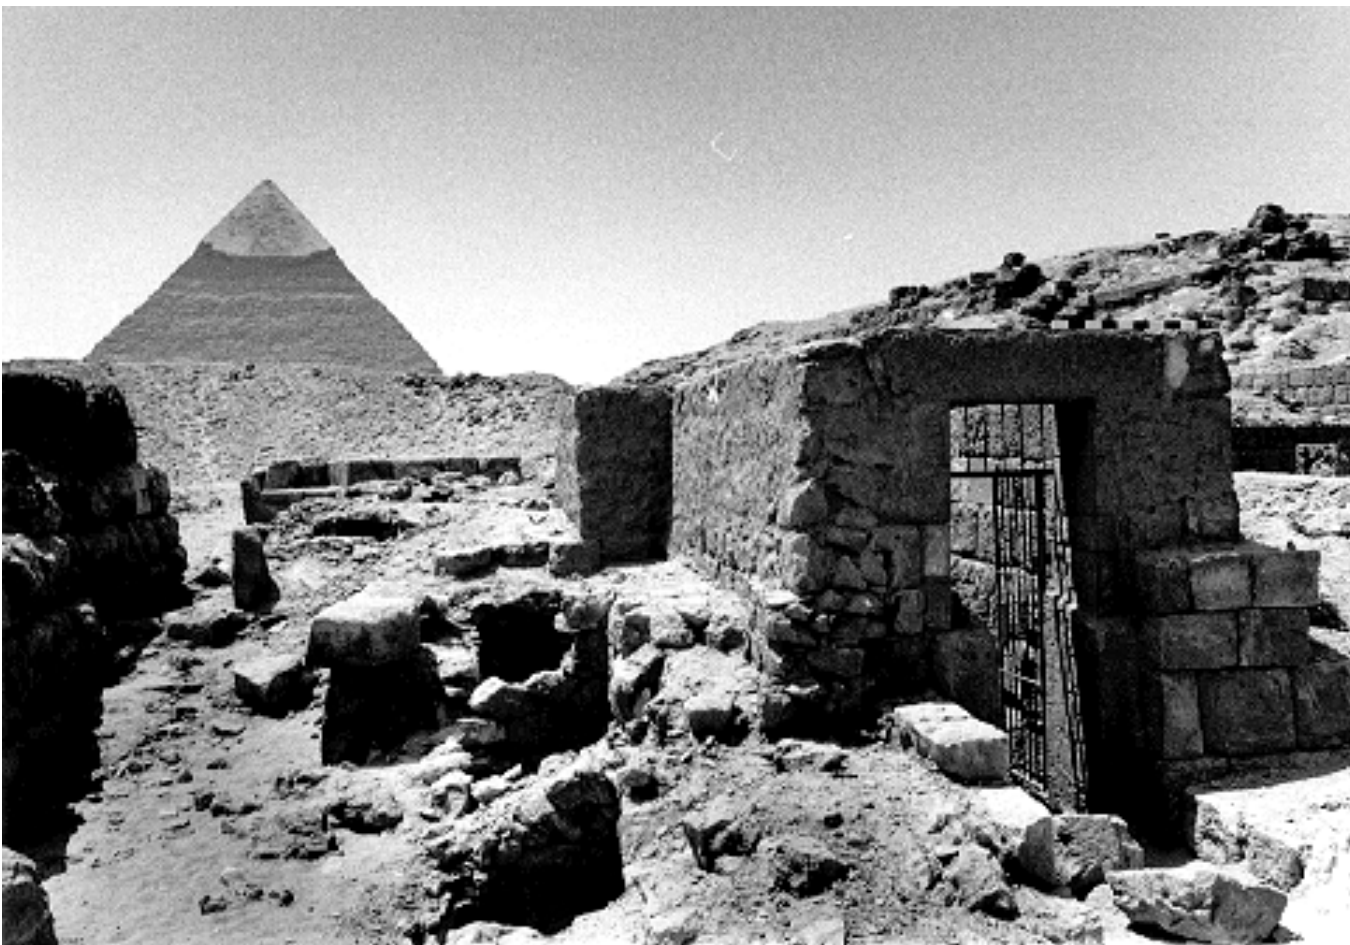
13b. 2085: false door, in profile (beneath pyramid of Khafre), and entrance jambs and modern reconstruction of 2086. The wall abutting the north facade of 2086 north of its doorway belongs to 2086a (rg 7-35, 1989)

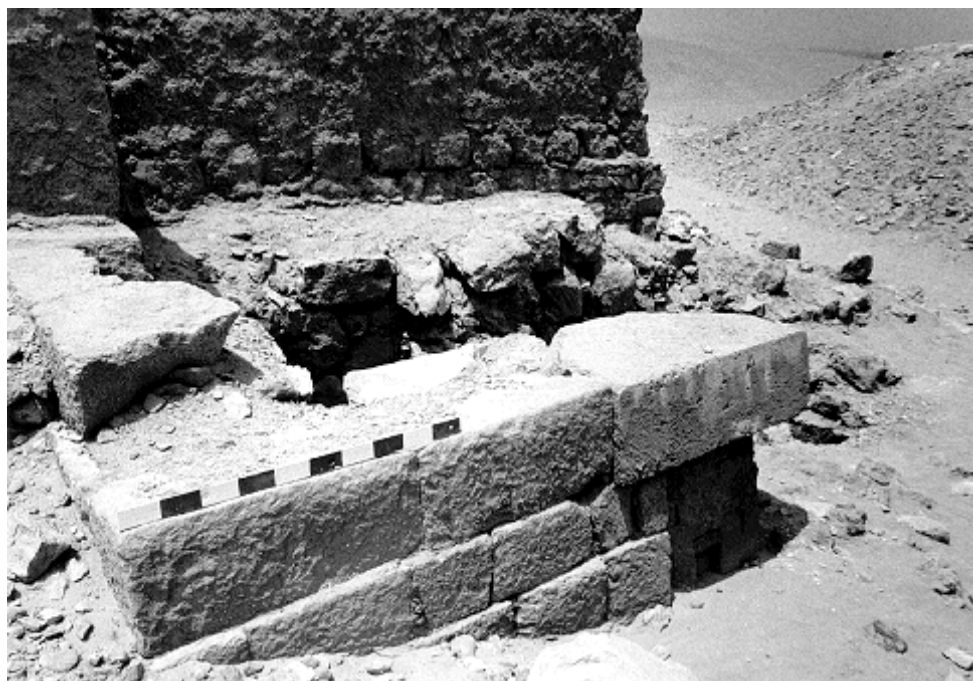
14a. 2085: southeast corner of the stepped ("z masonry") facade and false door (rg 12-27, 1989)

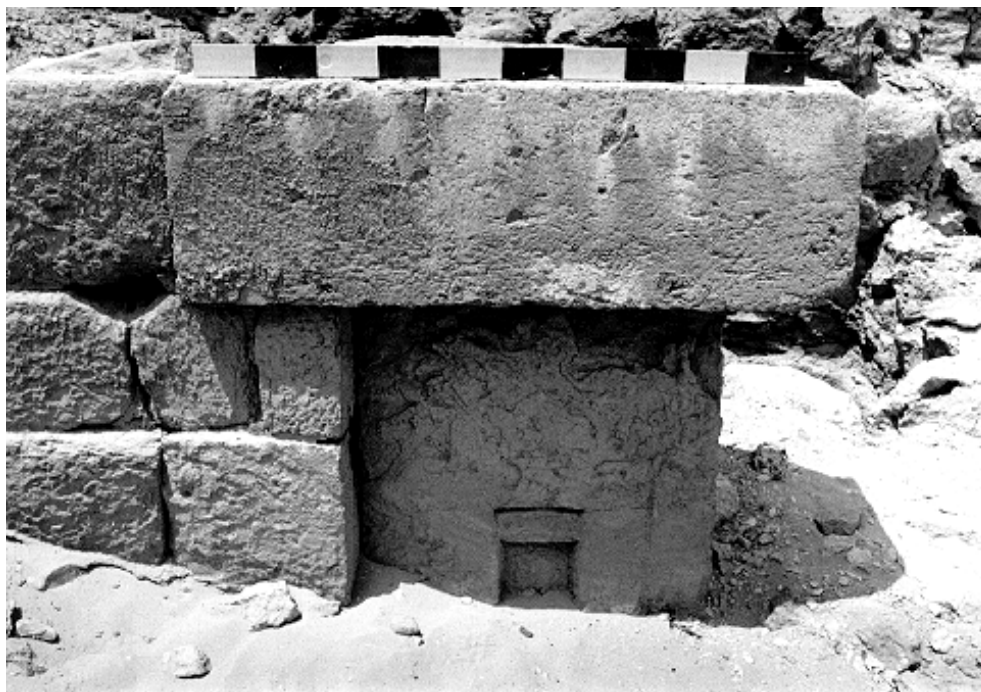
14b. 2085: false door. Despite the protective overhang of the massive lintel, the tablet and jambs are badly weathered, and it cannot be determined whether they were originally decorated (rg 12-22, 1989)

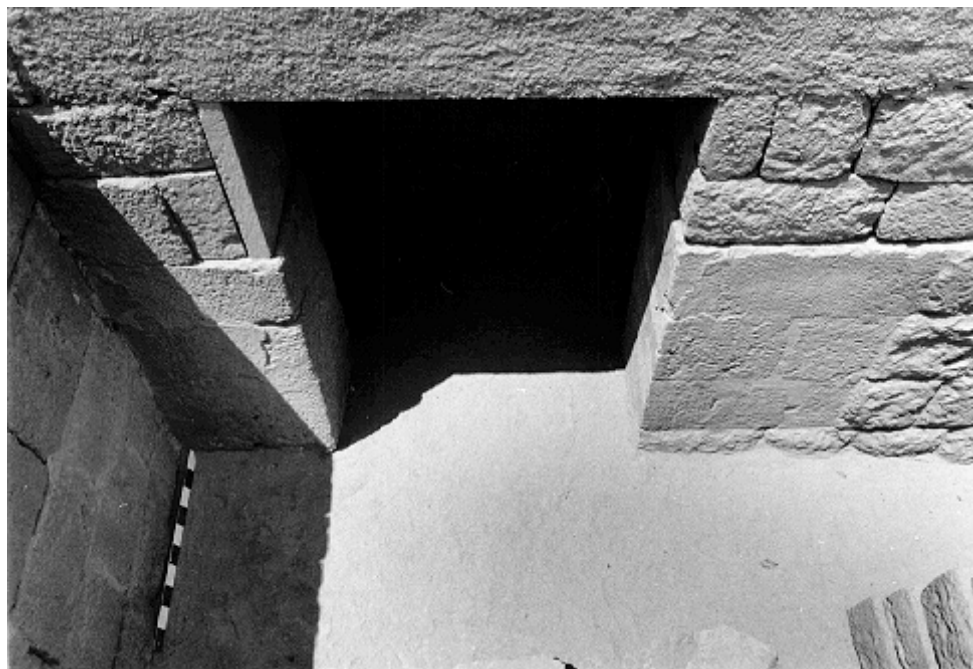
14c. 2086: entrance to inner chapel and original facade, with Phase ii enclosure wall at left and modern restoration. Note the smoothed areas on either side of the doorway. On the north this smoothing extended only to the point opposite the stepped facade of 2085, which can be seen at lower right. This facade showed traces of red paint, and was probably decorated or meant to be decorated (rg 12-24, 1989)
