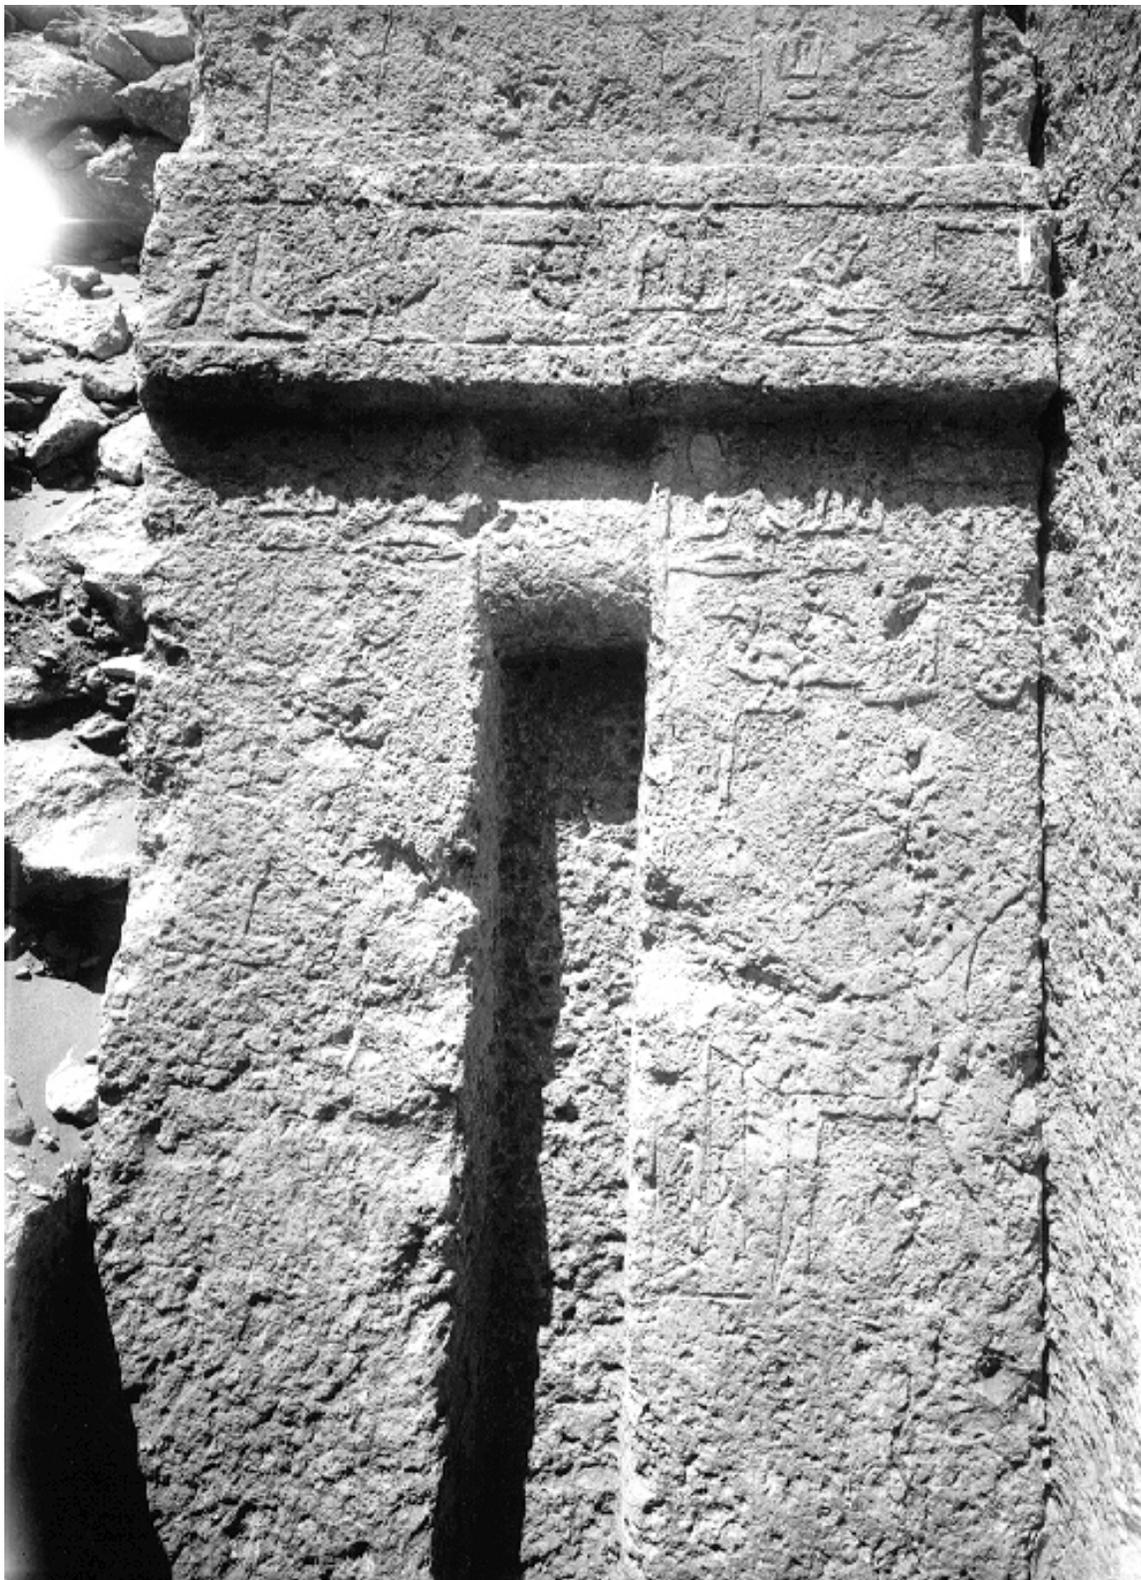
72a. 2092+2093: lower part of false door, with Za-ib shown seated with a tall staff on both jambs (a 7682)

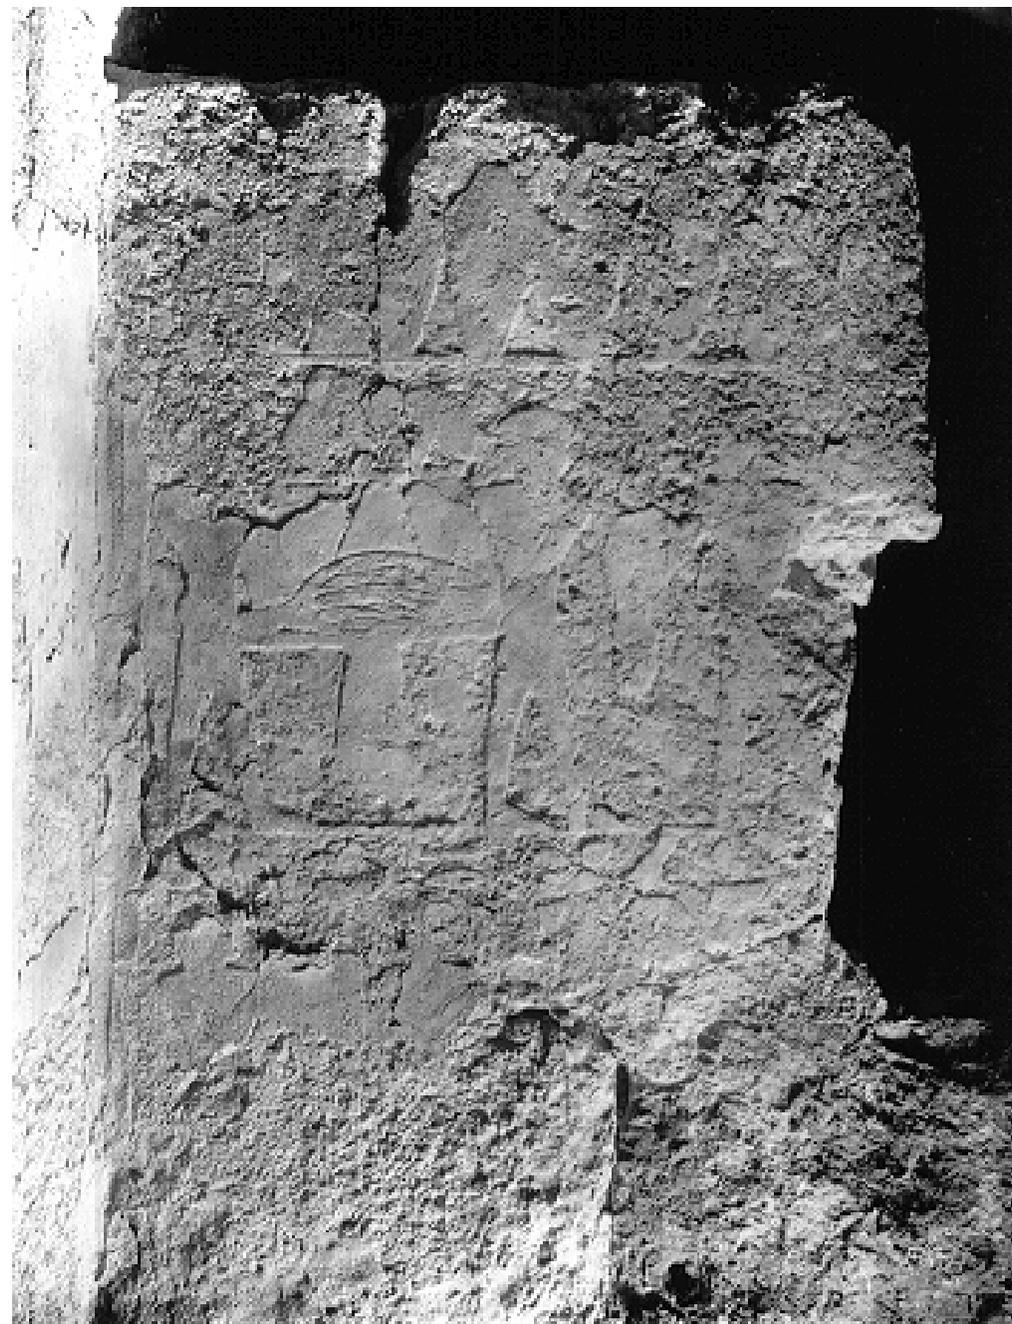
72b. 2092+2093: south wall at end of corridor (only the left part survives). Men carry offerings toward the false door (b 8735)

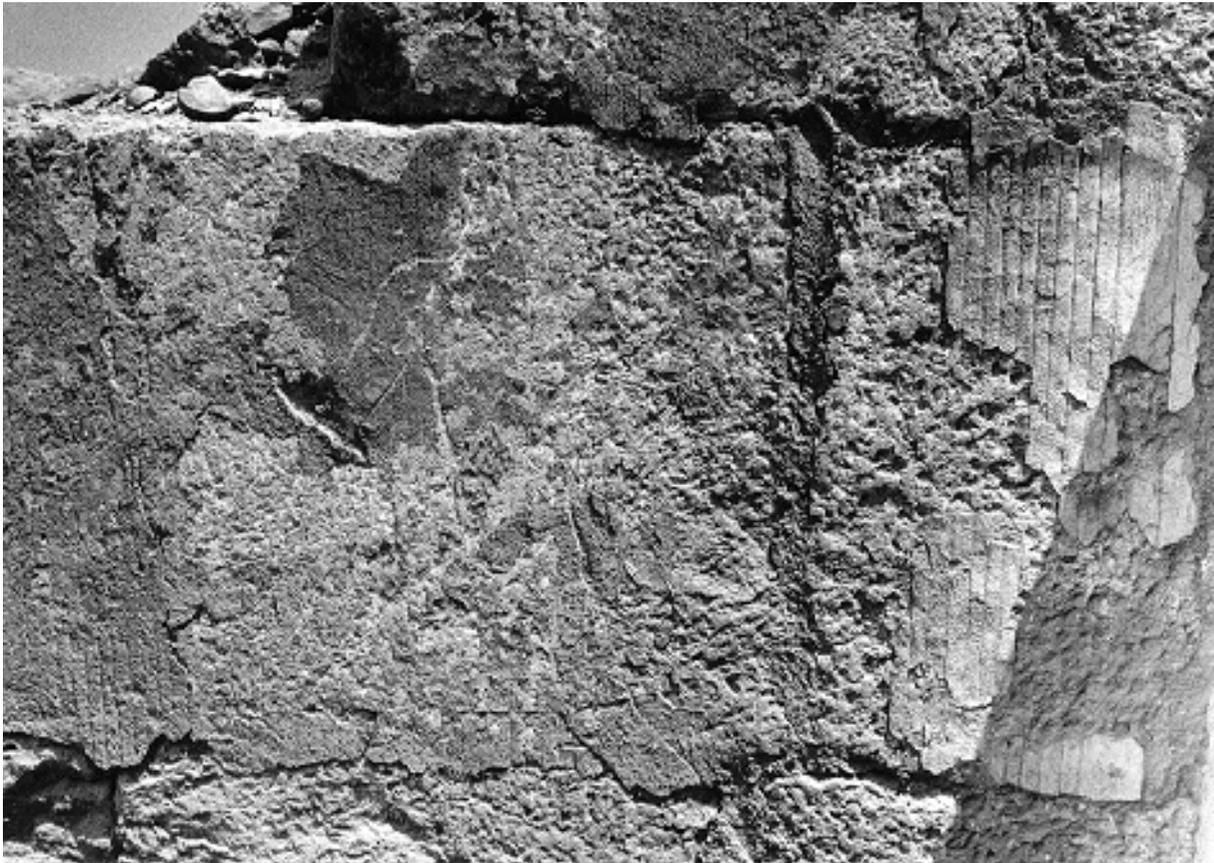
73a. 2092+2093: south end of east wall. The remains of a scene of Za-ib fowling in a papyrus marsh (rg 16-25, 1989)

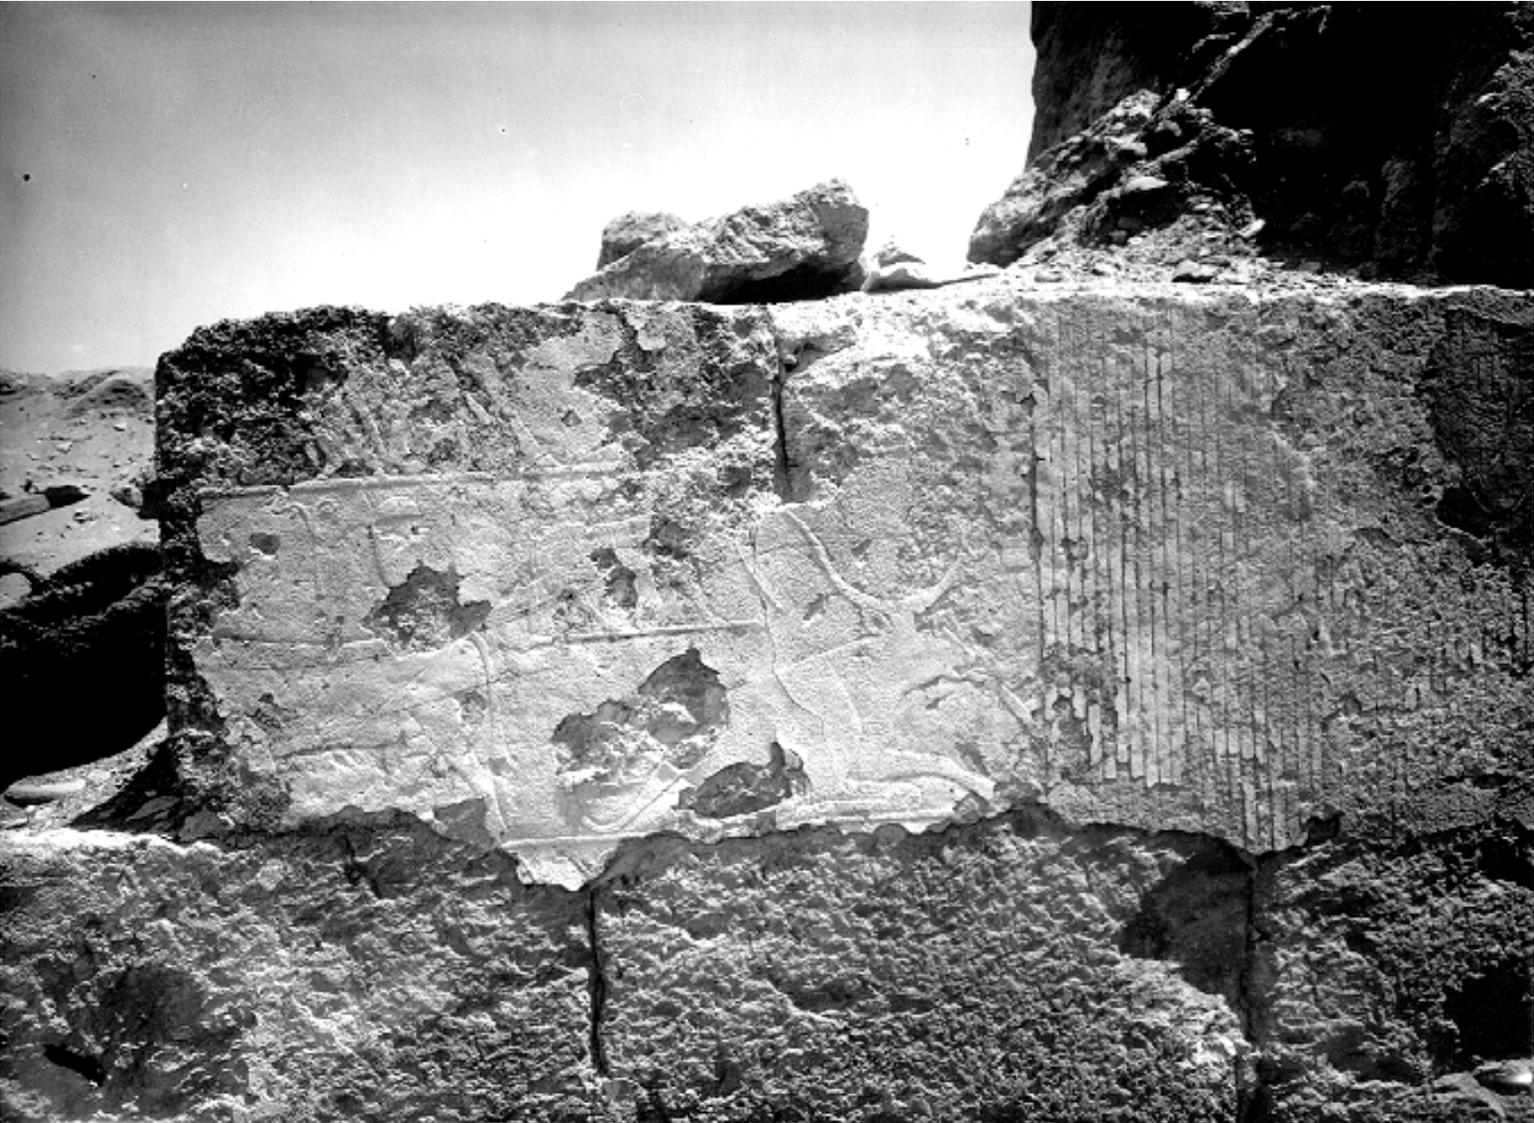
73b. 2092+2093: south end of east wall. The left end of the fowling scene is at left; at right are scenes of cattle-raising (a 7686)

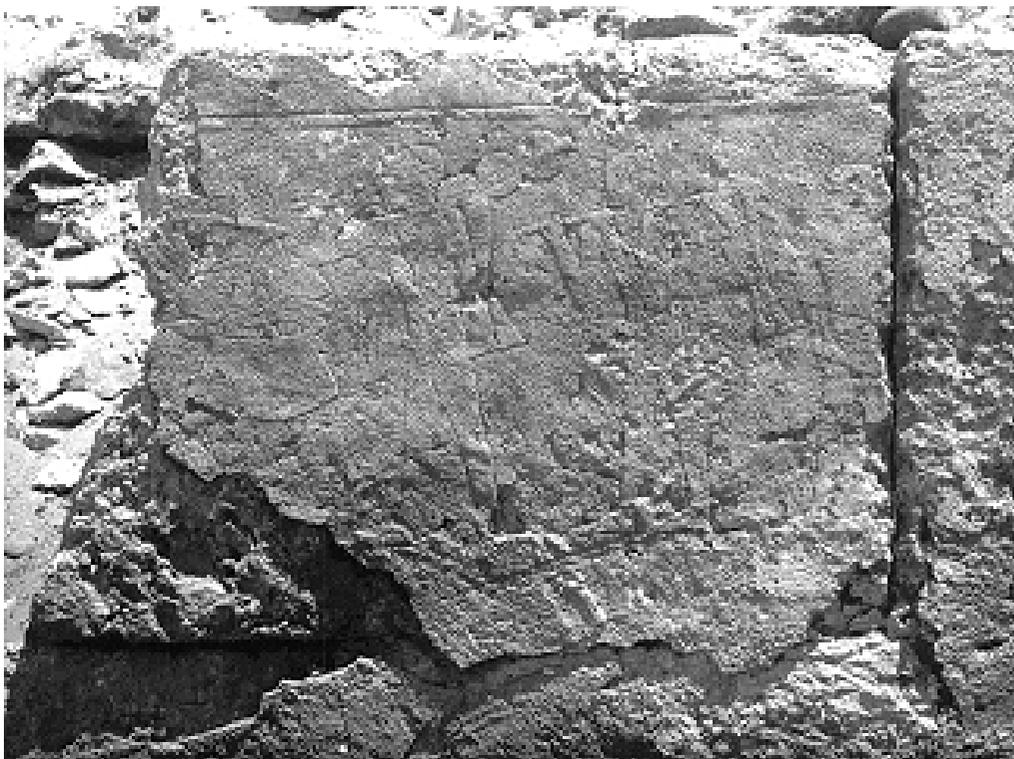
74a. 2092+2093: east wall, opposite beginning of recess. Men carrying marsh products and other offerings to the north (c 13899)

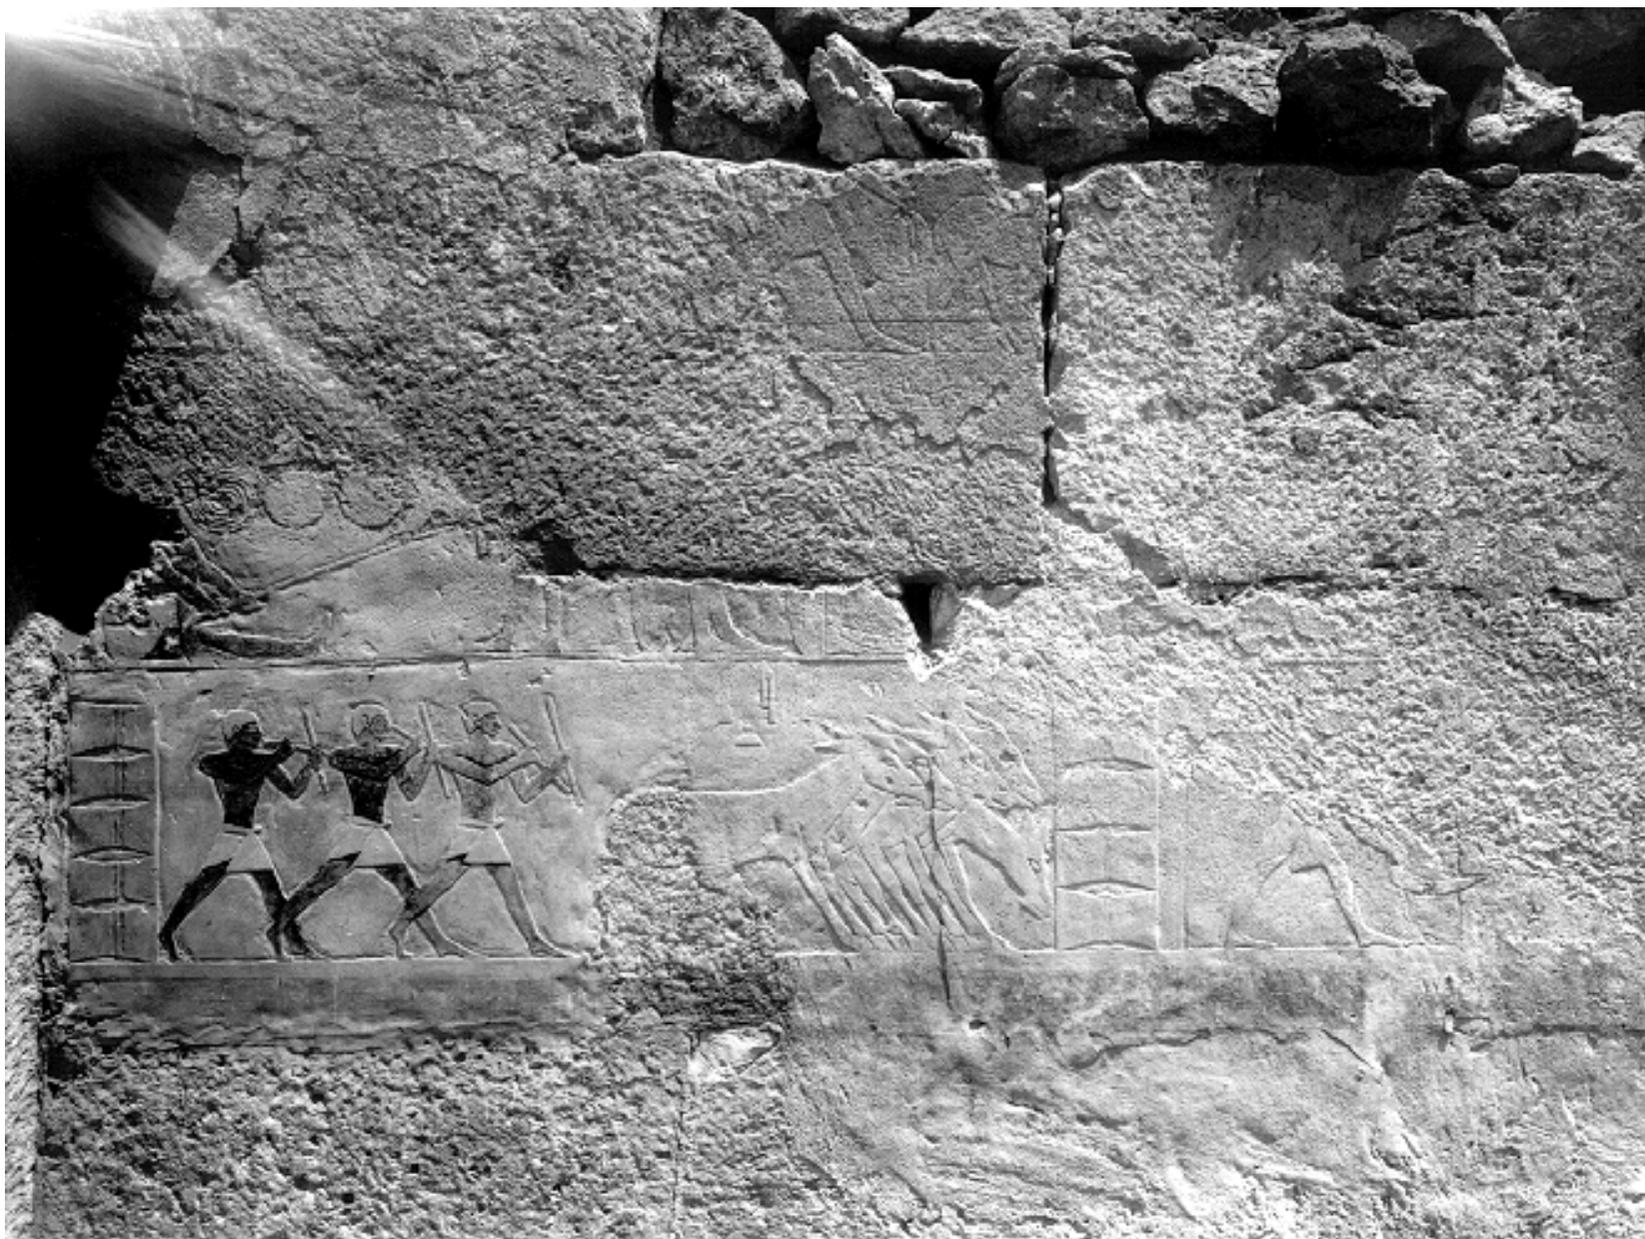
74b. 2092+2093: north end of east wall. Reaping and threshing of wheat (lowest register), rope making (middle register), and the driving of animals (top). Note the remains of red paint on the three men at left and in the wide band at the top of the dado (a 7687)

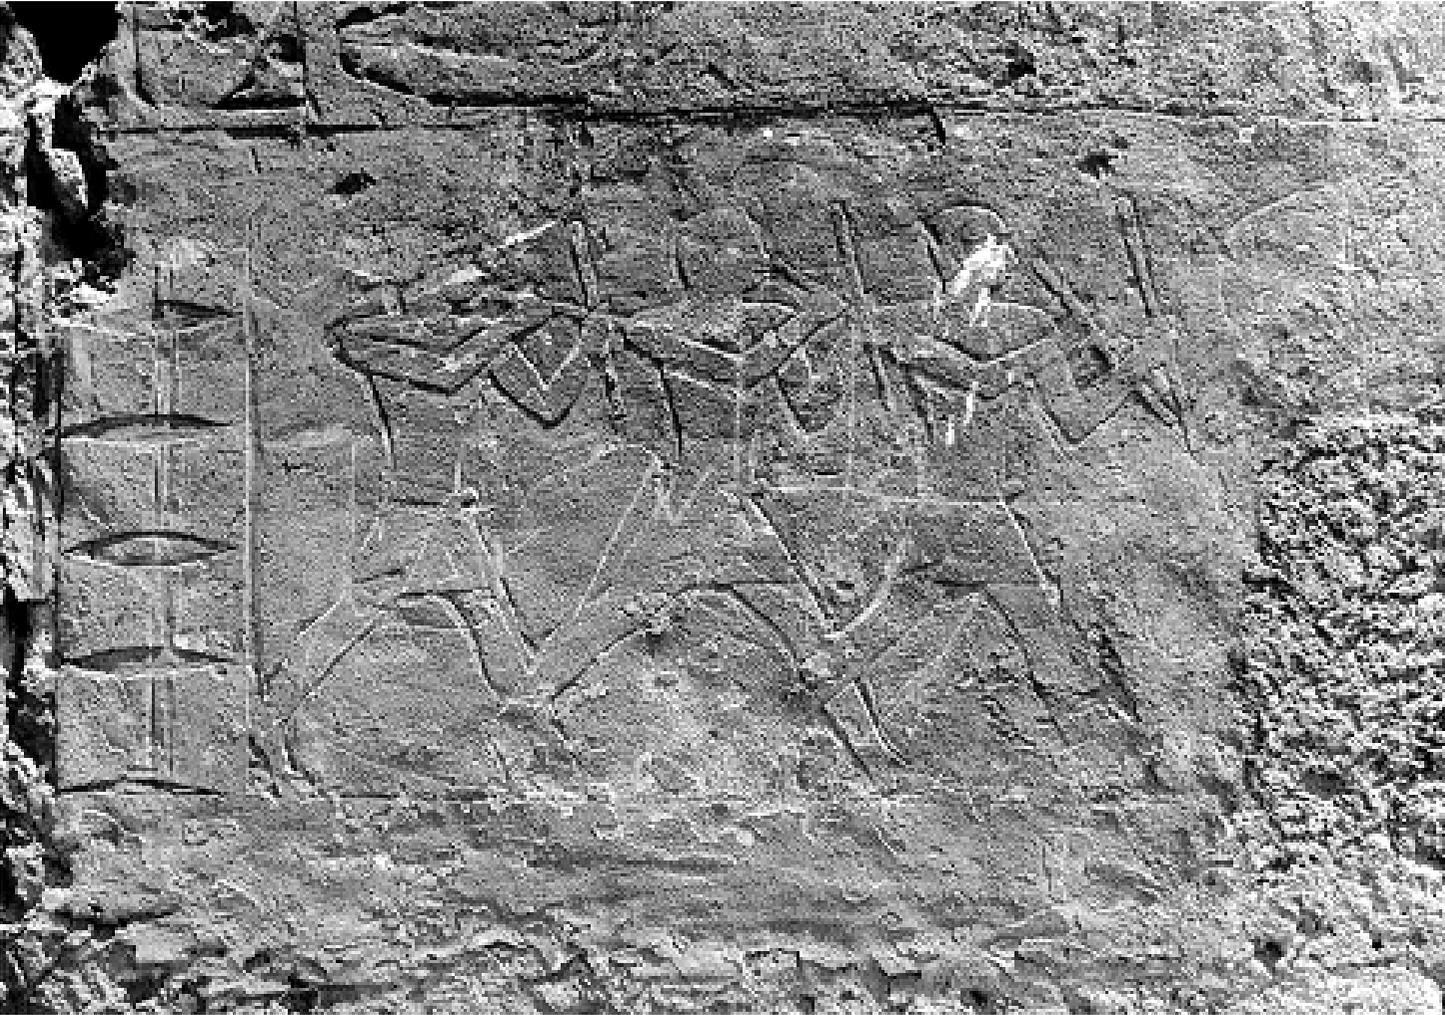
75a. 2092+2093: north end of east wall. Detail of three men, showing the weathering and vandalism since excavation (rg 15-34, 1989)

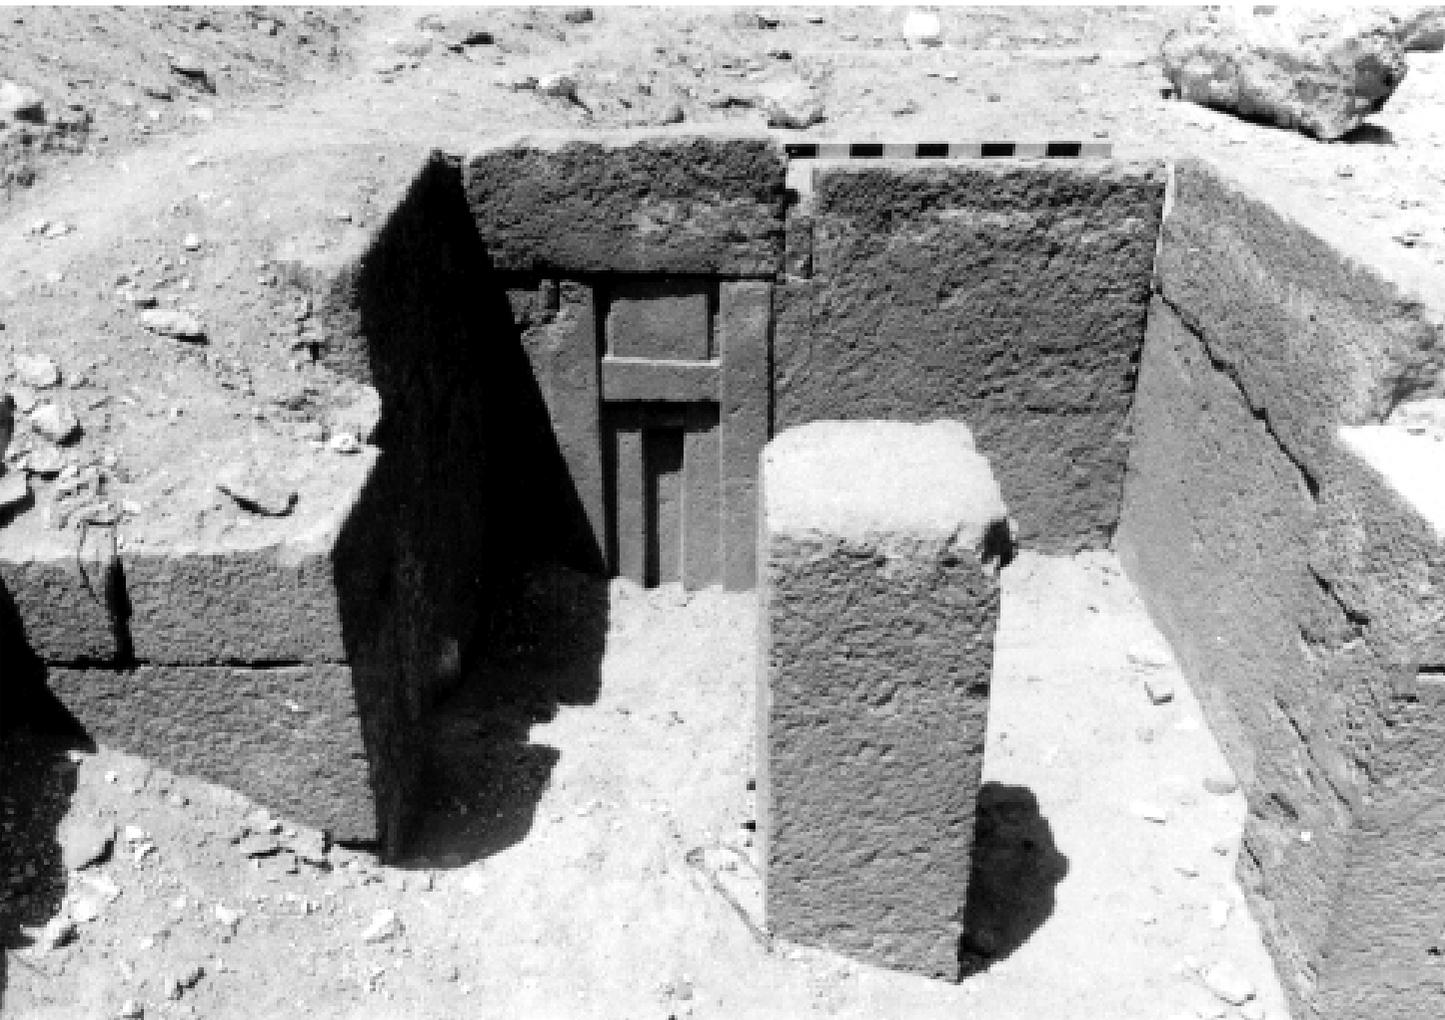
75b. 2094: undecorated chapel. The partially-filled vertical slot right of the false door may have given access to the serdab. Note that the pilasters are not single slabs, but are coursed with the adjacent walls (rg 8-8, 1989)

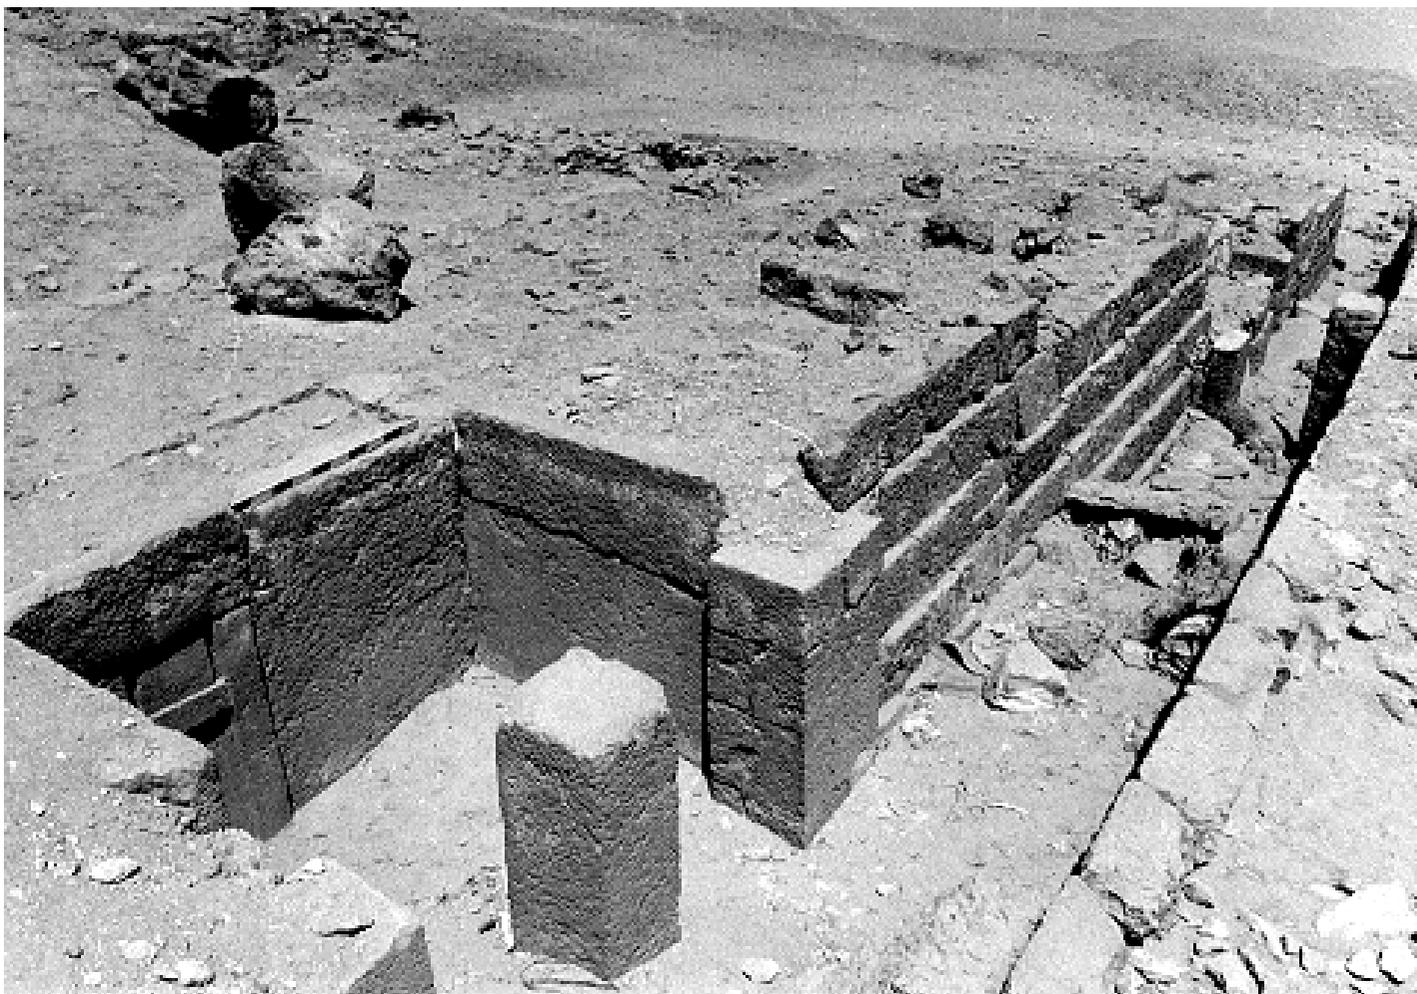
76a. 2094: stepped facade north of the chapel. A small secondary false door, cut in the lower two steps, is visible just left of the fallen blocks in the corridor (rg 8-9, 1989)

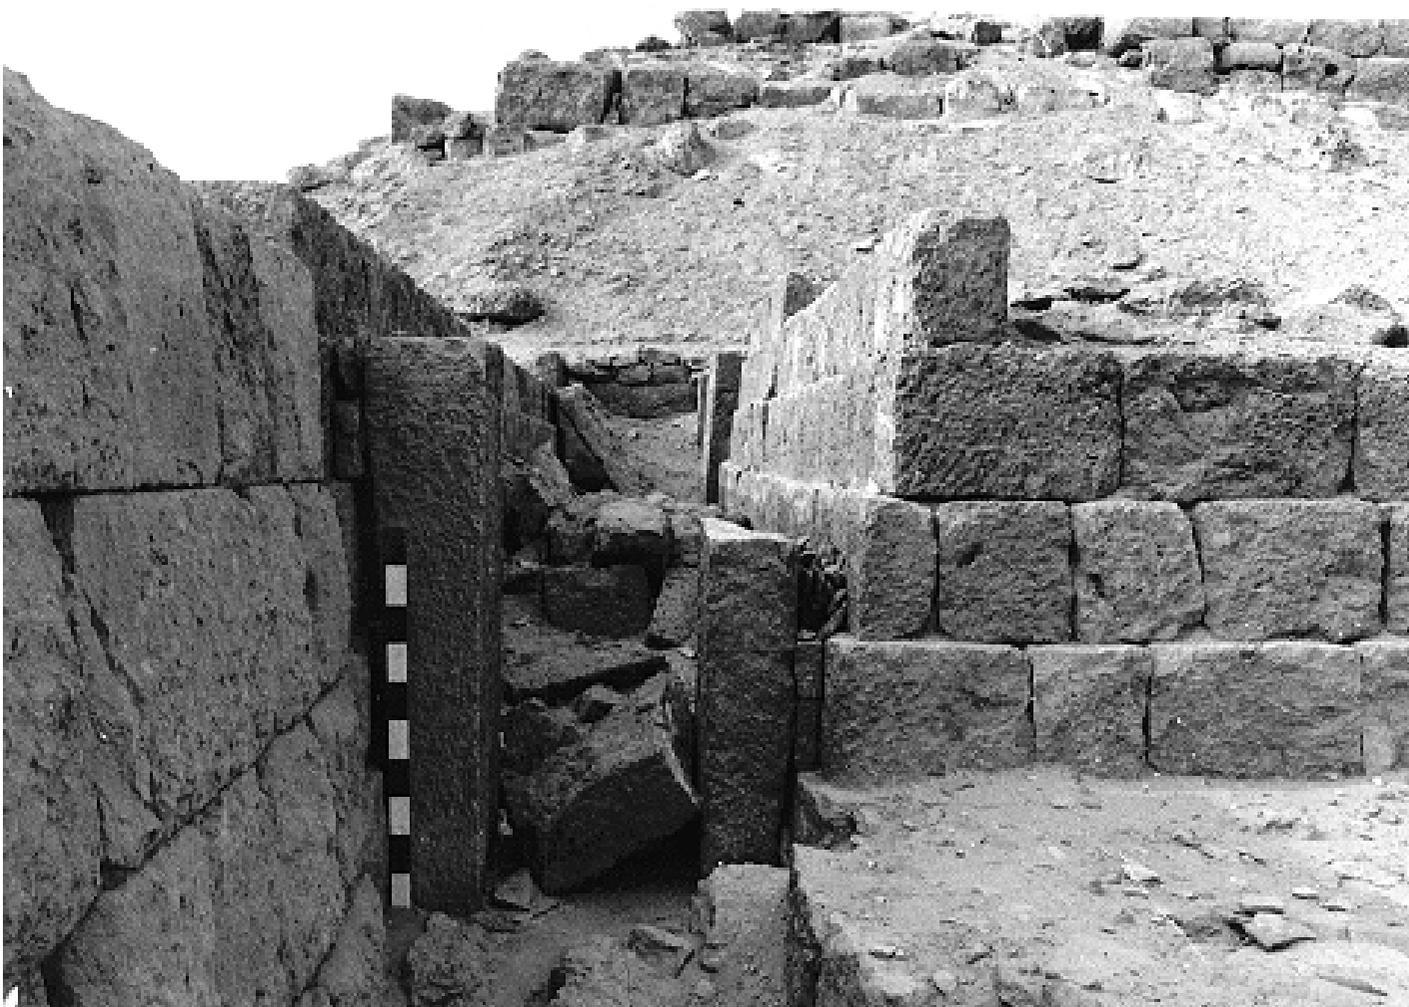
76b. 2094: remains of northern entrance doorway in corridor. At left, 2096 and, behind the doorjamb, 2093. The low platform in the right foreground is 2095 (rg 7-5, 1989)

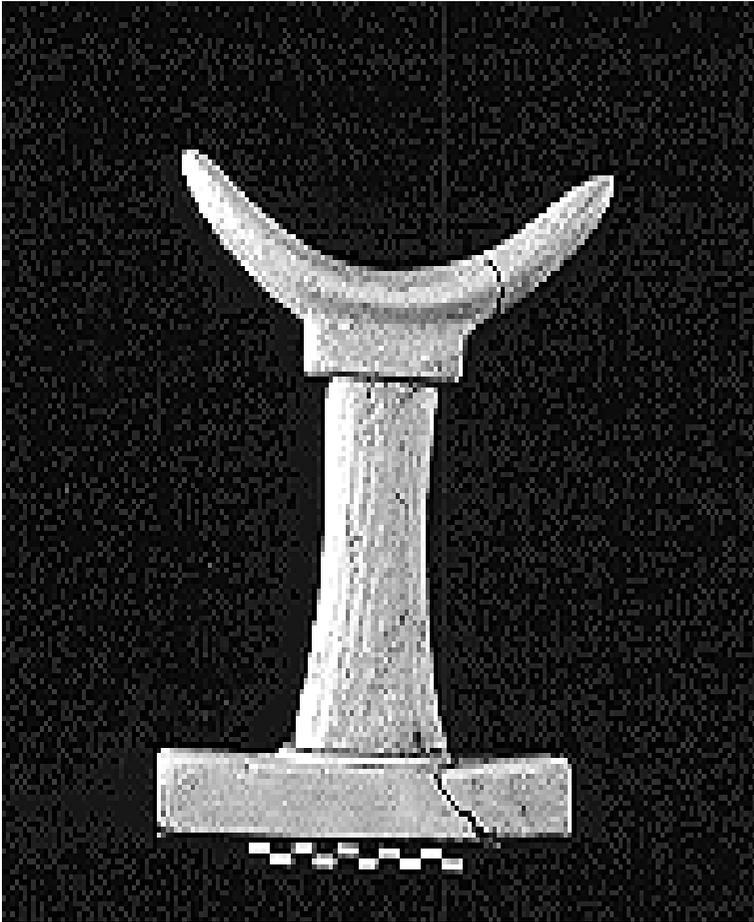
77a. 2094 a: limestone headrest (36-9-1) from the burial chamber (c 13940, top half)

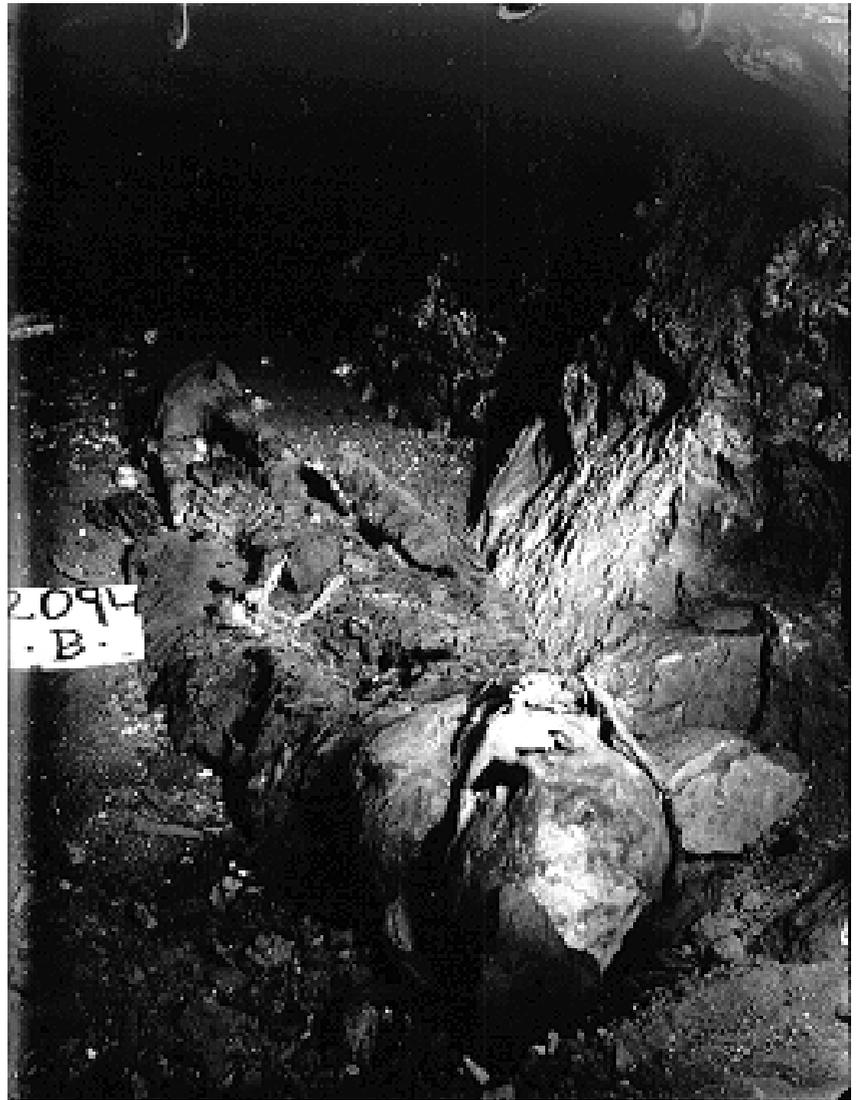
77b. 2094 b: burial of extended skeleton. The body was completely wrapped in linen, with the arms and legs wrapped separately (c 13931)

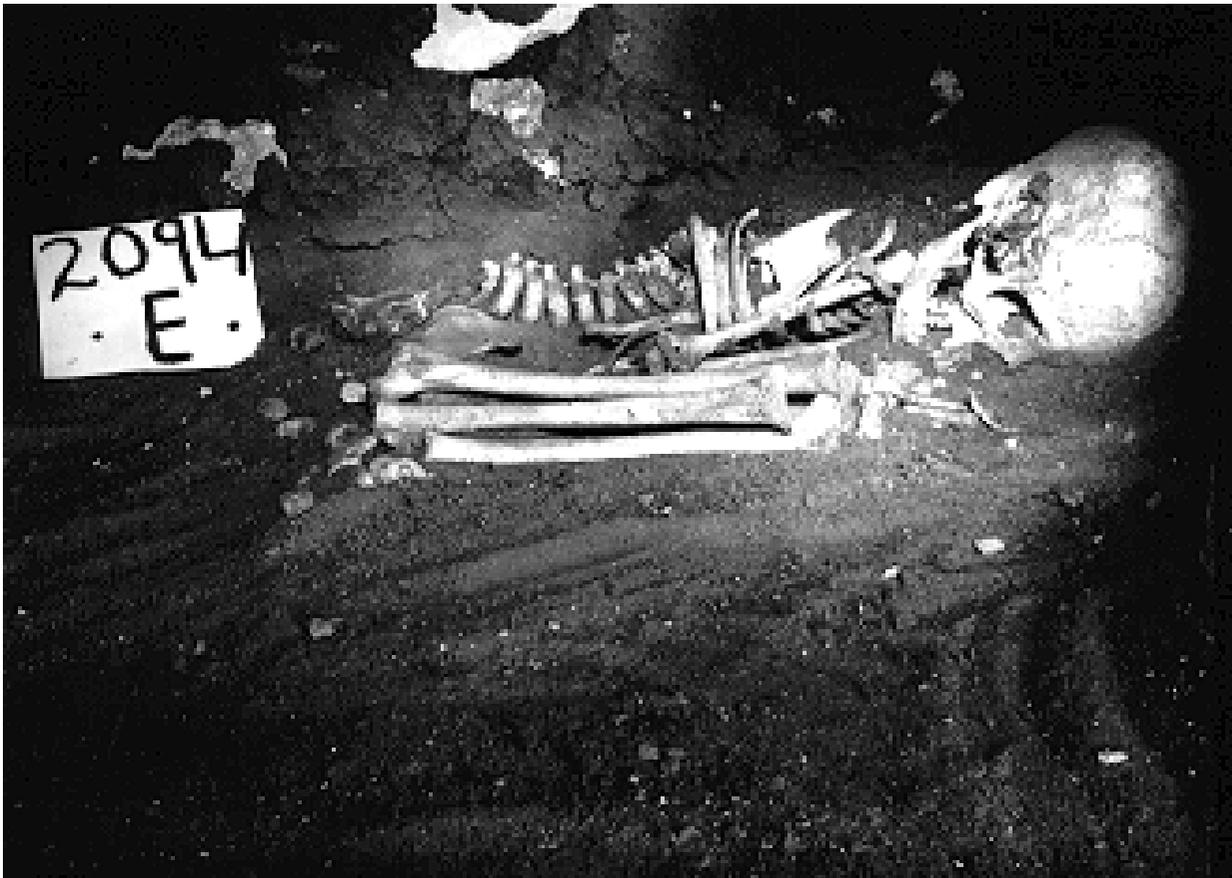
77c. 2094 e: burial of small, tightly contracted skeleton. Judging from the state of the teeth (the canines are only partially erupted), the age is about ten years (+/- 2 years) (c 13932)

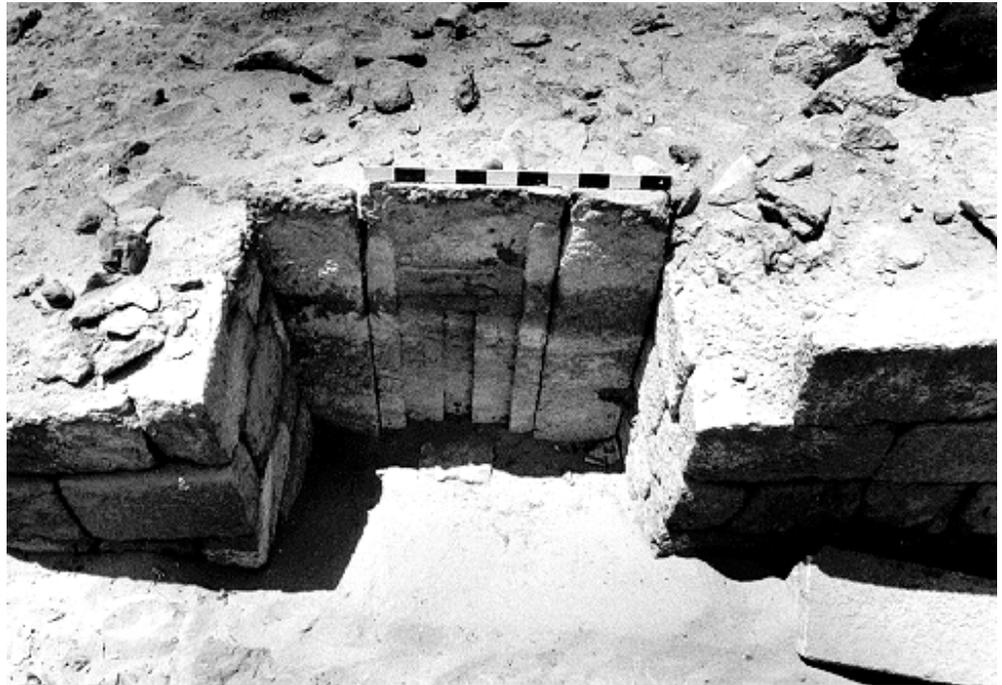
78b. 2095: west wall of chapel and central false door (rg 8-2, 1989)

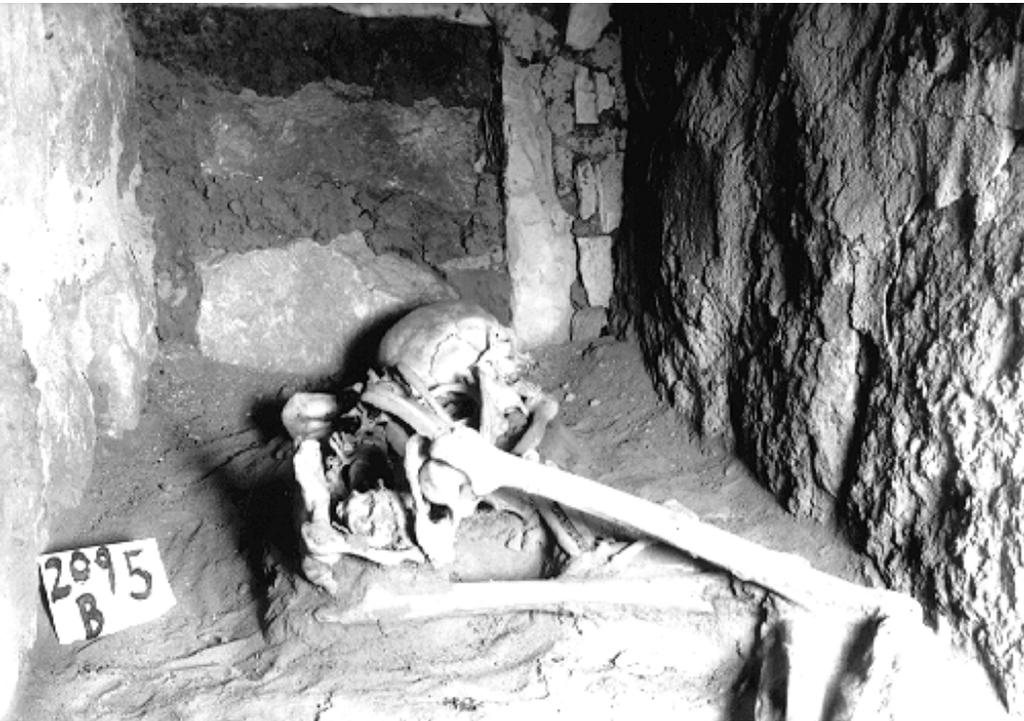
79b. 2095 b: chamber with leg-contracted, skeletally adult burial. At its north end (beyond the head), the chamber broke through to shaft c, and was repaired with rubble and mud (b 9014)

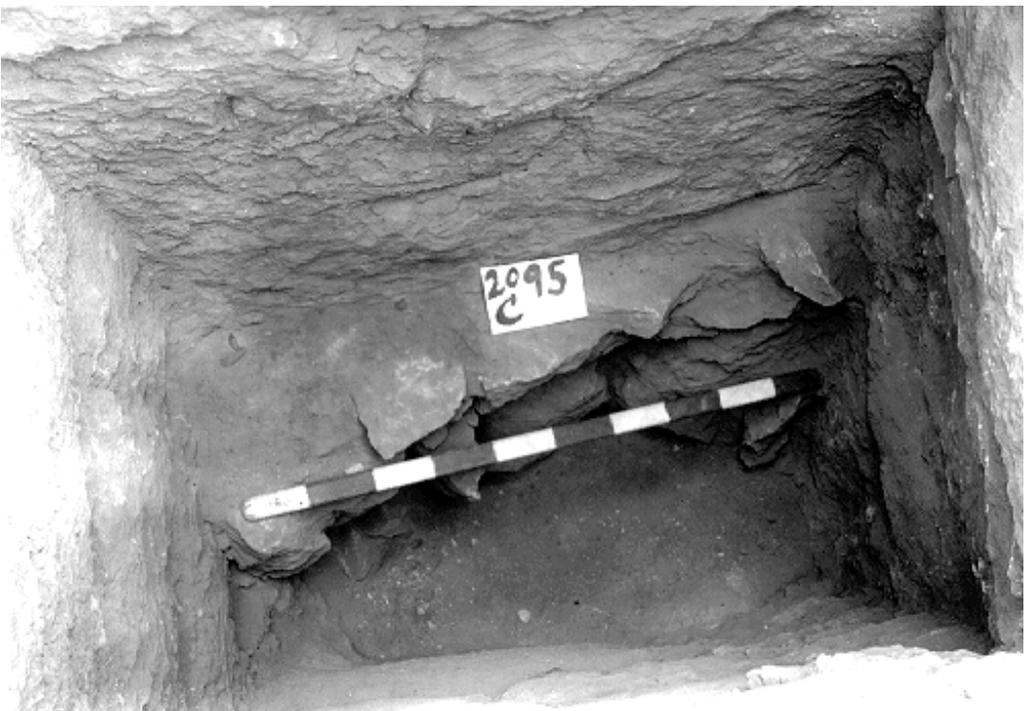
79c. 2095 c: blocking of type v c(2), leaning wall of four courses of rough masonry (b 9012)

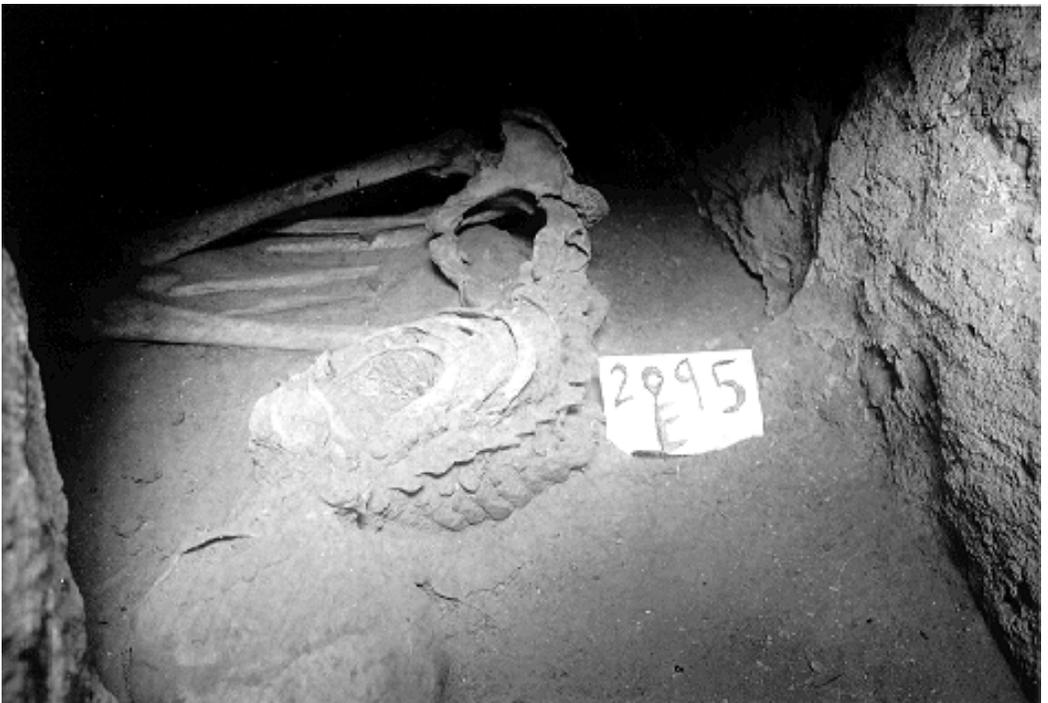
80c. 2095 e(2): tightly contracted skeleton, described by the excavators as a child. However the skeleton is more probably a young adult, a conclusion supported by the visible wear on the teeth. Anomalously, the head lies to the west rather than the north (b 9035)

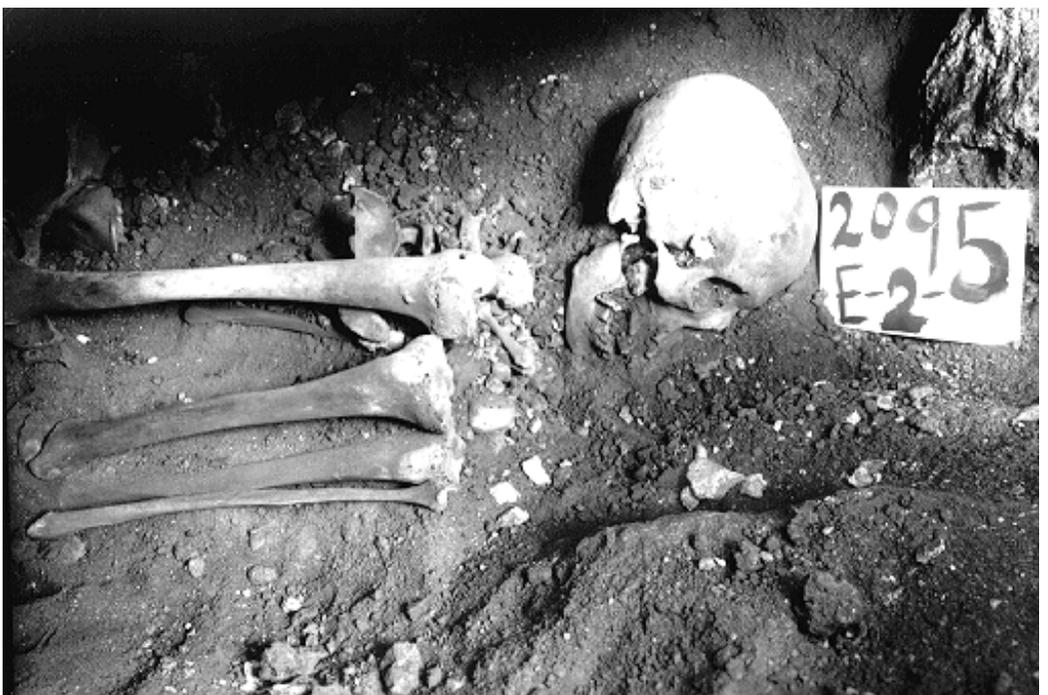
81a. 2095 f: entrance and north part of burial chamber, showing skull of leg-contracted skeleton, which may be male, based on the well-developed supraorbital torus (c 14253)

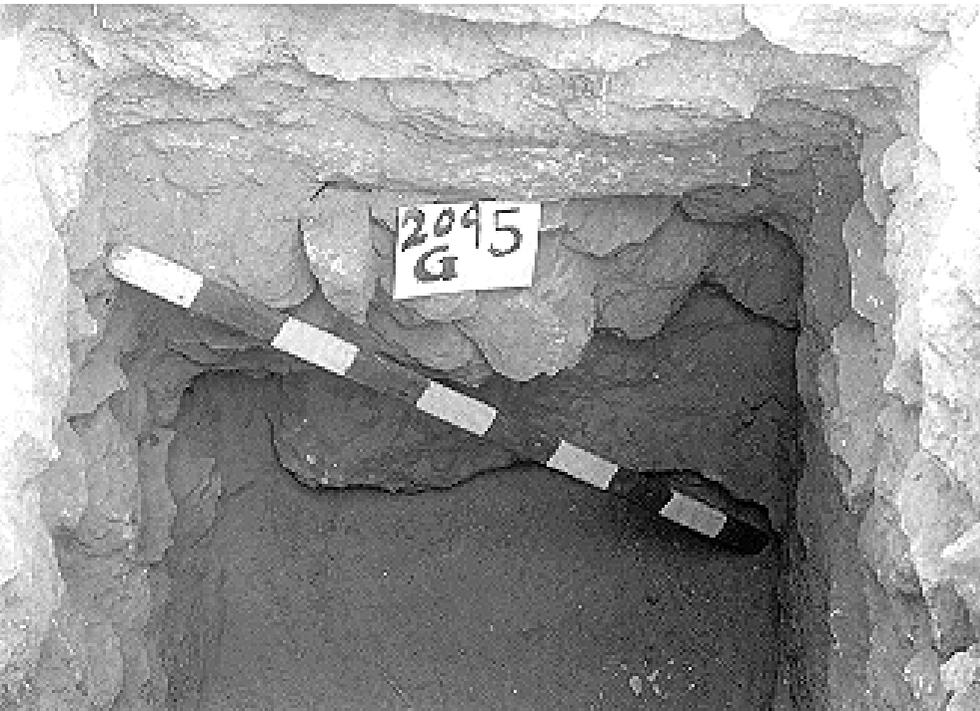
81b. 2095 g: intact blocking of type v d(2), leaning rubble wall bound with mud (c 14248)

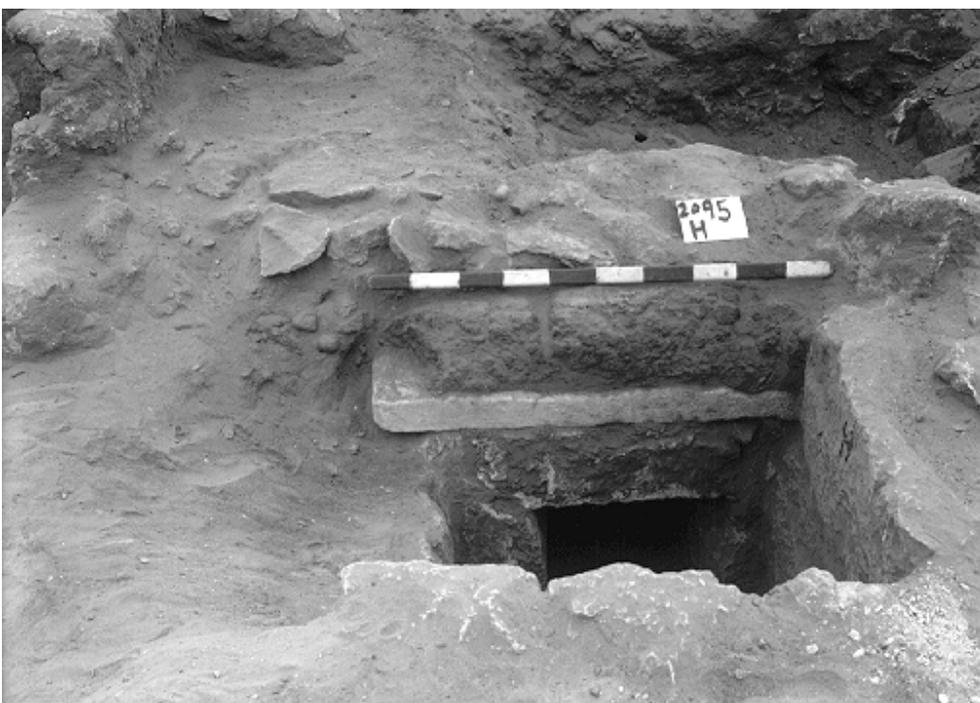
81c. 2095 h: shaft, roofing slab, and entrance to burial chamber (b 9010)
