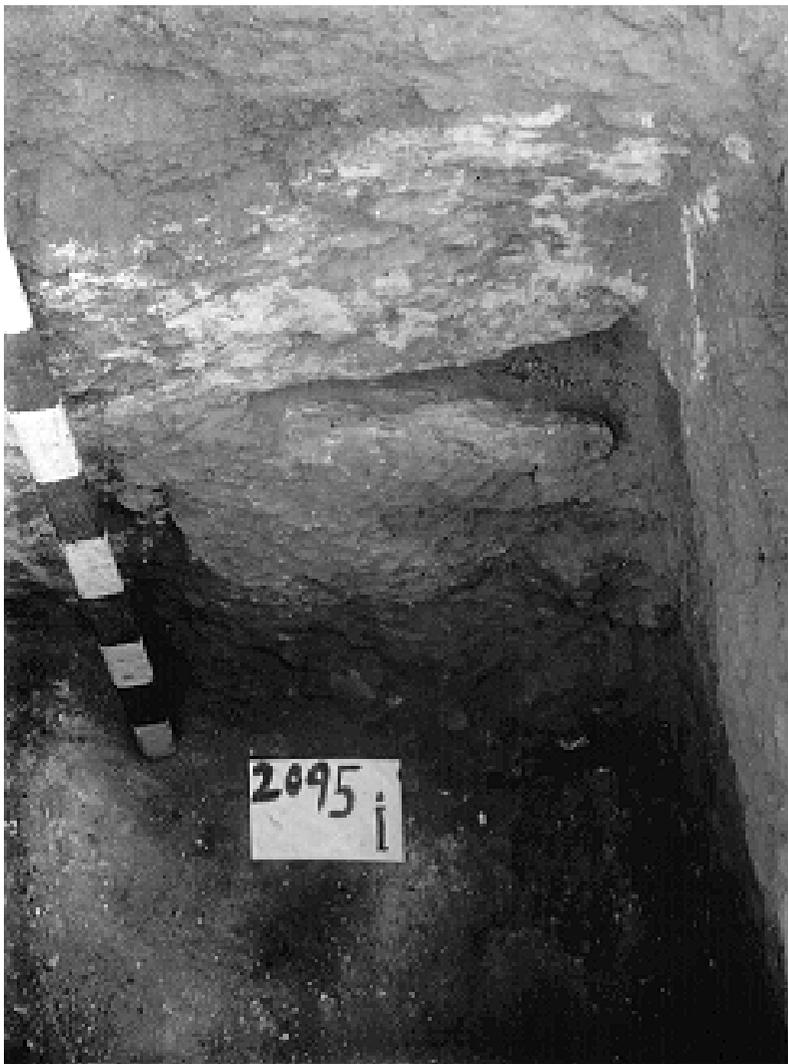
82a. 2095 i: blocking of chamber, type v e(2), one leaning slab bound with mud (c 14247)

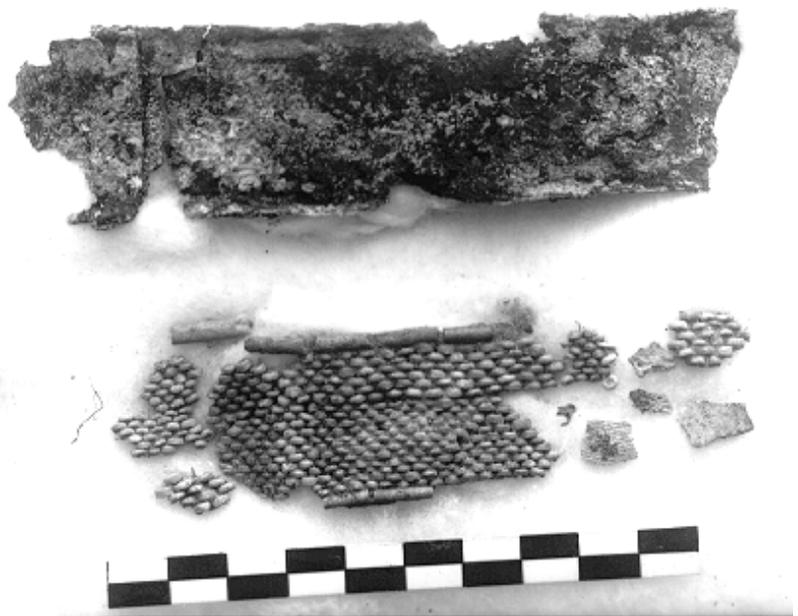
82b. 2095 i: fragment of copper band from the head of the skeleton and, below, a section of the beadwork that filled it. The horizontal cylindrical beads framing the beading are of blue-green faience. The space between was filled with blue-green faience ring beads, broken in at least two places by three vertical black-white-black stripes, two beads in width. (These stripes may be discernible at the left edge of the fragment, although the stripes appear slightly wider) (b 9028)

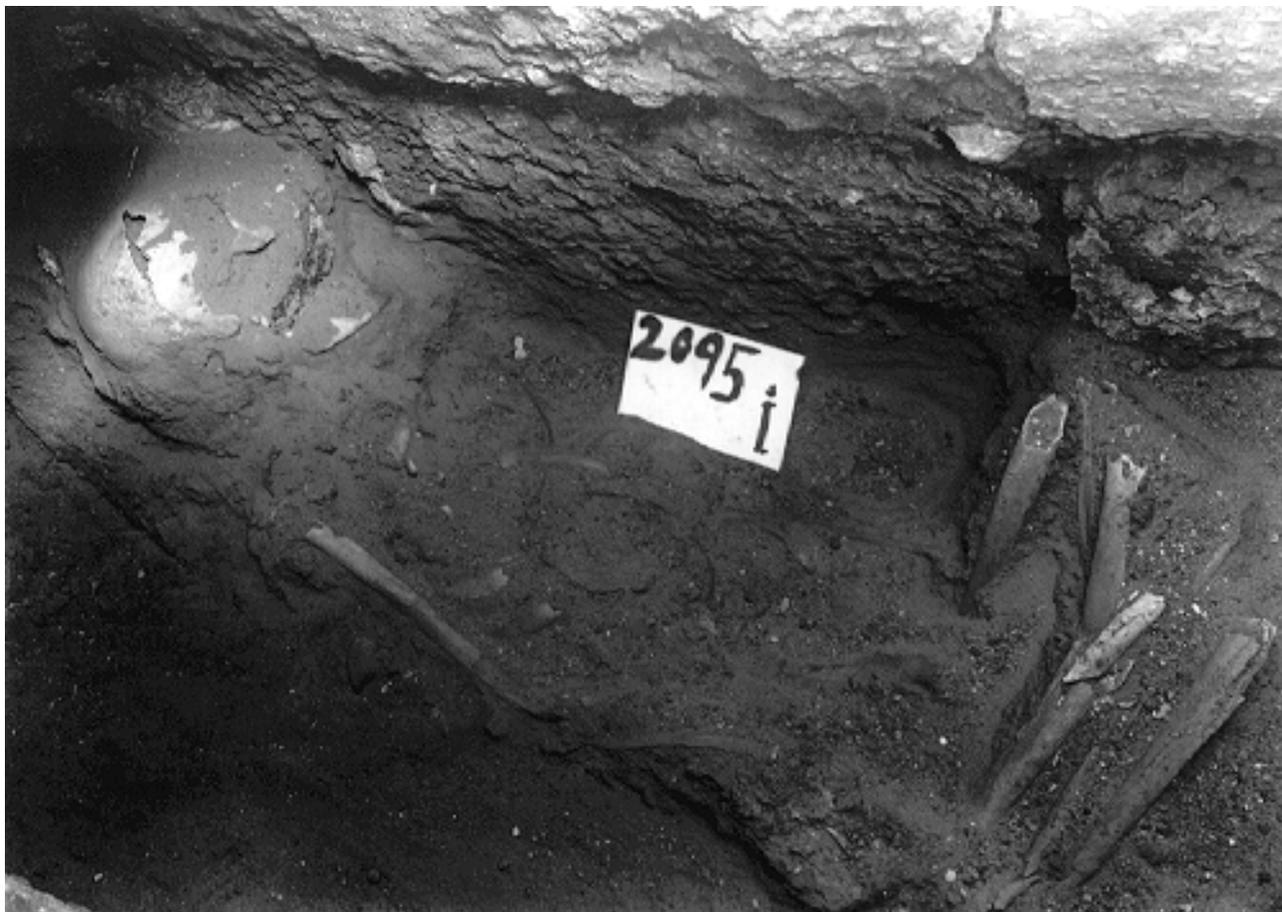
82c. 2095 i: burial. In its original position around the skull is a copper band decorated with blue, black, and white beads (b 9015)

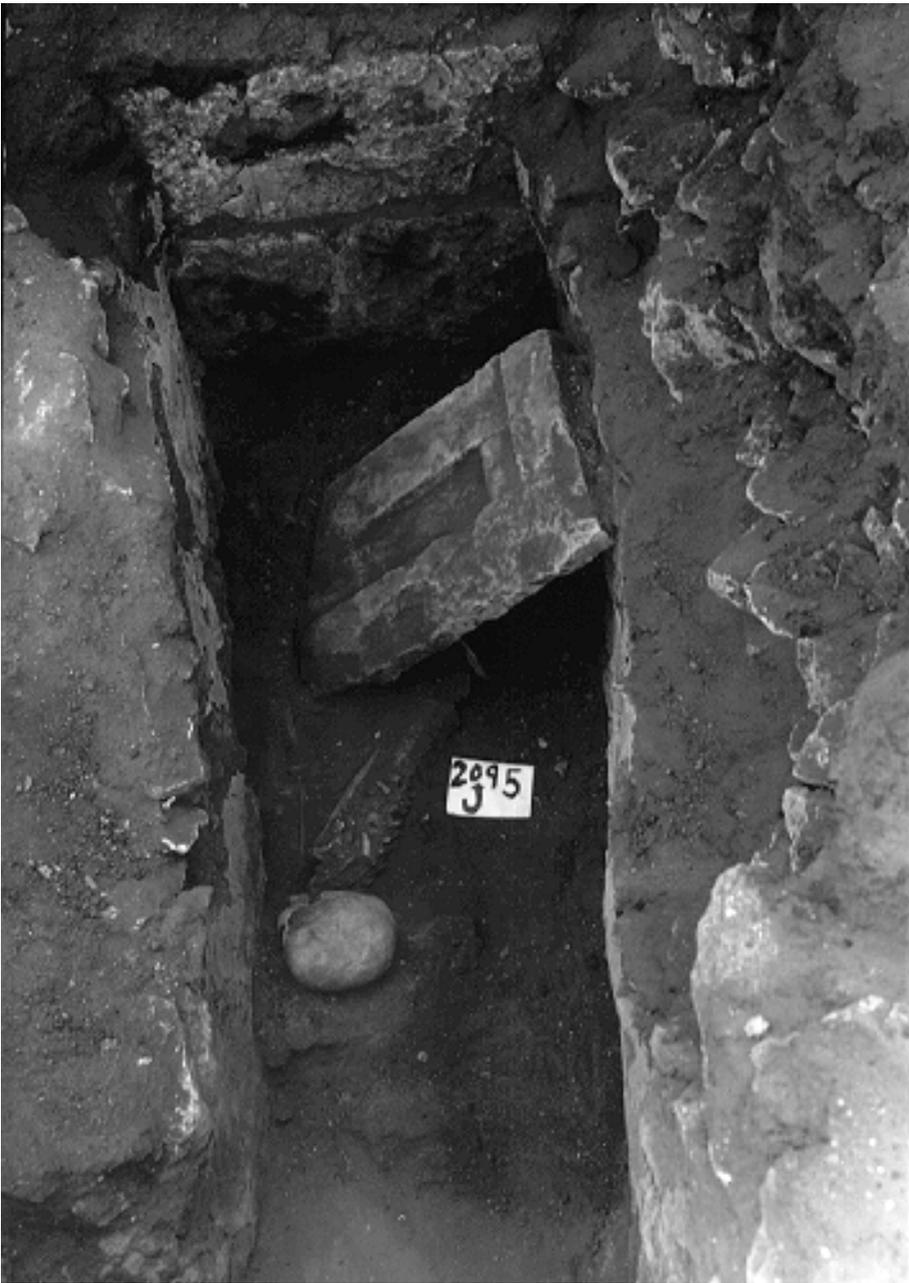
83a. 2095 j: leg-contracted burial. The unscribed false door was presumably re-used as a roofing block, from which position it fell into the burial chamber (b 9018)

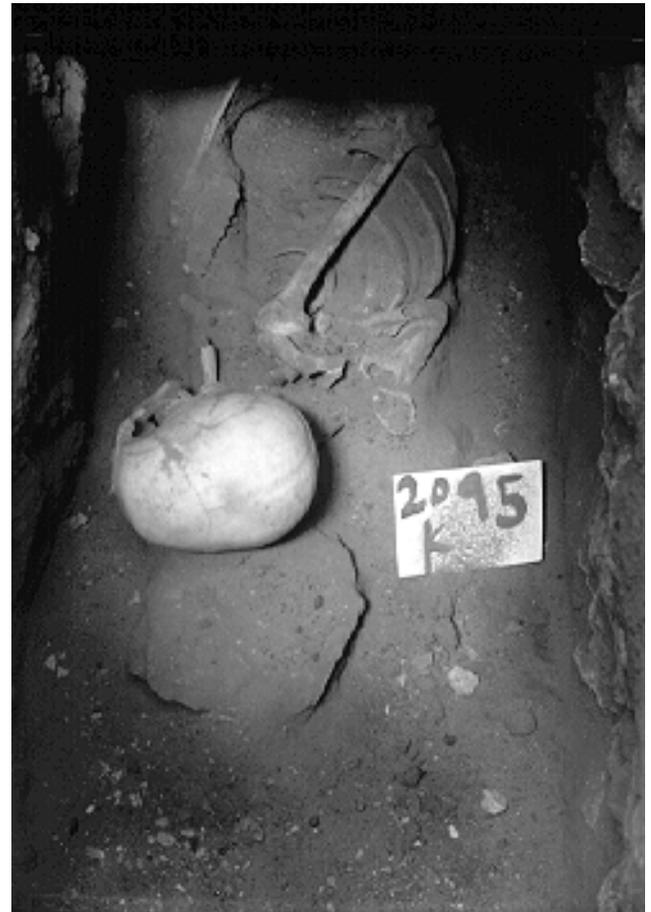
83b. 2095 k: leg-contracted, skeletally adult burial with the head resting on a rough stone pillow (c 14254)

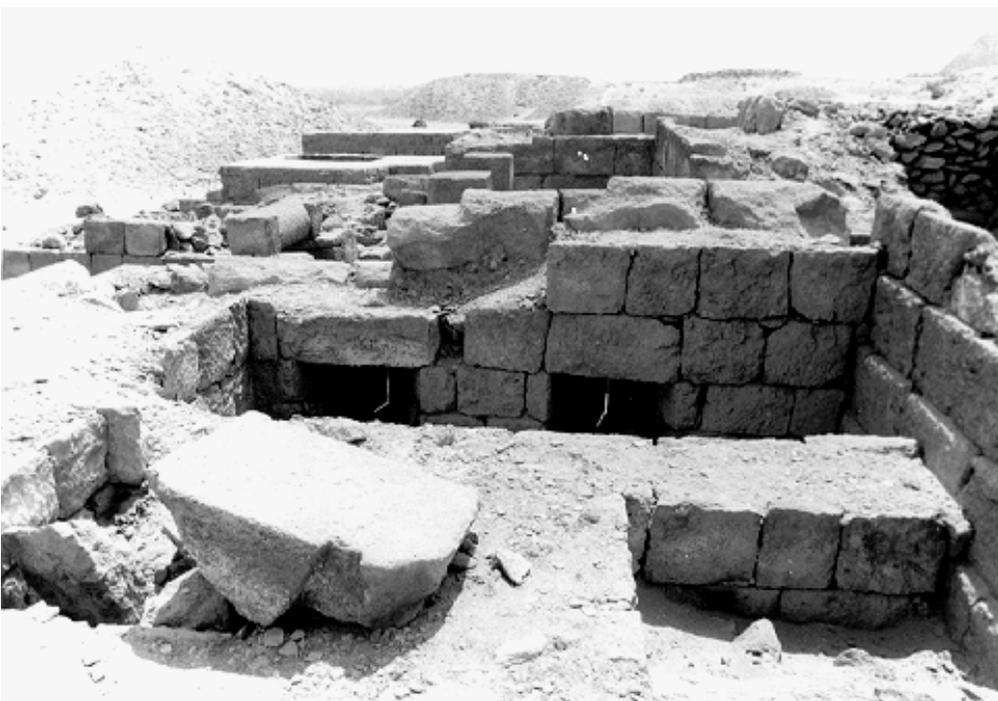
83c. 2096: top. Shafts b (right) and a are in the foreground. The loose block lying above Shaft b is from 2092+2093; a serdab slot was cut in its upper surface (turned to the viewer). Behind the shafts is the serdab chamber, with its two narrow vertical slots (see pls. 63a–b) widening to windows on the inside. Beyond it, the tops of the pillars of the 2092+2093 courtyard can be seen, aligned with the notches in the neighboring walls that support the architrave. To the left of the nearer of these notches is another, higher, notch, which supported an architrave in an earlier stage of construction, when it served as a portico for 2092+2093 rather than for 2097 (amr, 1990)

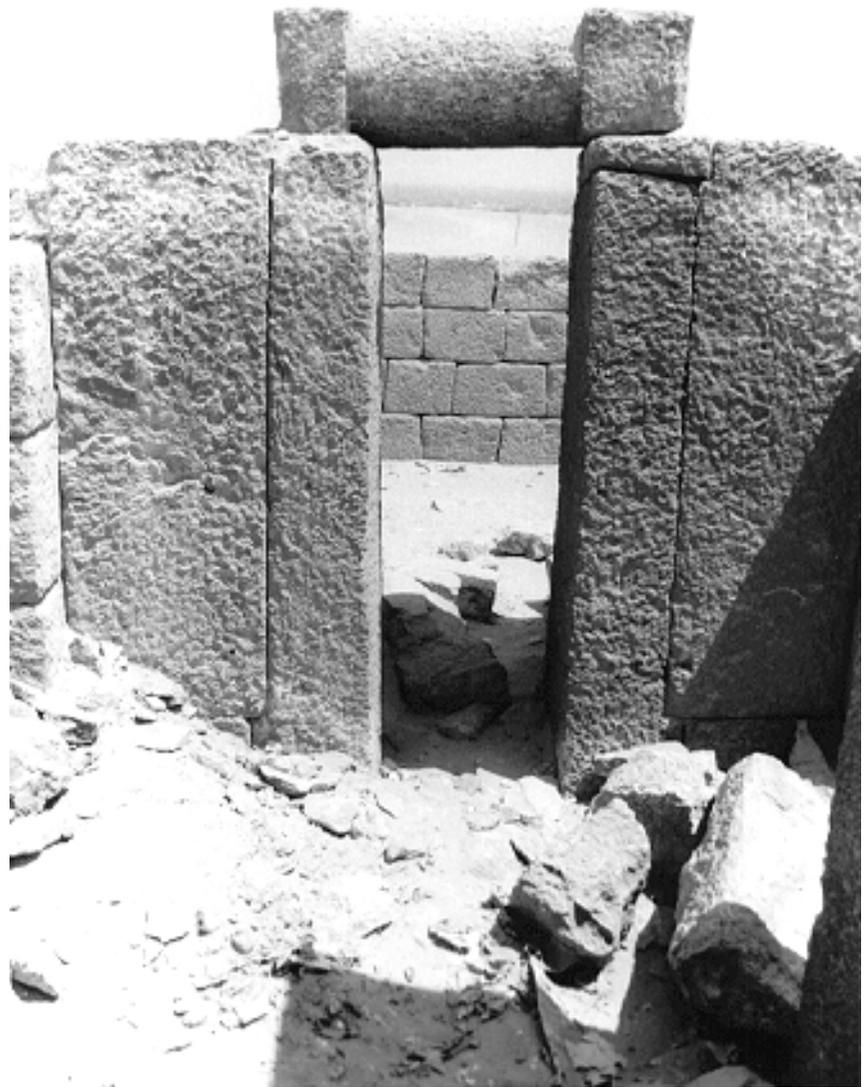
84a. 2097: doorway set between serdabs 2 and 3, leading from 2092+2093 courtyard into courtyard south of 2097. The direction of the drum lintel implies that it was an entrance to 2097 rather than 2092+2093, as does the elegant symmetrical stonework on this face. The large blocks behind the jambs rest on a lower course and a slight horizontal extension at the base of each jamb (amr, 1990)

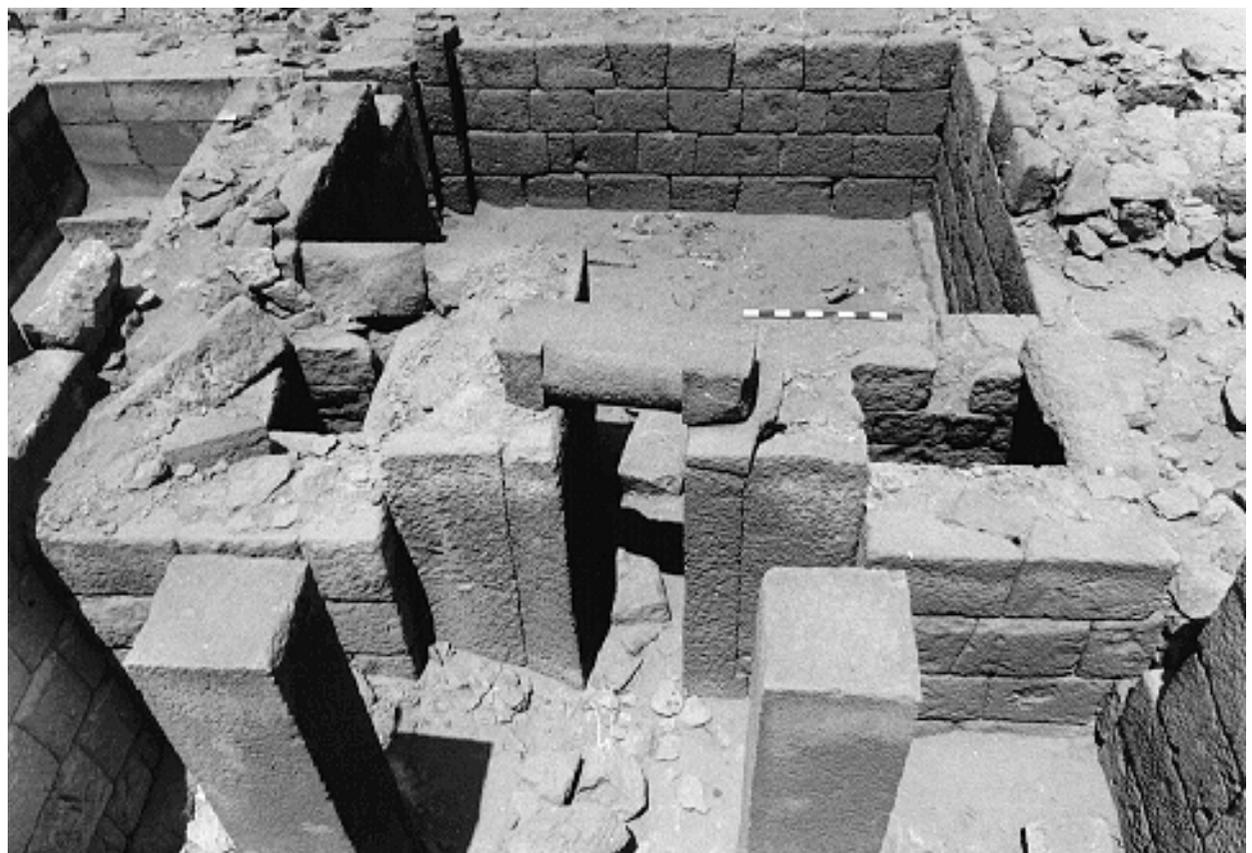
84b. 2097: view from the top of 2092. The courtyard behind the serdabs and the monumental doorway leads into the decorated chapel to the left. The lower course of the original back face of 2097' is visible at the bottom of the wall on the right of the courtyard (rg 24-28, 1989)

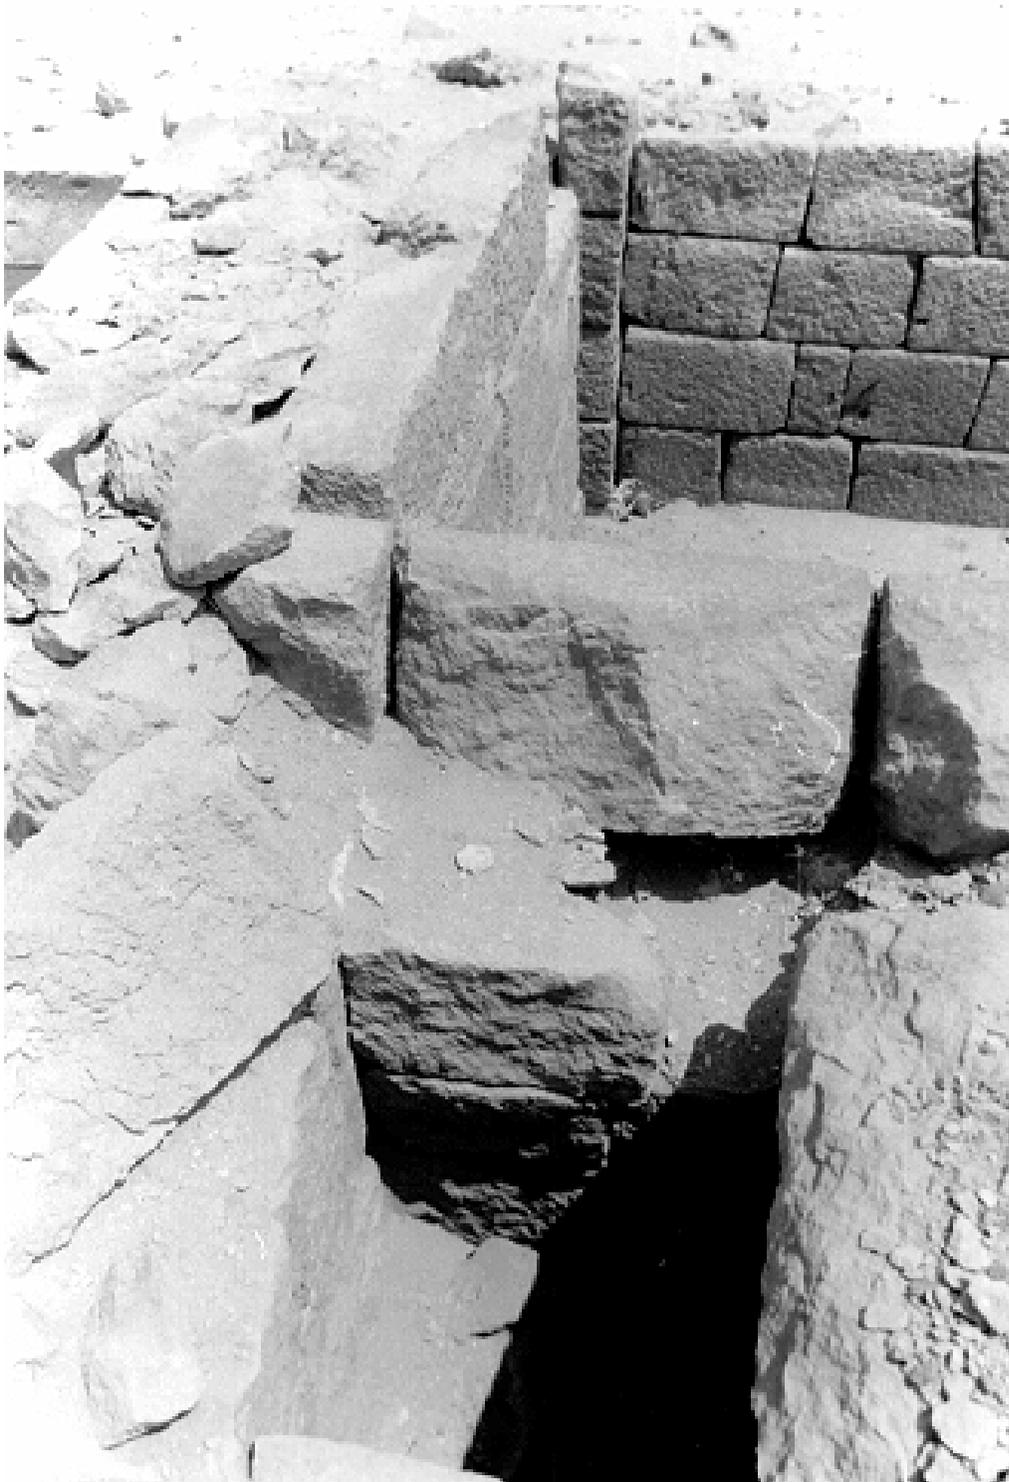
85a. 2097: The abutment of the west wall of the 2097 courtyard against the north face of serdab 3, viewed from the back. The angle of the 2097 wall is clearly different from the inner west wall of the serdab. That wall is parallel to the earlier angle of the west facade of 2097'. (See pl. 85b) (amr, 1990)

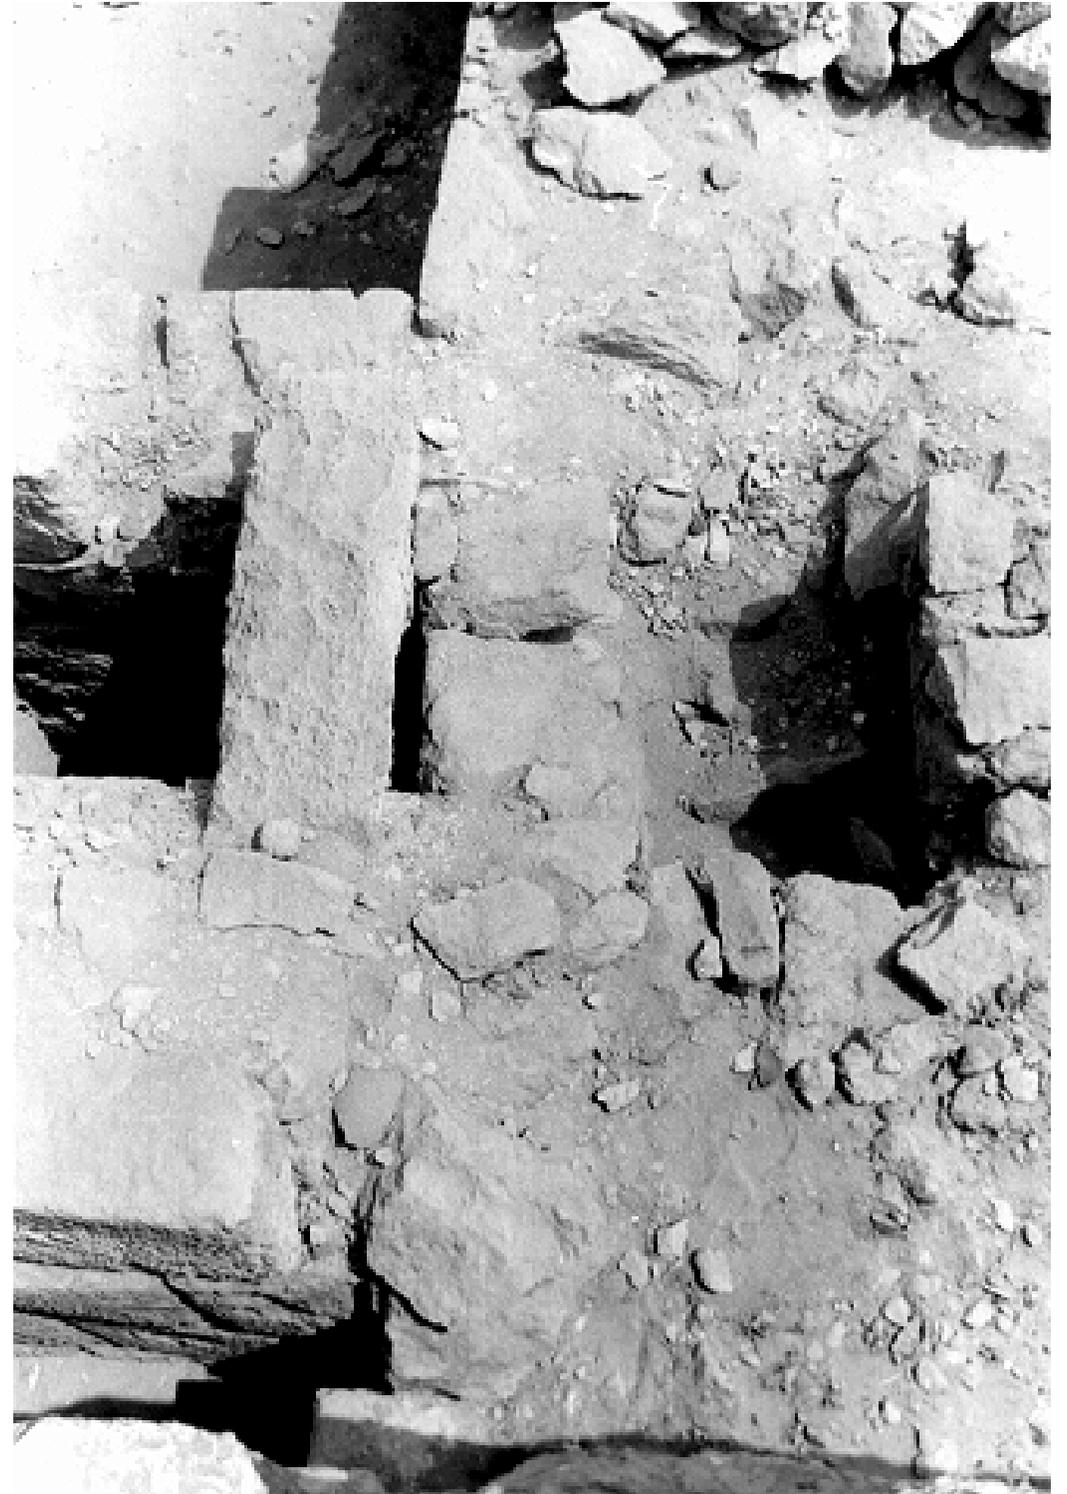
85b. 2097: Serdab 2 (left) and shaft 2097' f, showing the original angle of the west facade of 2097'. North of the serdab (above), the facade has been rebuilt at a different angle to form the east wall of the rectangular courtyard east of 2097 (amr, 1990)
